Annual Audit Compliance Report Form

| Trading as: | Northam Wastewater Treatment Plant | | |
| Reporting period: | 01 / 07 / 2019 to 30 / 06 / 2020 | | |

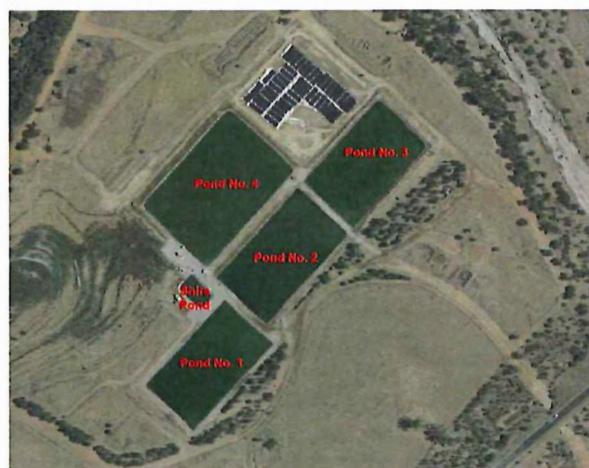
Figure 1. Aerial of Northam WWTP

When Secondary Treatment Pond 2 was taken offline and drained for de-sludging works in November 2019, at the time it was observed that the pond floor was undulating with evidence of hard material (possibly cemented lateritic gravel) exposed in several locations and damp areas were observed in the north-western portion of the pond floor. A geotechnical engineering assessment was completed on 18 March 2020 by Water Corporation, which concluded that it is likely that the clay liner has been compromised where the affected damp areas have been observed.

The Northam WWTP is not within a Bush Forever Site or classified as an Environmentally Sensitive Area. As part of the incident investigation, Water Corporation undertook a targeted soil assessment for the northern portion of Secondary Treatment Pond 2. The findings of this assessment demonstrated that all samples were below the adopted assessment criteria with the exception of concentrations of copper for two samples (95mg/kg and 85mg/kg), which exceeded the specific Ecological Investigation Level criteria of 70mg/kg. To decrease the residual risk and mitigate potential environmental and human health impacts, relining of the affected portion of Secondary Treatment Pond 2 was proposed and completed. Due to low flows in the Avon River (nearest sensitive receptor) since October 2019, no upstream or downstream surface sampling was able to be taken. However, in stream monitoring data obtained prior to the event indicated that there had been no adverse trends. Data remained consistent and generally within historical ranges. Additional monitoring data and analysis will be provided in the 2019-2020 Annual Environmental Report.

It is suspected that the compromise in the clay liner had resulted due to the cementing of lateritic gravel, a composite material of the clay liner itself. The cementing of the lateritic gravel is likely to have caused cracks in the liner and opportunity/pathway for seepage. The structural integrity of the containment infrastructure itself was not compromised as a result.
