Annual Environmental Report 2020-21

1 May 2020 to 30 June 2021

Business name:		Ref/licence #:	L7065/1997/11
Premises address:		Property #:	A3919 DP183655 1210 P069587 531
Proprietor:	Shire of Carnarvon	File #:	ADM0008
Manager/contact person:		Report date:	13/12/2021

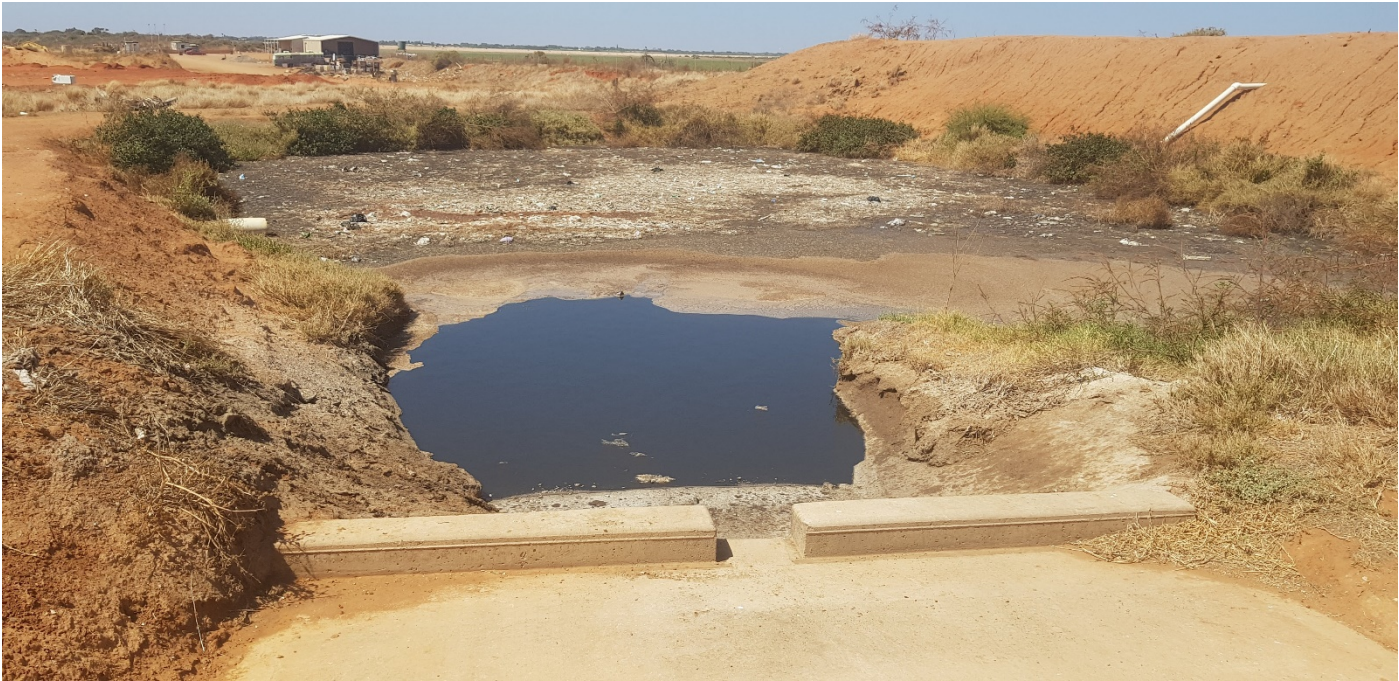
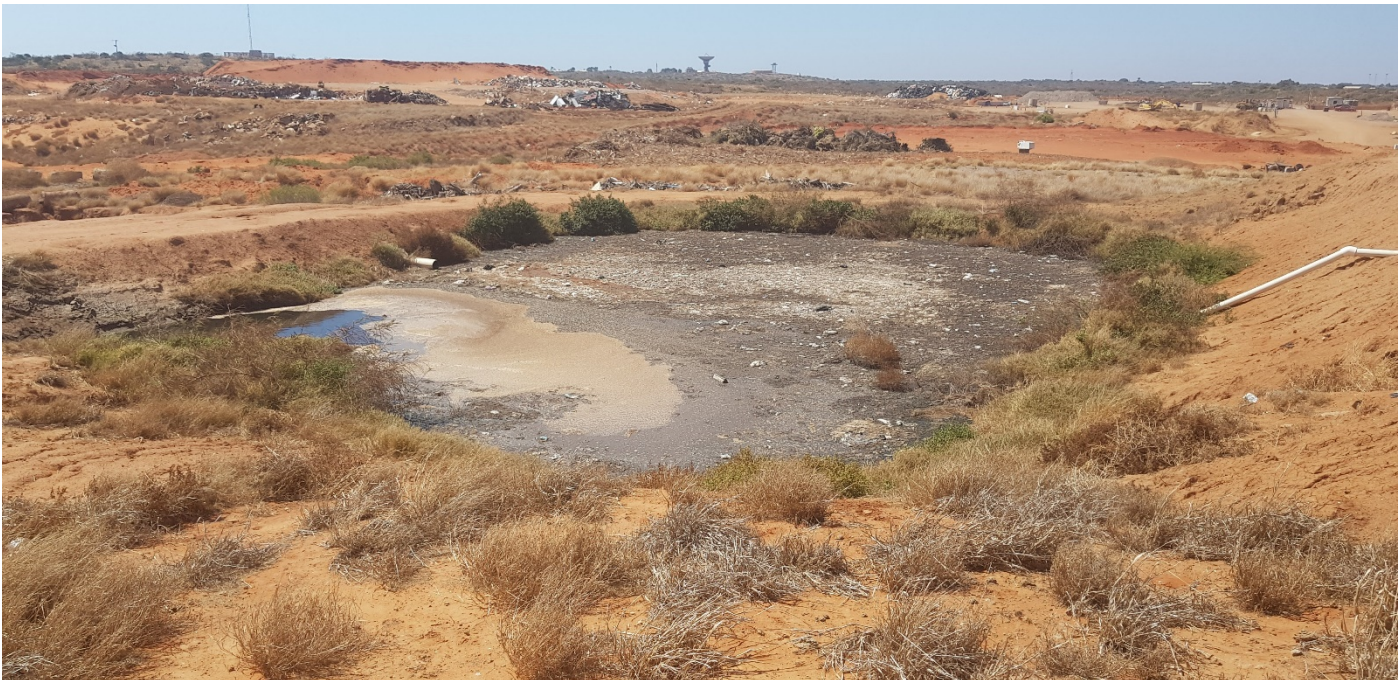
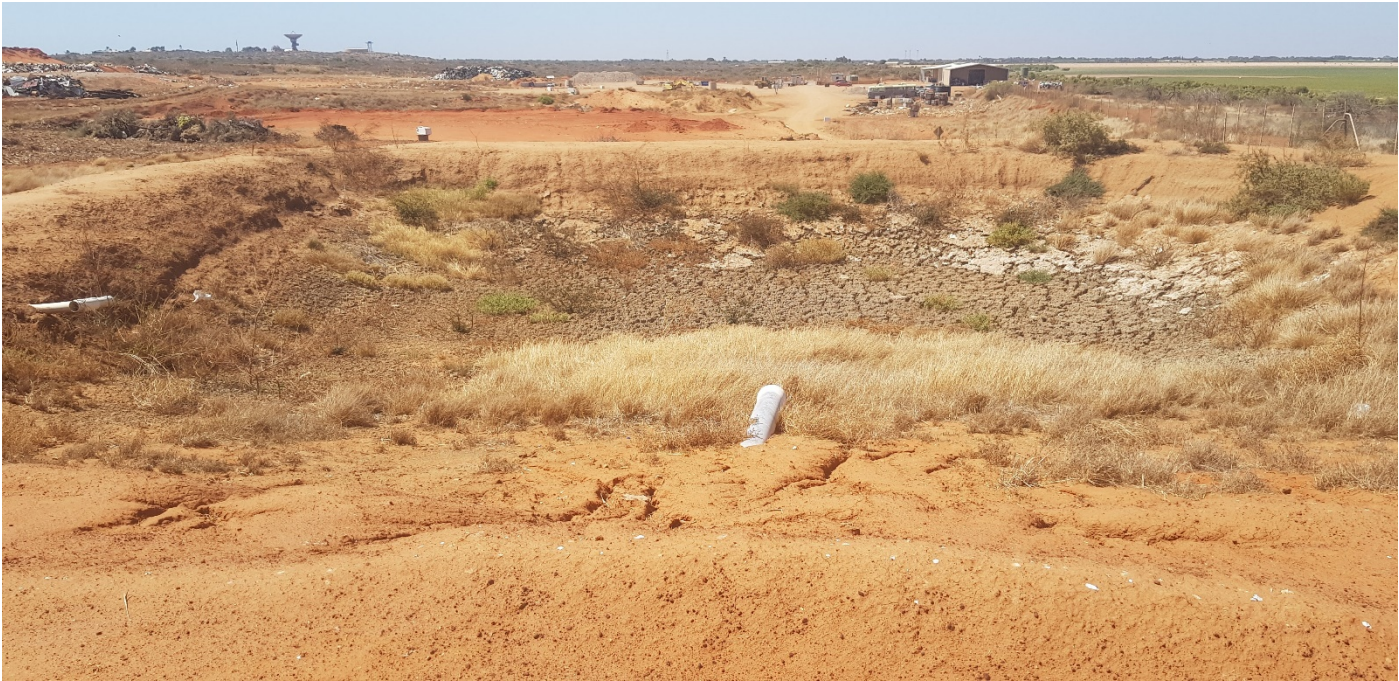
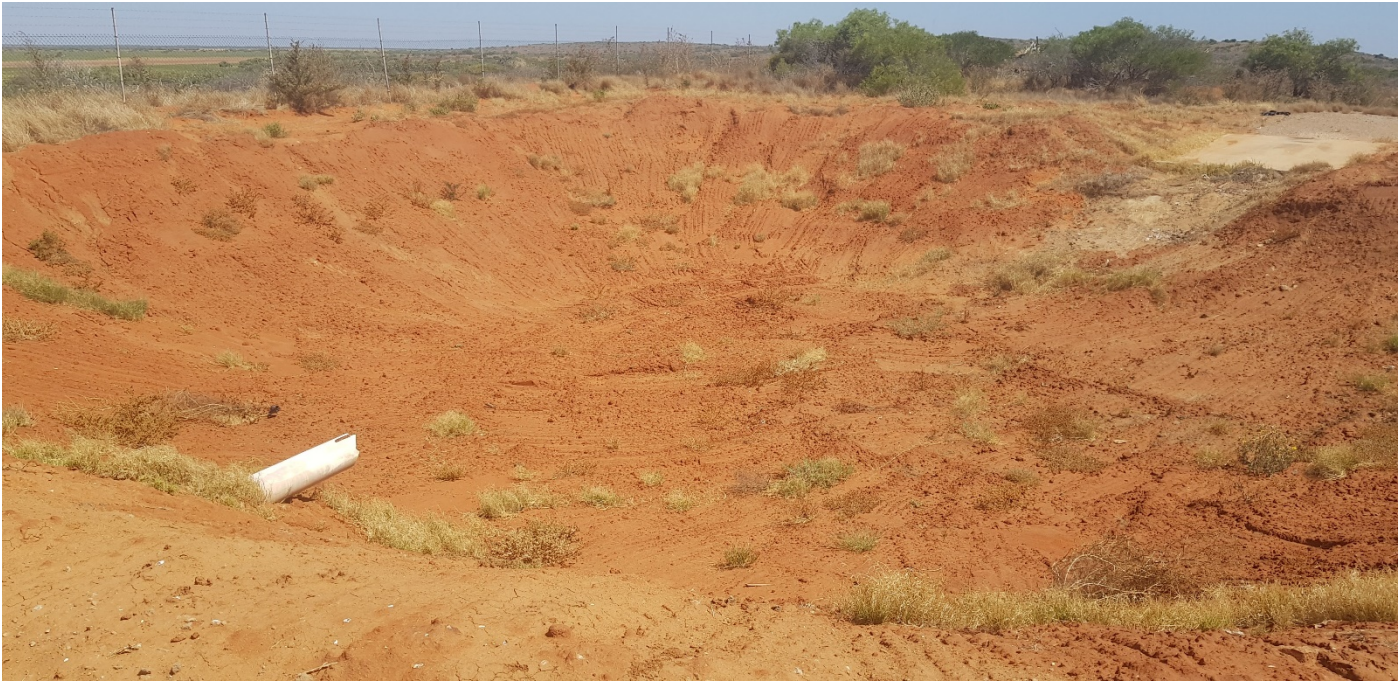
Figure 4. Liquid waste is increasing and a new location and design is recommended. Currently there are 2 primary pits and 2 secondary pits but the secondary pits should be larger and shallower to promote more evaporation, and all should be further from the tip entrance to reduce odour. Ideally the tip entrance and buildings would be on the southern side of the premises (upwind) but they are currently directly downwind of the liquid waste ponds.

Recommendation: Consider relocating the liquid waste ponds further to the south provided dense clay can be identified. Recommend redesign allowing for 3x deep primary ponds with chutes for direct delivery from the trucks without splashing, and 1x large shallow evaporation pond connected via a long square from each primary pond. Consider allowing room for another evaporation pond in the event that the first needs drying out and removal of biosolids.
