Application for Licence Amendment

Licence Number	L4680/1988/13
Licence Holder	FMR Investments Pty Ltd
ACN	009 411 349
File Number	2013/003899-1~13
Premises	Greenfields Processing Site Greta Eastern Highway COOLGARIE WA 6429 Legal description – Part of mining tenement M15/1836 and Lot 102 on Plan 40393 As defined by the Premises maps attached to the Revised Licence
Date of Report	03 November 2023
Decision	Revised licence granted

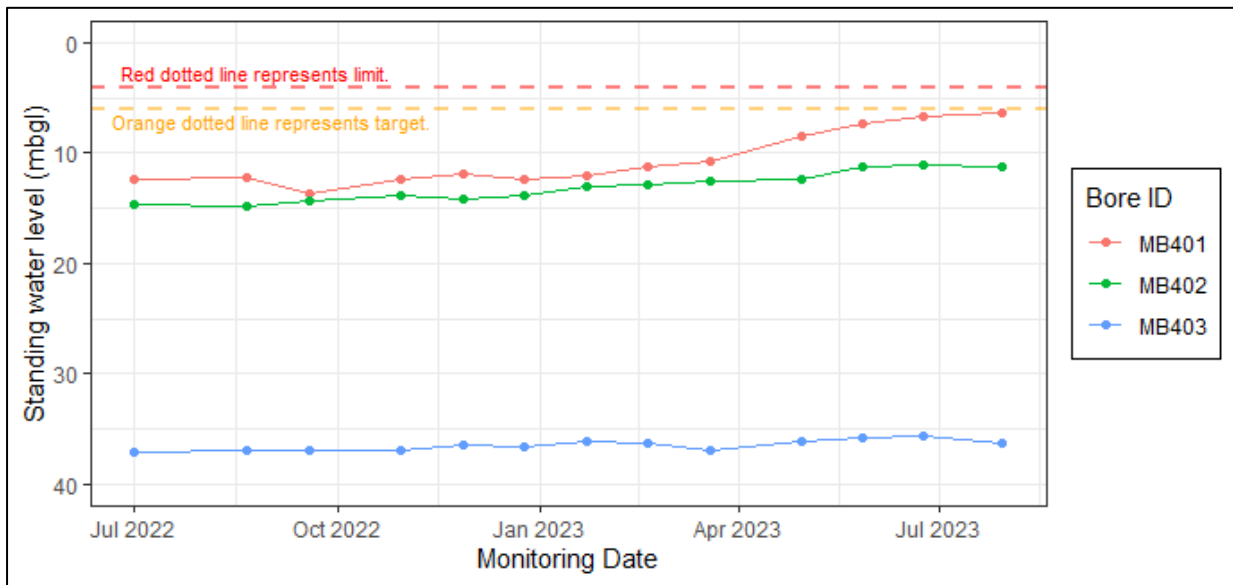
Figure 1: Standing water level at MB401, MB402 and MB403

- Standing water levels (SWL) of MB401 and MB402 were relatively shallow, ranging between 6.3 mbgl and 14.8 mbgl (Figure 1). Groundwater is deeper at MB403, encountered 35.7 mbgl and 37.2 mbgl. Groundwater monitoring data appears consistent with depth of water strike at the time of bore advancement.

- Standing water levels at all three monitoring bores appeared to be rising at varying rates. The shallowest groundwater was observed at MB401, increasing from 12.4 mbgl (July 2022) to 6.3 mbgl (July 2023), representing an approximate rise of 6 m within the previous annual period (Figure 1). Rate of SWL rise has been lower at the other monitoring bores, increasing by approximately 3 m and 1 m at MB402 and MB403, respectively.

Groundwater monitoring at the three monitoring bores around TSF4 has shown indications of localised groundwater mounding, which is characterised by a reduction in groundwater depth over time. Groundwater mounding along the northern portion of TSF4 appeared to be most severe, with SWL at MB401 increasing from 12.4 mbgl to 6.3 mbgl within twelve months, with higher rates of rise in later months (Figure 1). While there are indications of groundwater mounding observed at MB402 and MB403 as well, the extent of mounding appeared to be less severe, compared to MB401.

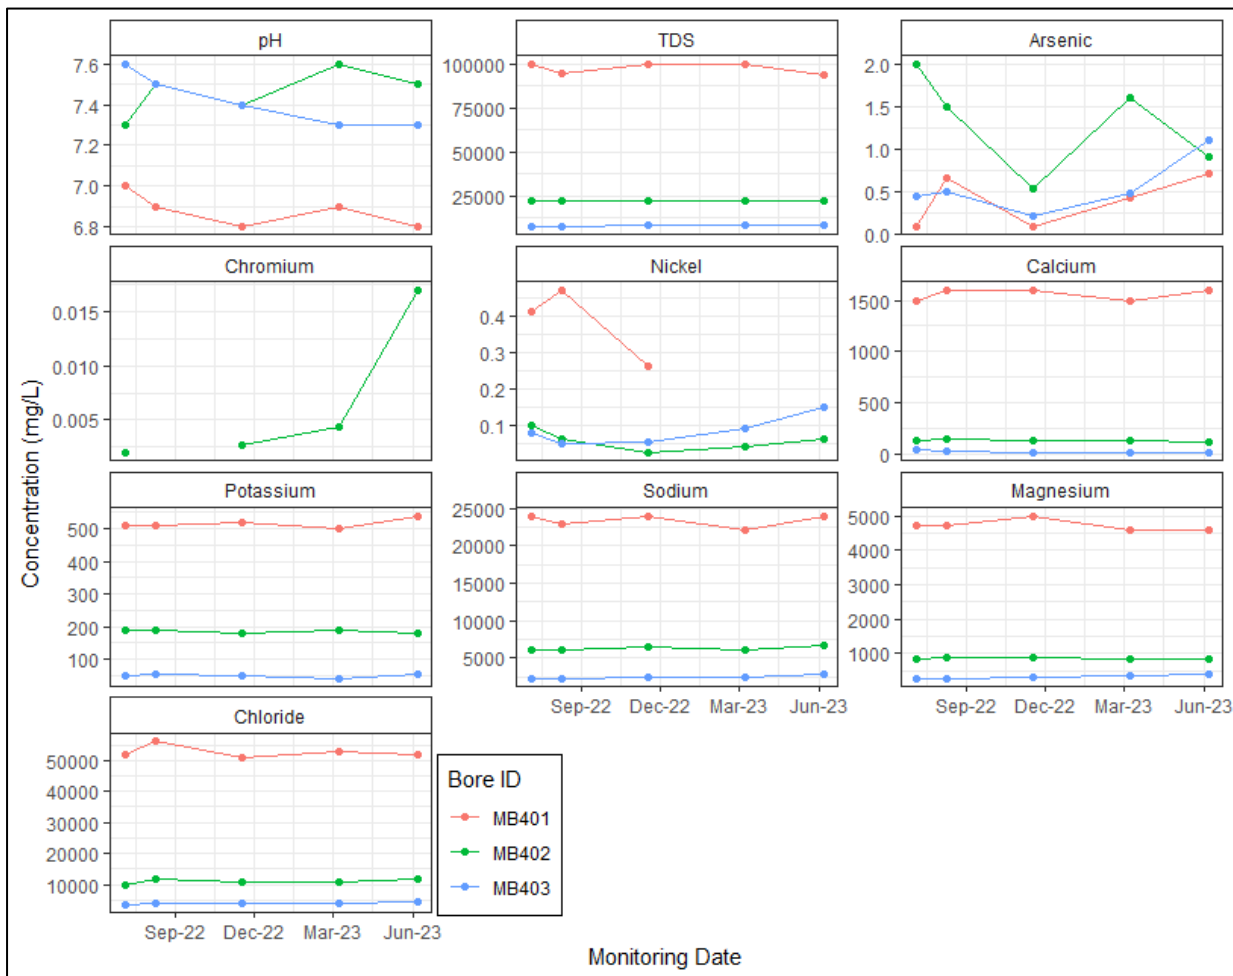
Figure 2: Water quality at MB401, MB402 and MB403

- Groundwater quality varied between the three groundwater monitoring bores (Figure 2). Generally, MB401 contained significantly higher total dissolved solids (TDS) and major ions (i.e., calcium, potassium, sodium, magnesium, chloride). Monitoring bores MB402 and MB403 contained similar concentrations of TDS and major ions, though concentrations in MB402 were slightly higher. The concentrations and trends observed were consistent with baseline monitoring undertaken prior to the time limited operation of TSF4, as required by works approval 6547/20221/1.

- Dissolved arsenic concentrations ranged between 0.09 mg/L and 2.0 mg/L, with the highest concentrations generally observed at MB402 (Figure 2). However, concentrations have decreased over time and was comparable to concentrations at MB401 and MB403 during the June 2023 monitoring event.

- Dissolved nickel concentrations ranged between 0.024 mg/L and 0.47 mg/L, with the highest concentrations generally observed at MB401 (Figure 2). However, concentrations have decreased over time and was reported below the limit of reporting during the March 2023 and June 2023 monitoring event (data not shown). However, the limit of reporting for samples from MB401 may have been raised due to the high TDS content in the sample matrix. Therefore, comparison of MB401 against MB402 and MB403 may be difficult. Further monitoring is required.

Seepage from tailings deposited into TSF4 have the potential to contaminate the local unconfined aquifer. Seepage influences from TSF4 appeared to be limited, as no significant changes were observed for TDS and major ions (i.e., calcium, potassium, sodium, magnesium, and chloride) within the monitoring bores (Figure 2). While dissolved arsenic and nickel were observed at detectable concentrations, further monitoring may be required to assess the impacts of tailings seepage more confidently on groundwater quality.
