Application for Licence Amendment

Licence Number	L5206/1987/10
Applicant	Wiluna Operations Pty Ltd
ACN	166 954 525
File number	APP-0027070
Premises	<p>Wiluna Mine Site</p> <p>WILUNA WA 6646</p> <p>Mining tenements: M53/30, M53/32, M53/468, L53/62, L53/20, M53/64, G53/18 and G53/19 and part tenements M53/40, M53/44, M53/50, M53/26, M53/6, M53/95, M53/96, M53/200, M53/69, M53/24 L53/50 and L53/77</p> <p>As defined by the coordinates in Schedule 4 of the licence.</p>
Date of report	14 July 2025
Decision	Revised licence granted

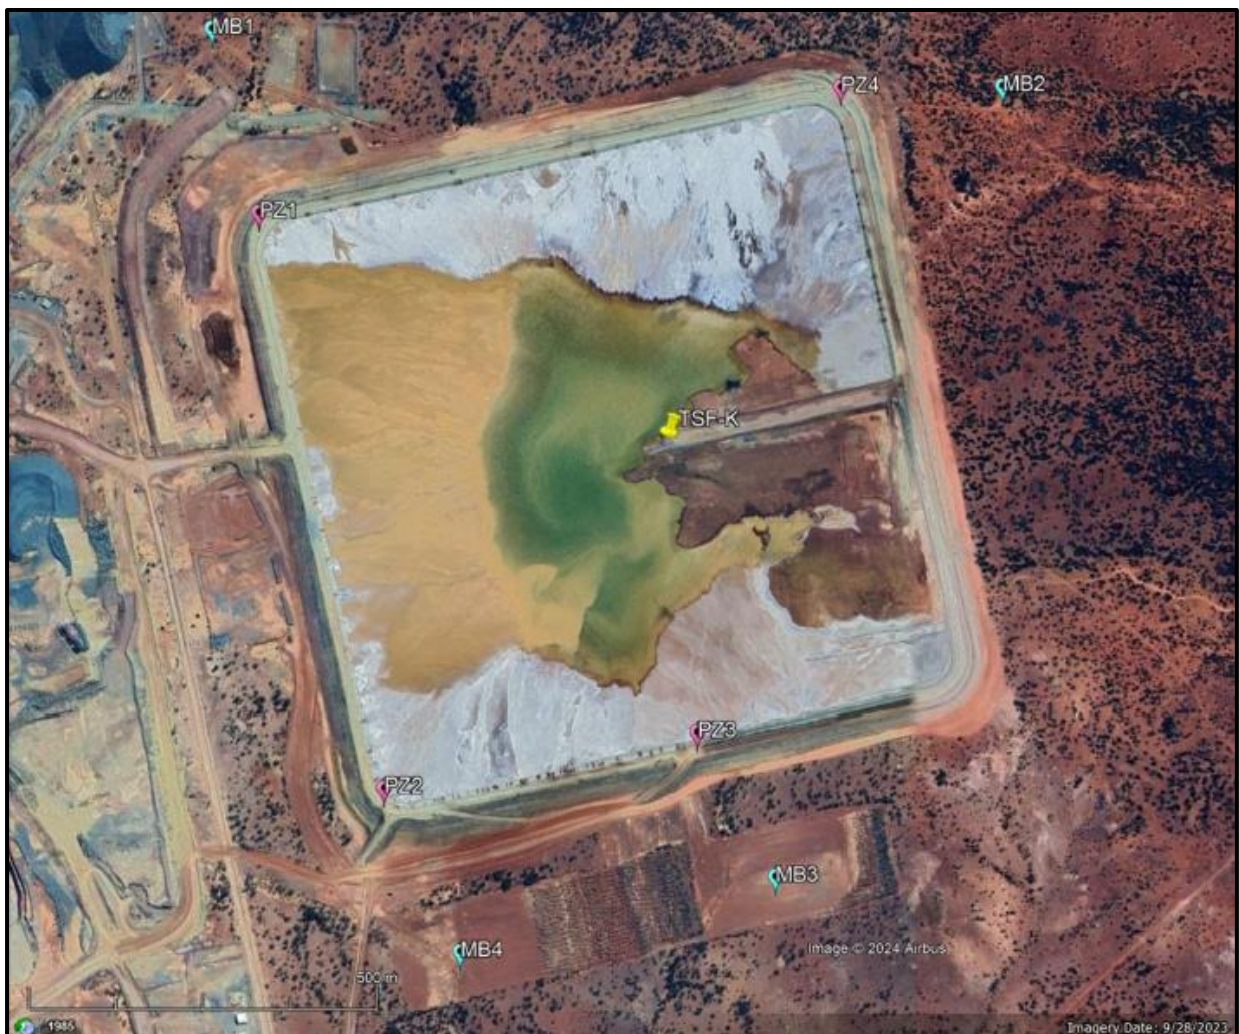
Figure 5. Location of current groundwater bores (MB1-4, equivalent to TD17K-20K on the licence) and standpipe piezometers (PZ1-4)

(TD17K – TD19K on the licence) and four standpipe piezometers (PZ1 – PZ4) – Figure 5. The groundwater bores became operational in June 2020. A monitoring program that includes standing water level and several metal, metalloids and non-metal parameters has been an obligation under the licence since the TSF construction. A limit of 4 mbgl with a target of 6 mbgl currently applies. Limits also apply to concentrations of soluble arsenic (0.4 mg/L) and weak acid dissociable cyanide (0.5 mg/L). Frequency of monitoring under the program varies either quarterly or annually depending on the parameter monitored (condition 3.4.1).

The standpipe piezometers are located to the north and south of the embankment wall. Piezometers monitoring is outside the scope of the licence conditions, however, TSF K Stage 2 embankment raise application showed that trigger levels were set by the licence holder, and controls were implemented to maintain an acceptable factor of safety of the embankment.

The licence holder deemed the current monitoring infrastructure sufficient for Stage 3 embankment raise operations, however it was proposed to replace the piezometers during Stage 4 raise construction in adjacent locations to the existing ones.

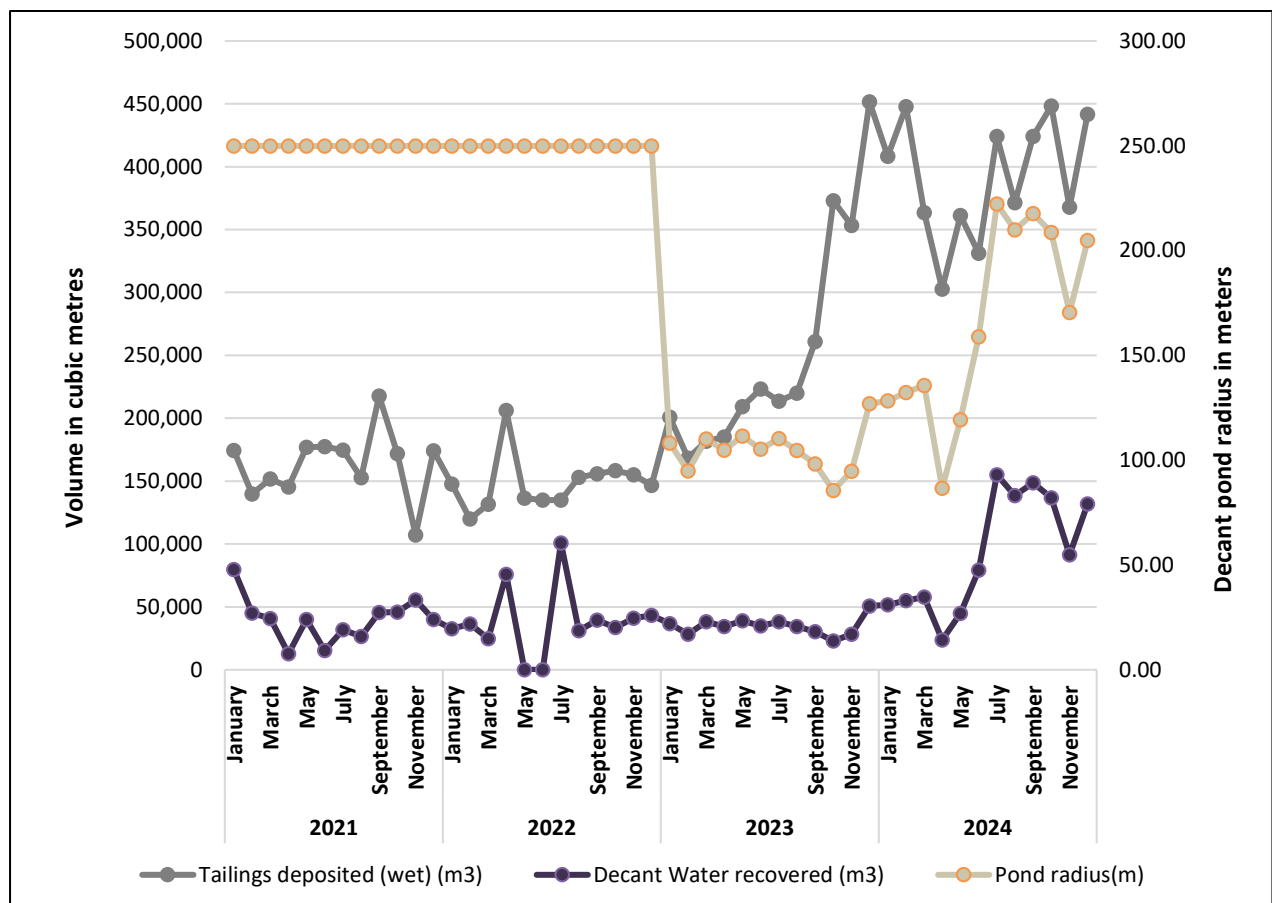
Figure 11. Volume of tailings deposited, decant water recovered and pond radius over time

Figure 11 shows how the volumes of tailings slurry deposited, decant water recovered and the pond radius vary between 2021 (beginning of deposition) and 2024. The figure is based on the data provided by the licence holder as part of the annual reporting requirements, with the decant pond radius extrapolated from the data provided.

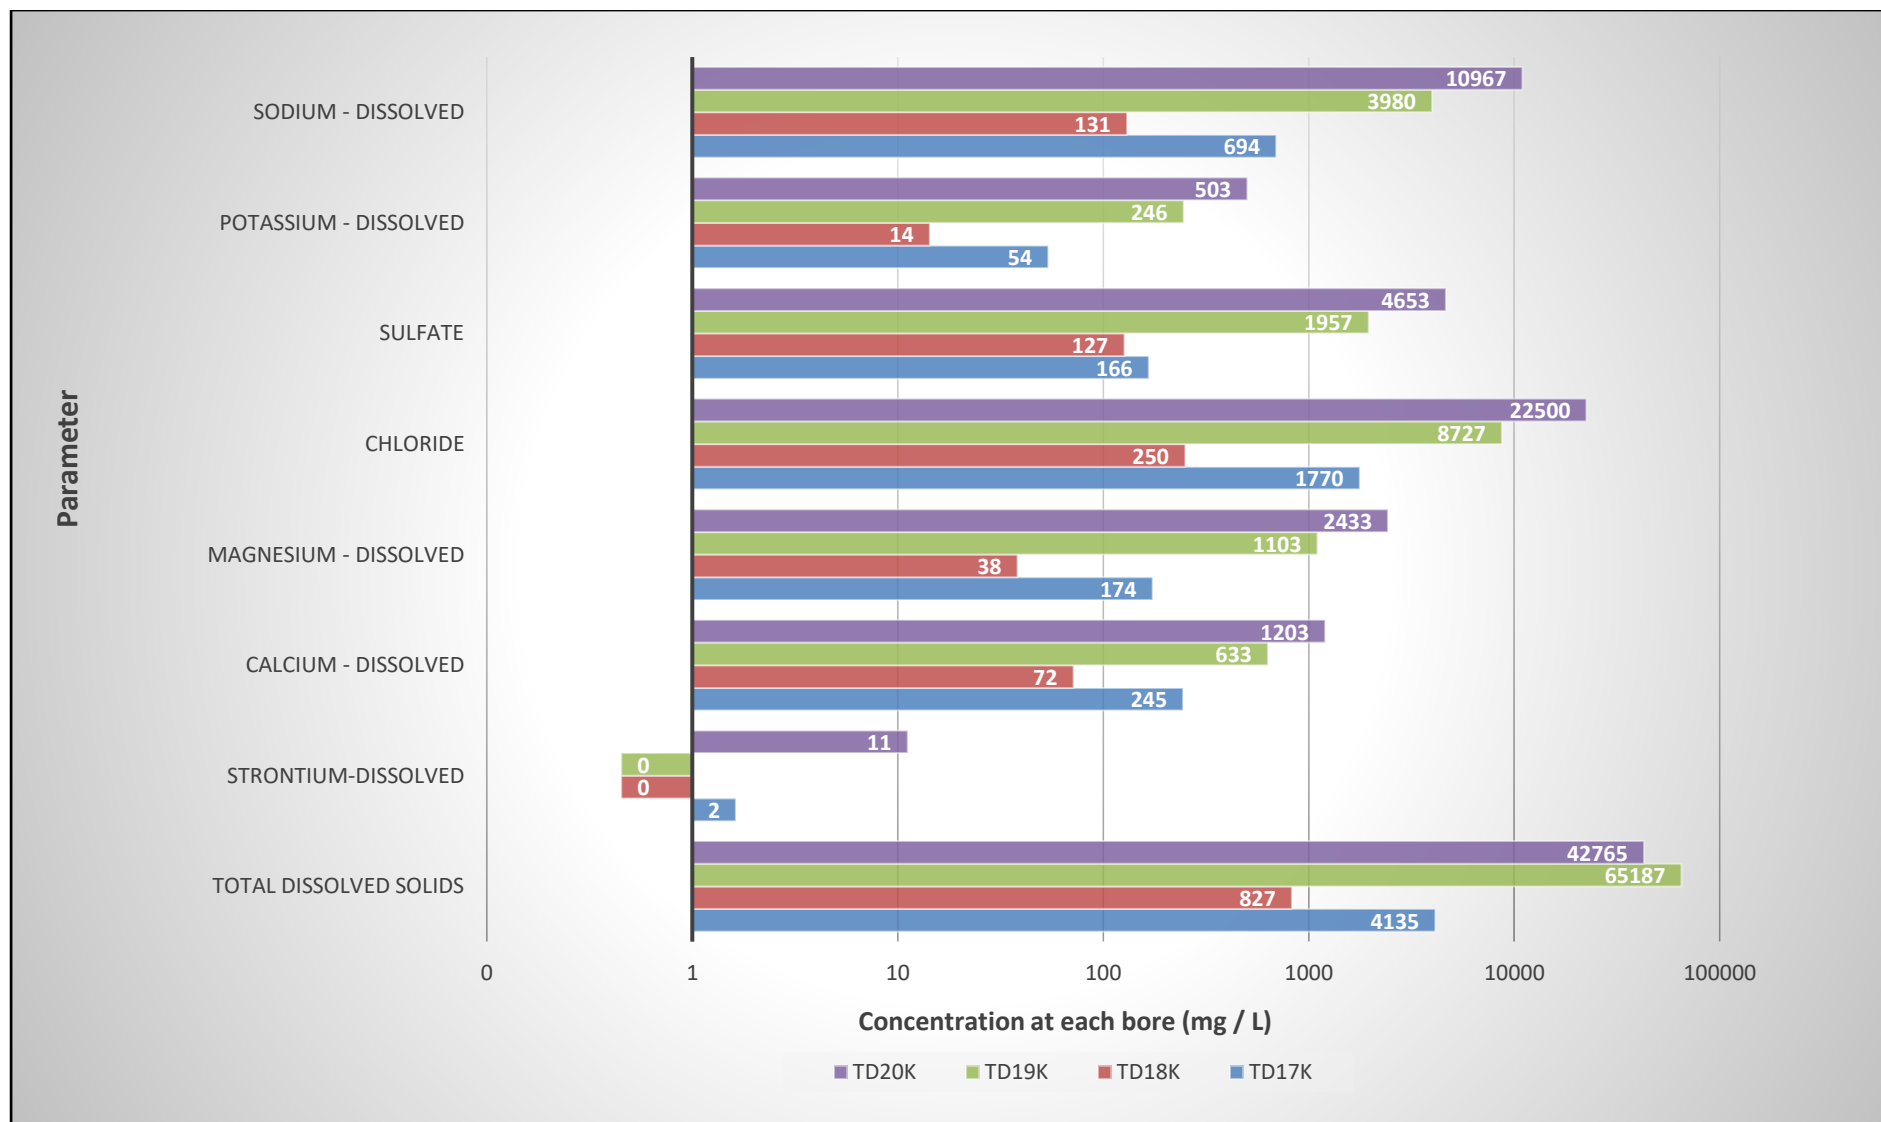
Figure 14. Comparison of concentration of some of the parameters in groundwater at the TSF K monitoring bores

Figure 14 shows a comparison of the data presented by the licence holder for the 2024 reporting year at the different bores surrounding the TSF.
