Application for Licence Amendment

Licence Number	L5946/1988/13
Licence Holder	Kalgoorlie Consolidated Gold Mines Pty Ltd
ACN	009 377 619
File Number	APP-0029965
Premises	Gidji Processing Plant KALGOORLIE WA 6430 Legal description – General purpose leases G24/24, G24/25, G24/26, G24/27, G24/28, G24/29, G24/30, G24/31, G24/32, and G24/33 As defined by the Premises map attached to the Revised Licence.
Date of Report	25 March 2026
Decision	Revised licence granted

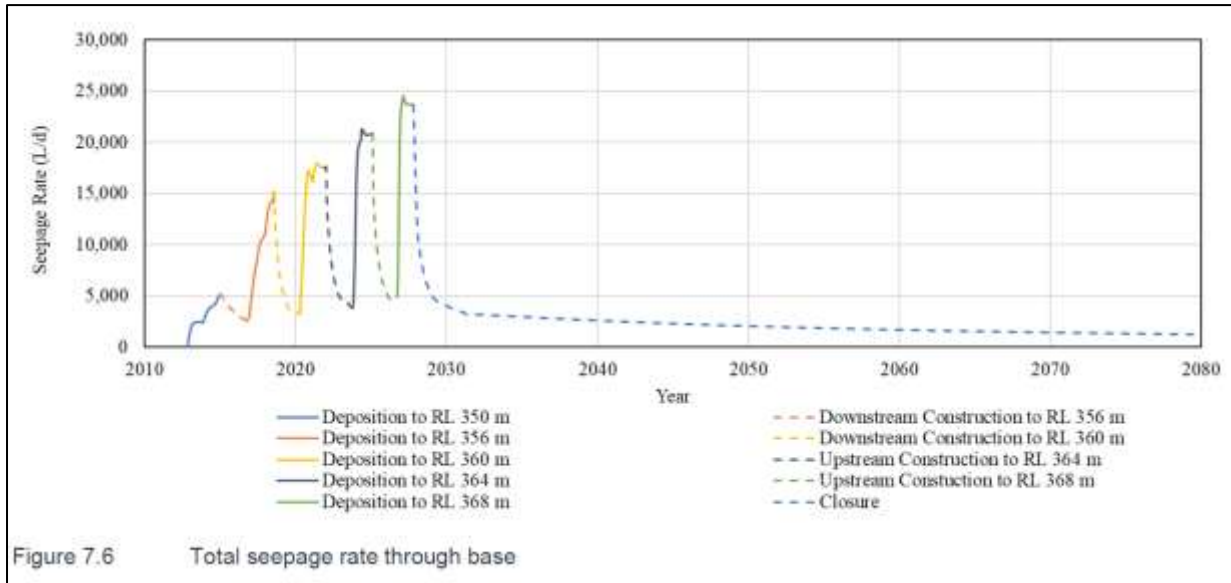
Figure 3: Predicted seepage rate through the base of Gidji II TSF over time

While seepage rates through the embankments are not expected to increase significantly due to the HDPE liner, predicted seepage rates through the base of Gidji II TSF would have increased from the current embankment height. At the current approved height, Golder (2022) previously estimated seepage rate through the base of the facility to be 21,350 L/day or approximately 2% of volumetric water deposited into the TSF (Figure 3). Under the proposed embankment raise, maximum seepage rate through the base of the facility was predicted to increase to 24,500 L/day or approximately 2.5% of volumetric water deposited.

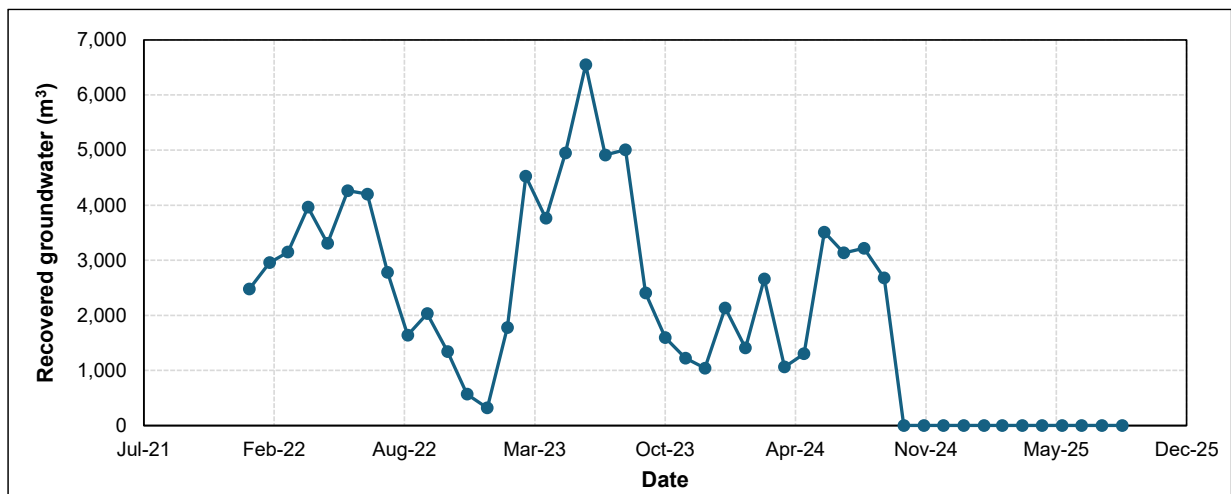
Figure 4: Annual groundwater recovery from 2022 to 2025

Furthermore, the department noted that groundwater recovery bores yielded approximately 32,678 m³ and 38,060 m³ of groundwater over the 2022 and 2023 annual periods (Figure 4). However, recovery yield decreased to 21,106 m³ in 2024 annual period, as pumping ceased in October 2024. No groundwater yield has not been reported since then.

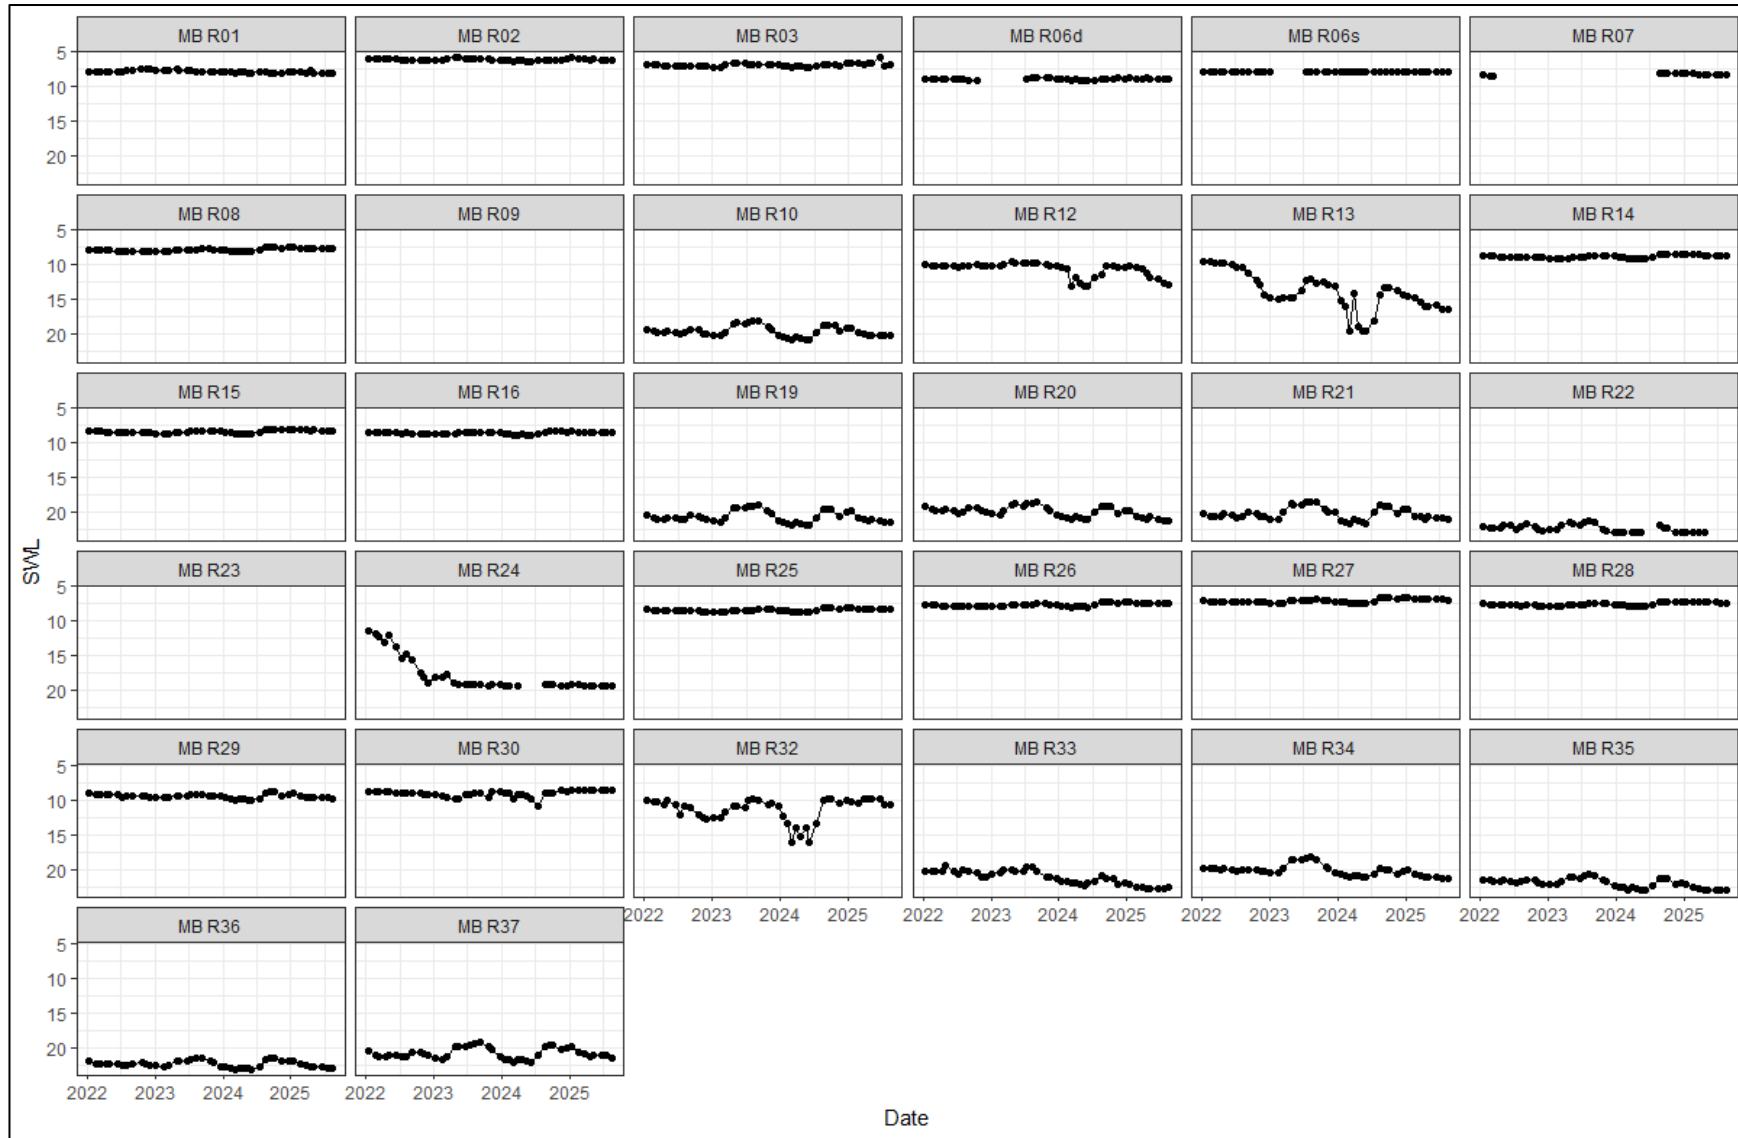
Figure 6: Groundwater level at monitoring bores between 2022 and 2025

In recent years, with continued tailings deposition into Gidji II TSF, groundwater levels remained relatively stable beyond exhibiting seasonal fluctuations (Figure 6). Overall, groundwater levels were relatively deep around the premises, except near the TSF perimeters and to the west and south-west (Figure 7). Fittingly, historical groundwater recovery efforts have focused in this area, especially around the Gidji I TSF toe. Nevertheless, a noticeable declining trend in groundwater level was observed at some monitoring bores (e.g., MB R12, MB R13, MB R24).

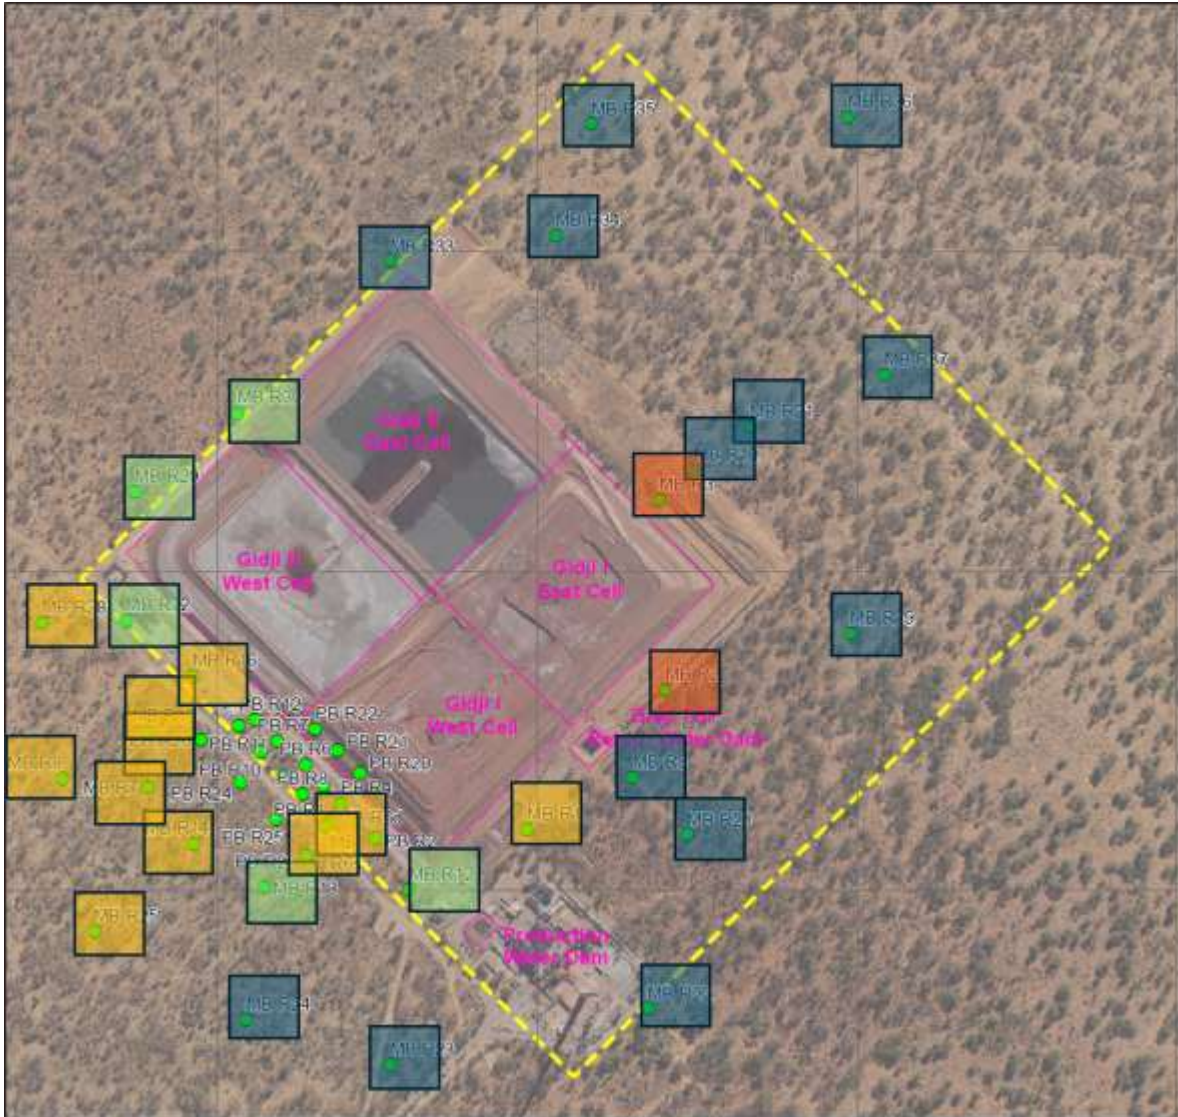
Figure 7: Groundwater level at the premises, represented by blue boxes (approx. 20 mbgl or deeper), green boxes (between 10 to 20 mbgl), yellow boxes (10 mbgl or shallower), and orange boxes (10 mbgl or shallower, with at least one exceedance of 6 mbgl between 2022 and 2025)
