## Application for Licence Amendment

### Part V Division 3 of the *Environmental Protection Act 1986*

| <b>Licence Holder</b> | Murrin Murrin Operations Pty Ltd |
| <b>Premises</b> | <p>Murrin Murrin Nickel Cobalt Project</p> <p>Mining tenements: L39/62, L39/81, L39/83, L39/136, L39/168, M39/299, M39/300, M39/301, M39/314, M39/322, M39/421, M39/422, M39/423, M39/435, M39/436, M39/424, M39/342, M39/343, M39/420, M39/446, M39/553, M39/562, M39/637, M39/651, M39/686, M39/692, M39/714, M39/715, M39/716, M39/737, M39/820, M39/848 and M39/1066.</p> <p>LAVERTON WA 6440</p> <p>As defined by Figure 1 attached to the Revised Licence</p> |

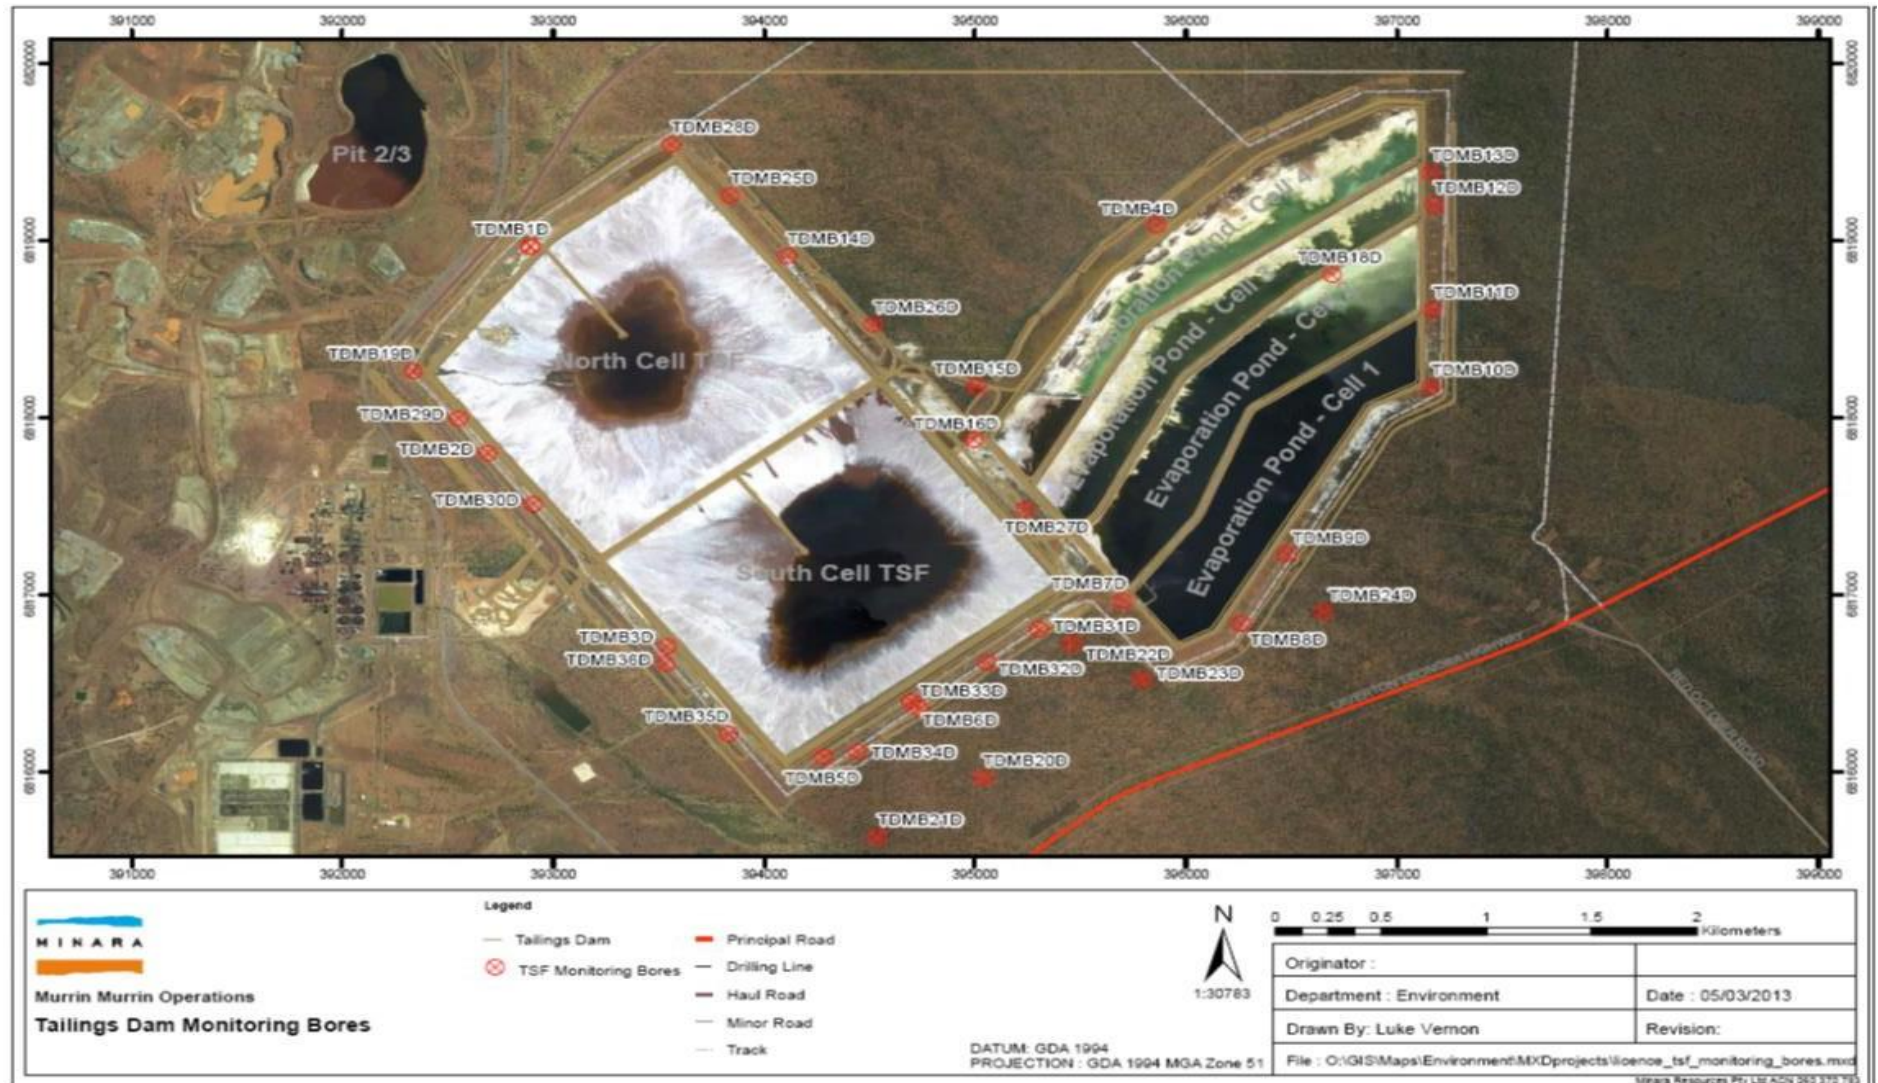
Figure 2: Evaporation ponds and monitoring bores

The recovered decant water from the 19Sth in-pit TSF will be transported by the newly constructed and existing pipeline (Figure 1). The decant will then be discharged into the existing evaporation ponds located to the east of the paddock TSF (Figure 2).

In 2004 the licence holder implemented a Seepage Mitigation Project (Minara Resources 2023) to lower the rising groundwater mound identified beneath the paddock TSF and evaporation ponds (Figure 2). The Seepage Mitigation Project goal was to also reduce the migration of contaminants seeping from the paddock TSF and evaporation ponds to downstream areas. To achieve these goals and assess the effectiveness of the Seepage Mitigation Project a Seepage Management Plan (SMP) was developed. As part of this SMP seepage recovery infrastructure was installed. As of 23 April 2025, there are currently 100 seepage recovery equipped bores and four seepage interception trenches around the perimeter of the paddock TSF and evaporation ponds (Minara Resources 2025).

Historical TDS and nickel concentrations recorded in monitoring bores associated with the evaporation ponds are presented in Table 4 and Table 5 respectively. Results indicate that generally TDS concentrations recorded around the evaporation ponds is brackish (1,000 – 10,000 mg/L). Saline (10,000 – 35,000 mg/L) to hypersaline results (>35,000 mg/L) have been recorded within TDMB4D, TDMB18D and TDMB27D which are located to the north, between cell 2 and cell 3 ponds and to the west of the evaporation ponds respectively (Figure 2).

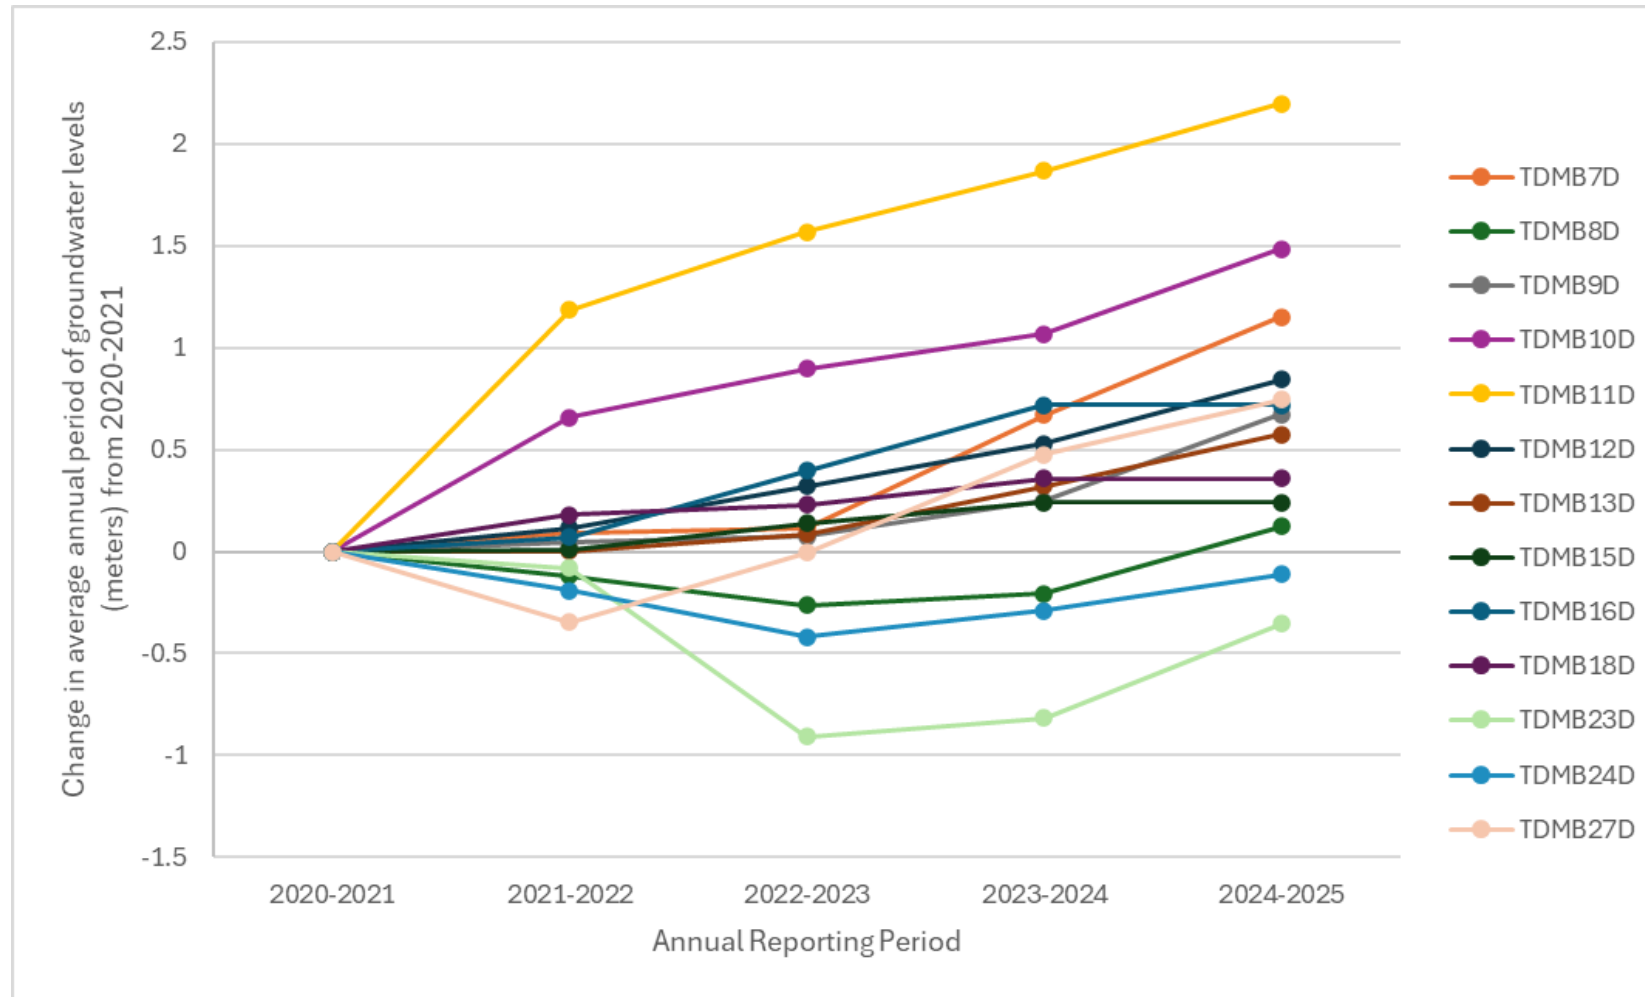
**Figure 7: Change in standing water levels from 2020-2021 annual period to 2024-2025 annual period**

Recent standing water level (SWL) measurements from groundwater monitoring bores surrounding the evaporation ponds indicate that groundwater levels have either plateaued or are continuing to rise. Figure 7 illustrates the change in groundwater levels over time, comparing data from the 2020–2021 annual reporting period to the 2024–2025 period. Average groundwater levels were calculated for each reporting year (1 May to 30 April) and plotted as deviations from the 2020–2021 baseline. All monitoring bores in the vicinity of the evaporation ponds show an upward trend in groundwater levels, with the exception of TDMB24D and TDMB27D, which did not follow this pattern. Figure 8 presents historical groundwater data dating back to 2001, highlighting that current groundwater levels are significantly elevated compared to baseline conditions.

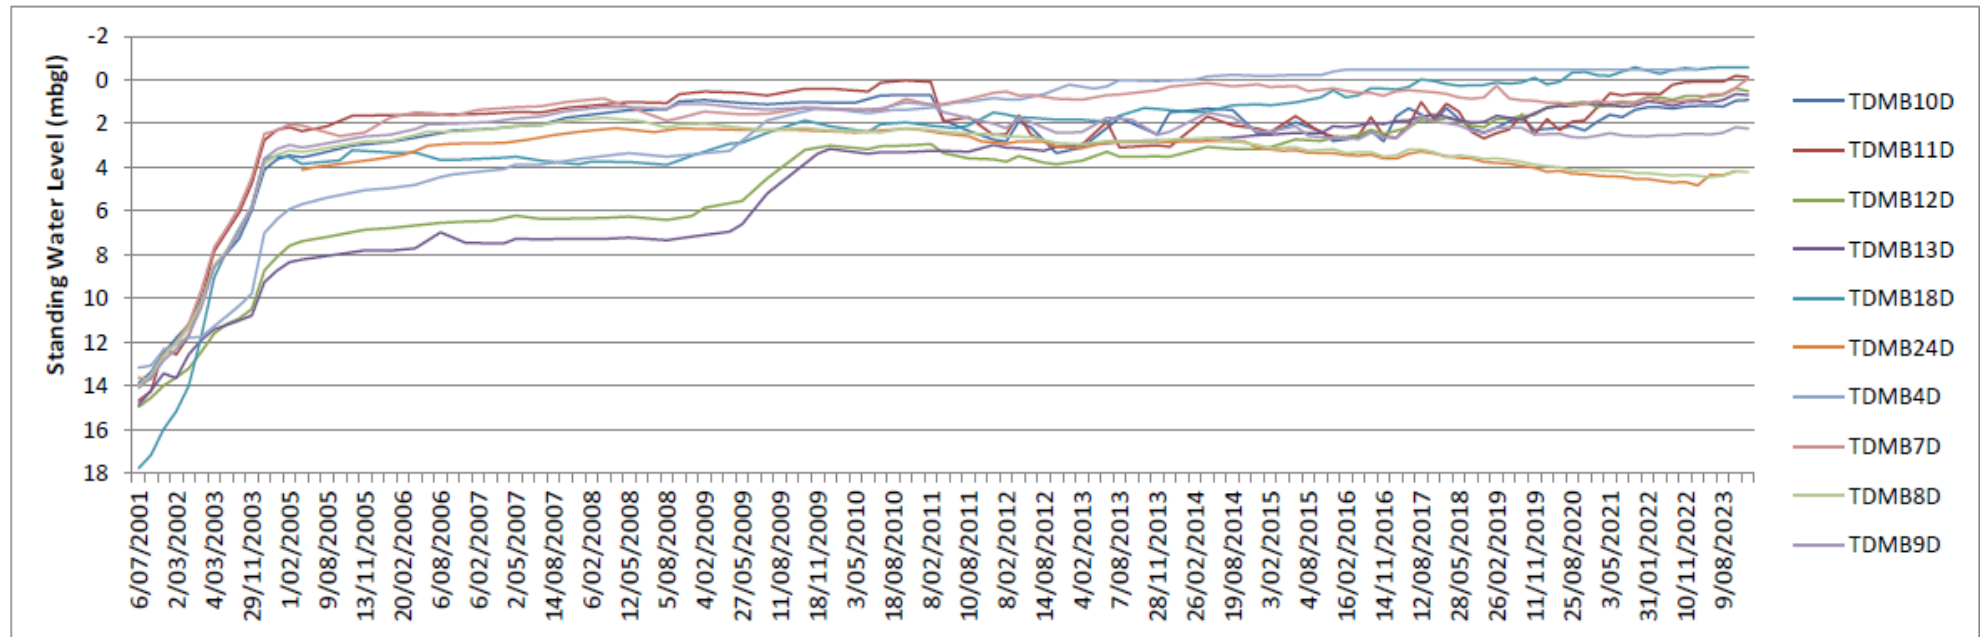
**Figure 8: Historical standing water levels from 2001 to 2024 in monitoring bores surrounding the evaporation ponds**

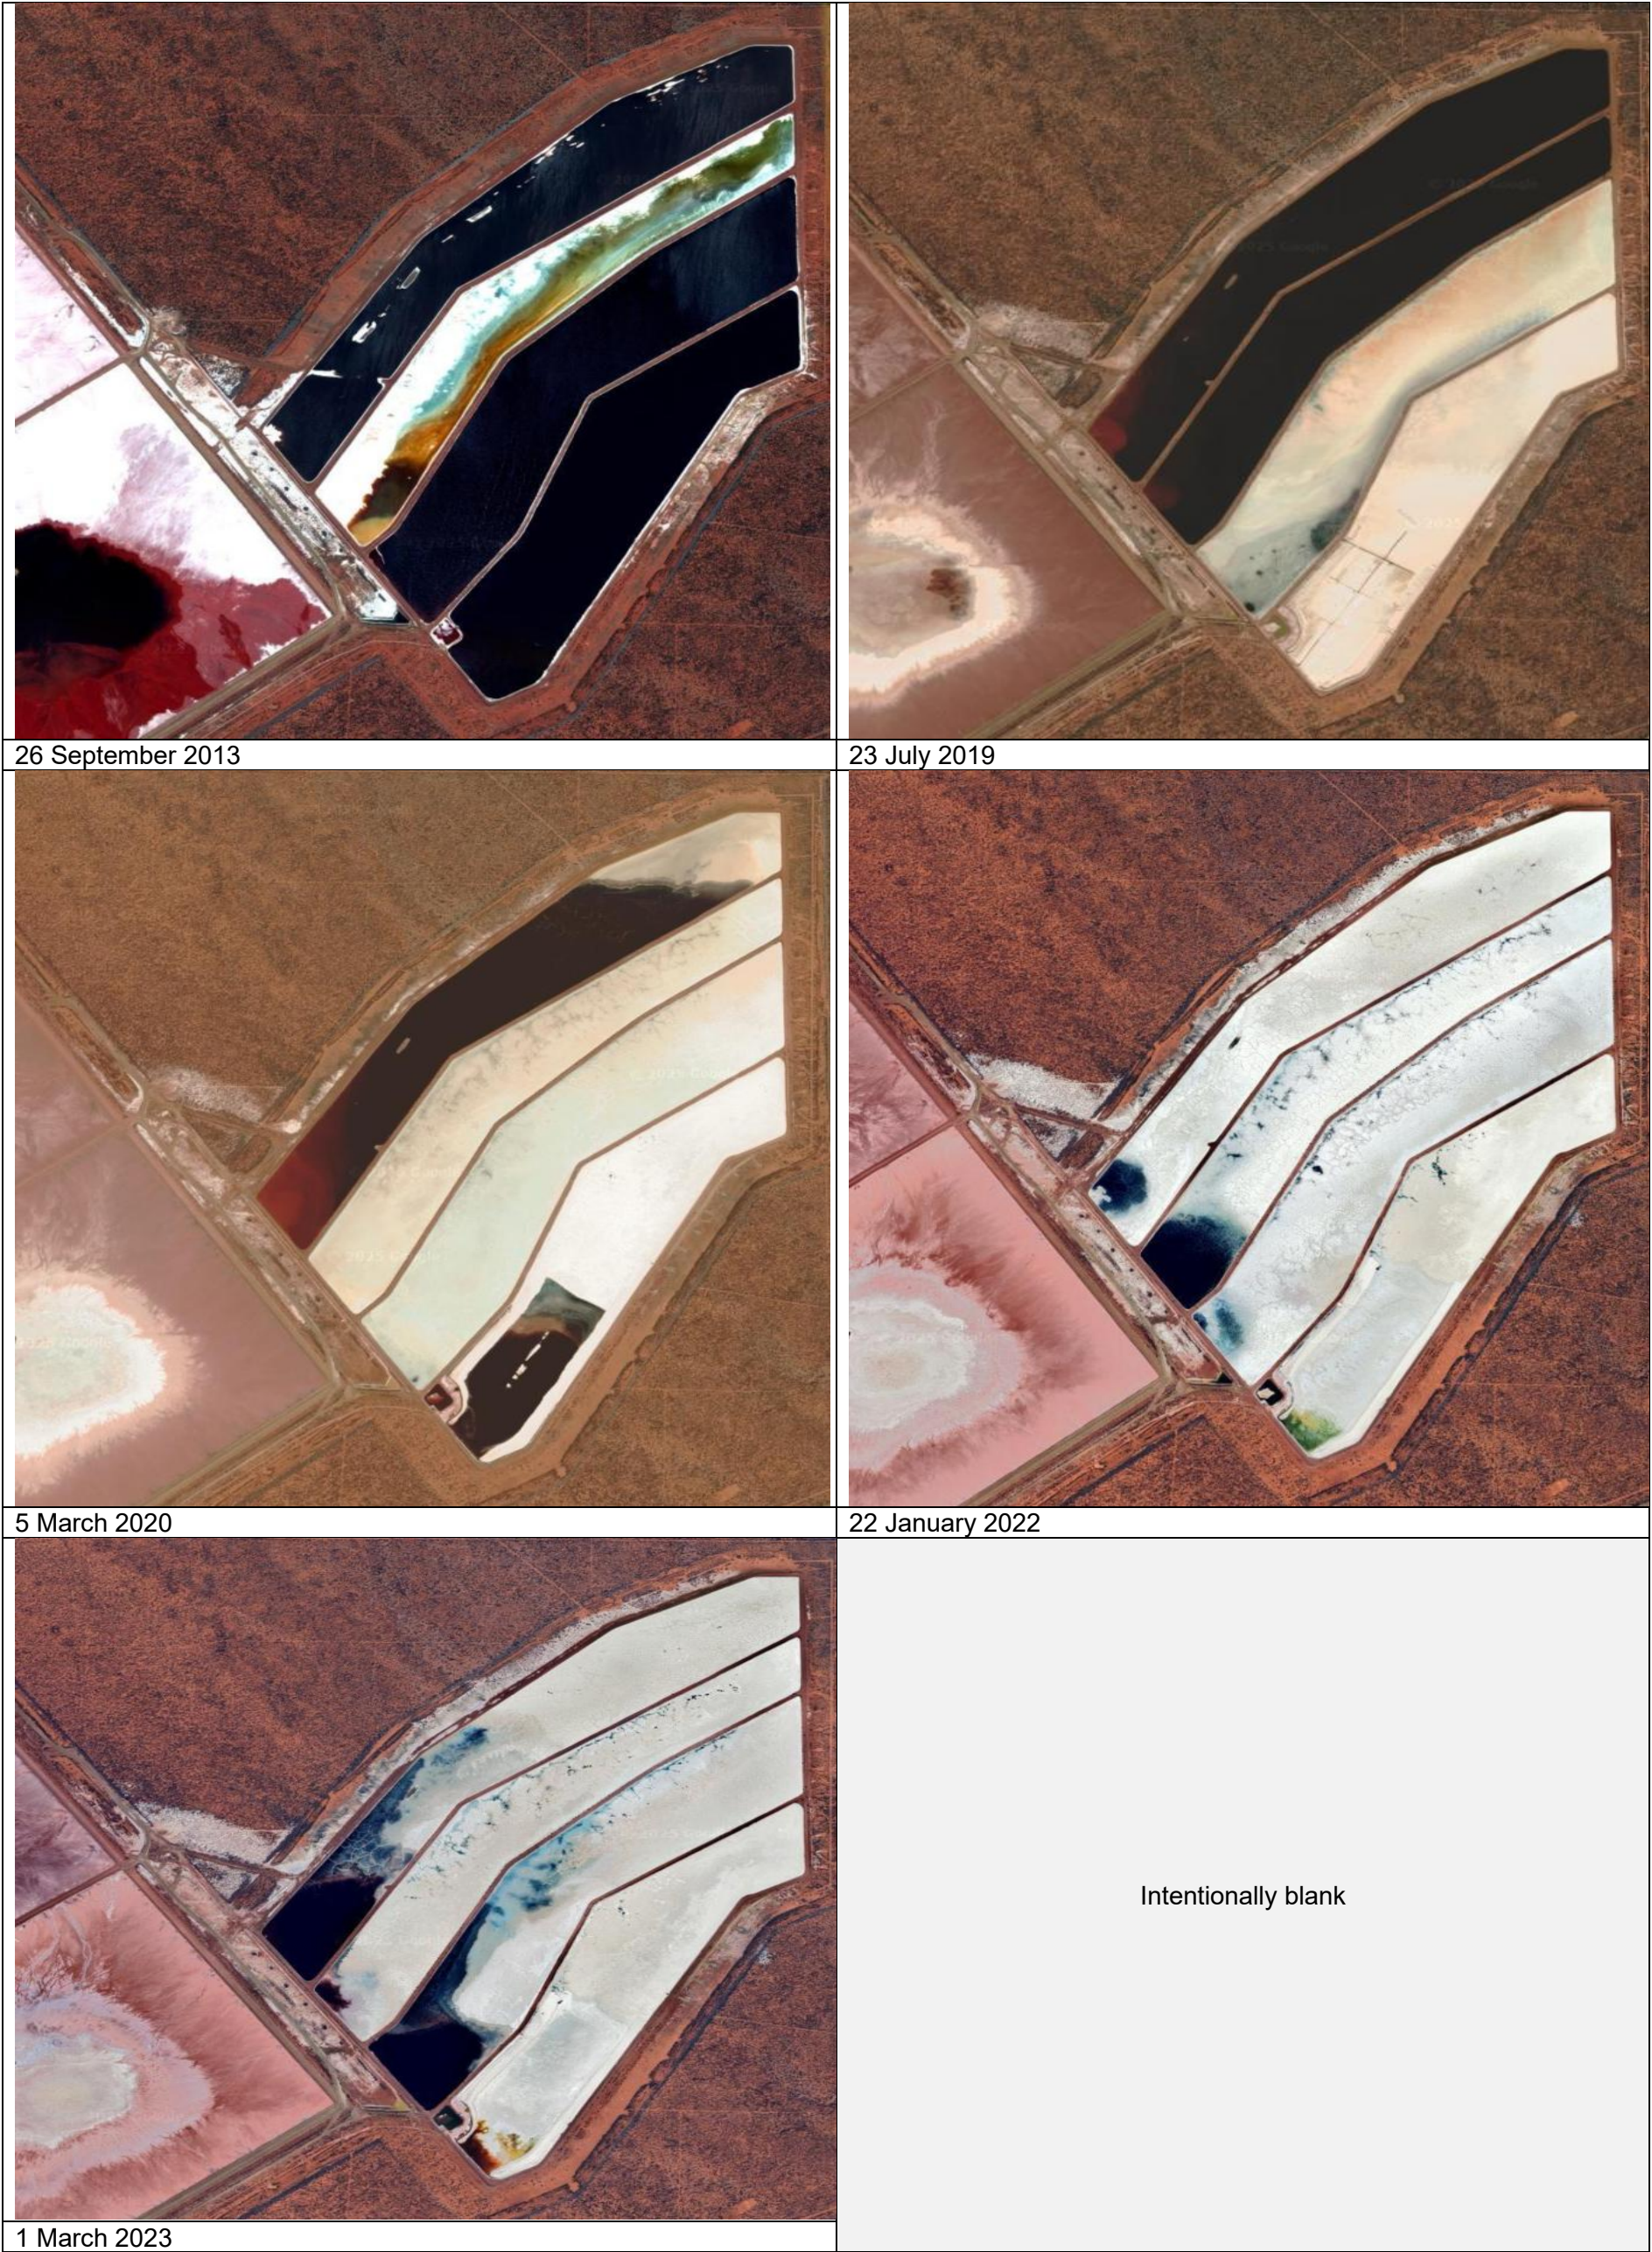
Figure 9: Historical imagery of Evaporation Ponds (sourced from Google Earth 2025)

Historical satellite imagery of native vegetation surrounding the evaporation ponds was reviewed by the department and is presented in Figure 9. In 2019 a decline in vegetation health appears to have occurred along the northern boundary of the evaporation ponds in the corner where they abut the paddock TSF. It is likely that these impacts are attributed to seepage or groundwater mounding from the evaporation ponds.

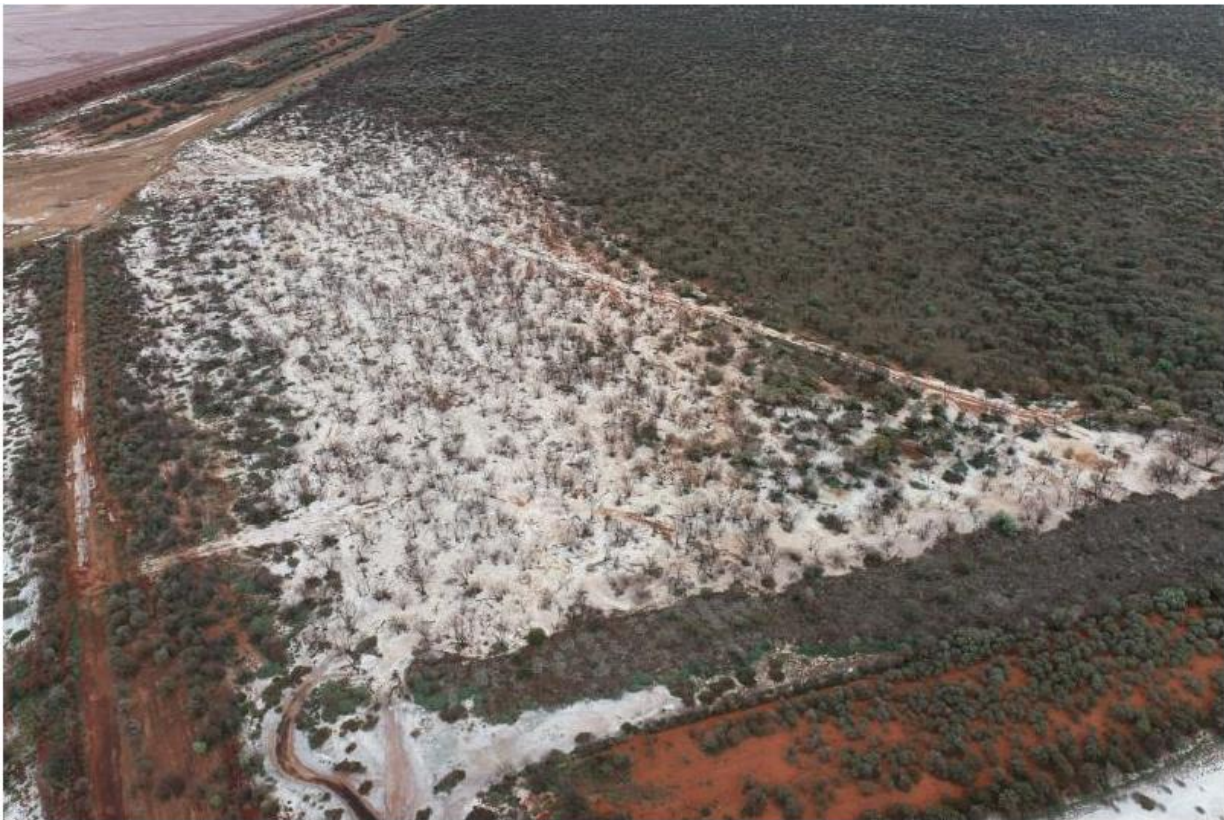
**Figure 10: Identified impacts northwest of evaporation ponds**

During a site visit conducted by DMPE in April 2025, it was observed that potential seepage and groundwater mounding had impacted over 20 hectares of native vegetation and may have led to soil contamination (Figure 10). DMPE advised the department that the evaporation ponds appear to be nearing the end of their operational life, and that the current seepage management measures may no longer be adequate.

- Impacts identified (visible salt crushing and areas of vegetation death) were at the north-western corner of the evaporation ponds (Figure 10) and approximately 100 m north along the northern embankment of the evaporation ponds;
