Application for Licence Amendment

Licence Number	L8306/2008/3
Licence Holder	Newmont Boddington Gold Pty Ltd
ACN	101 199 731
File Number	APP-0026065
Premises	Newmont Boddington Gold Gold Mine Road, BODDINGTON WA 6390 Legal description – As defined by the Premises maps and tenements in Schedule 1 of the Revised Licence.
Date of Report	13 August 2025
Decision	Revised licence granted

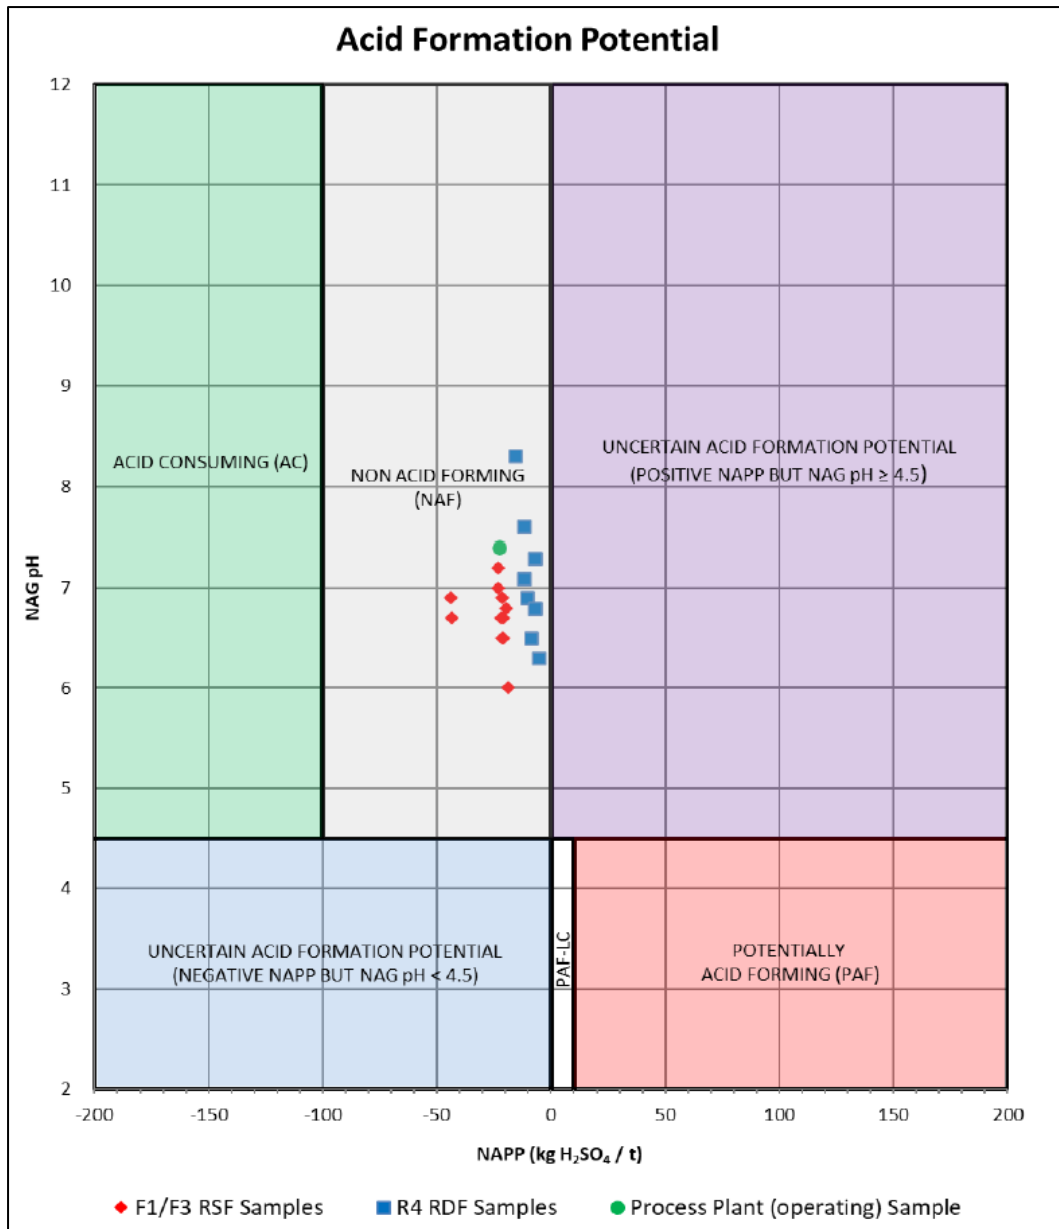
Figure 13: Acid formation potential for tailings at F1 RDA

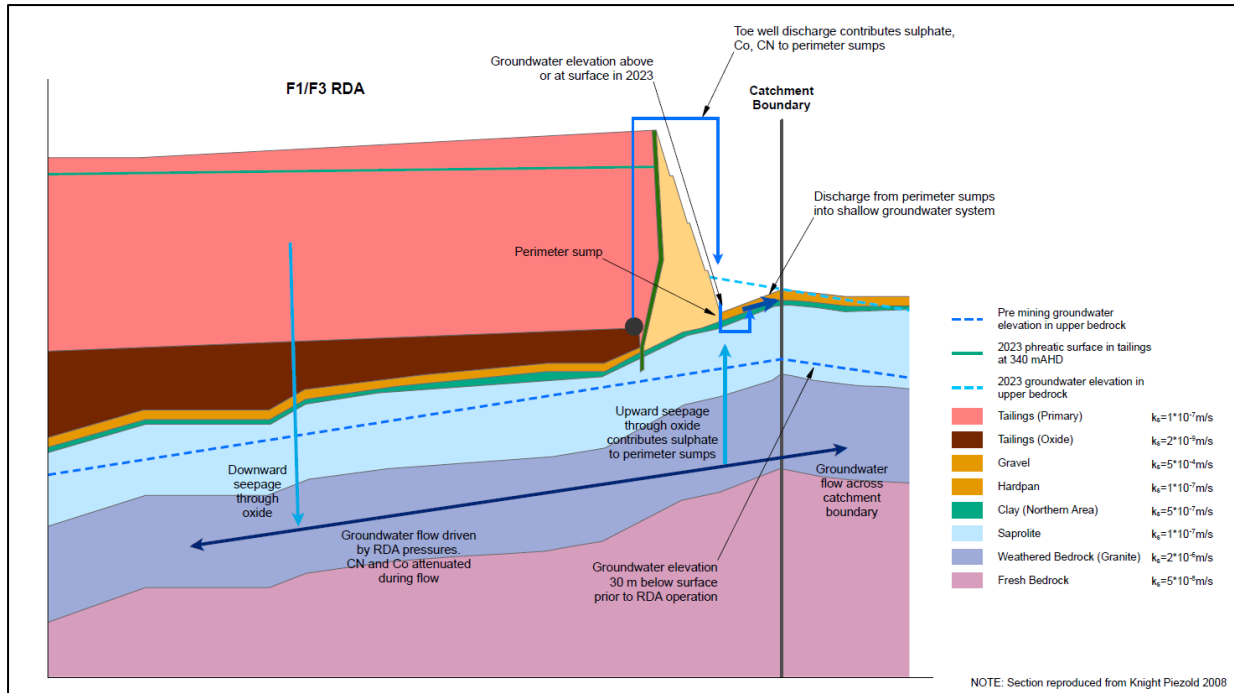
Figure 15: Conceptual hydrogeological model for seepage migration

The local hydrogeological setting of the F1 RDA, as well as the four primary hydrogeological units has been summarised in Section 3.1.4. Mechanisms by which tailings seepage is inferred to influence the local groundwater environment are shown in Figure 15 and summarised in Table 11.

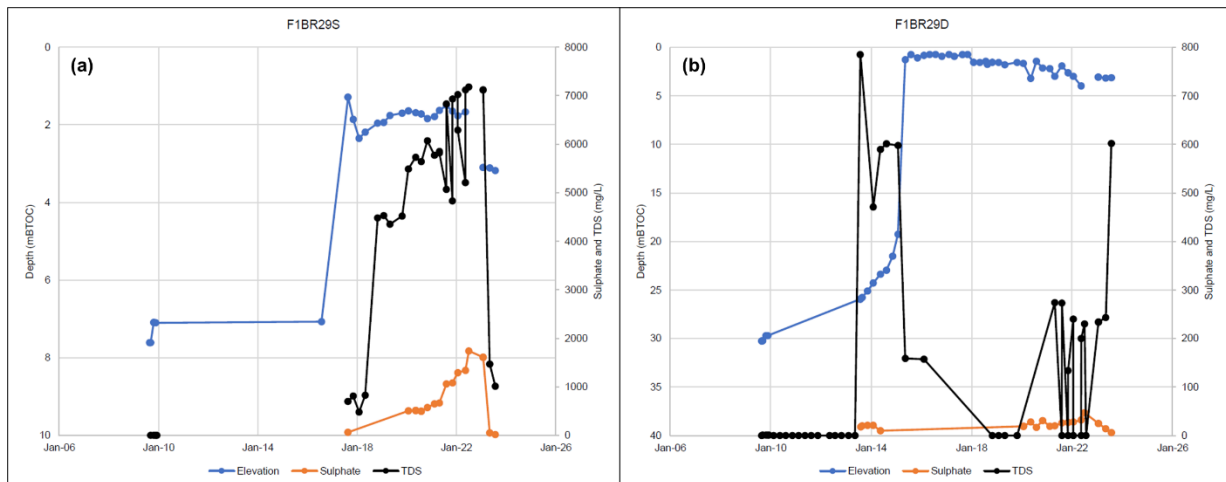
Figure 18: Groundwater level, total dissolved solid and sulfate concentrations at monitoring bores (a) F1BR29S and (b) F1BR29D

- By July 2023, groundwater levels and TDS had decreased marginally (Figure 18). The reduction in TDS was thought to be caused by a seasonal influx of freshwater due to winter rainfall infiltration. Vegetation condition did not show signs of improvements until November 2023, where drainage works were undertaken to reduce surface saturation.
