Application for Licence

Part V Division 3 of the *Environmental Protection Act 1986*

Licence Number	L8306/2008/3
Applicant	Newmont Boddington Gold Pty Ltd
ACN	101 199 731
File number	2013/002375-2
Premises	Boddington Gold Mine Gold Mine Road, BODDINGTON WA 6390 Legal description – As defined by the premises map attached to the issued licence.
Date of report	26 April 2023
Decision	Licence granted

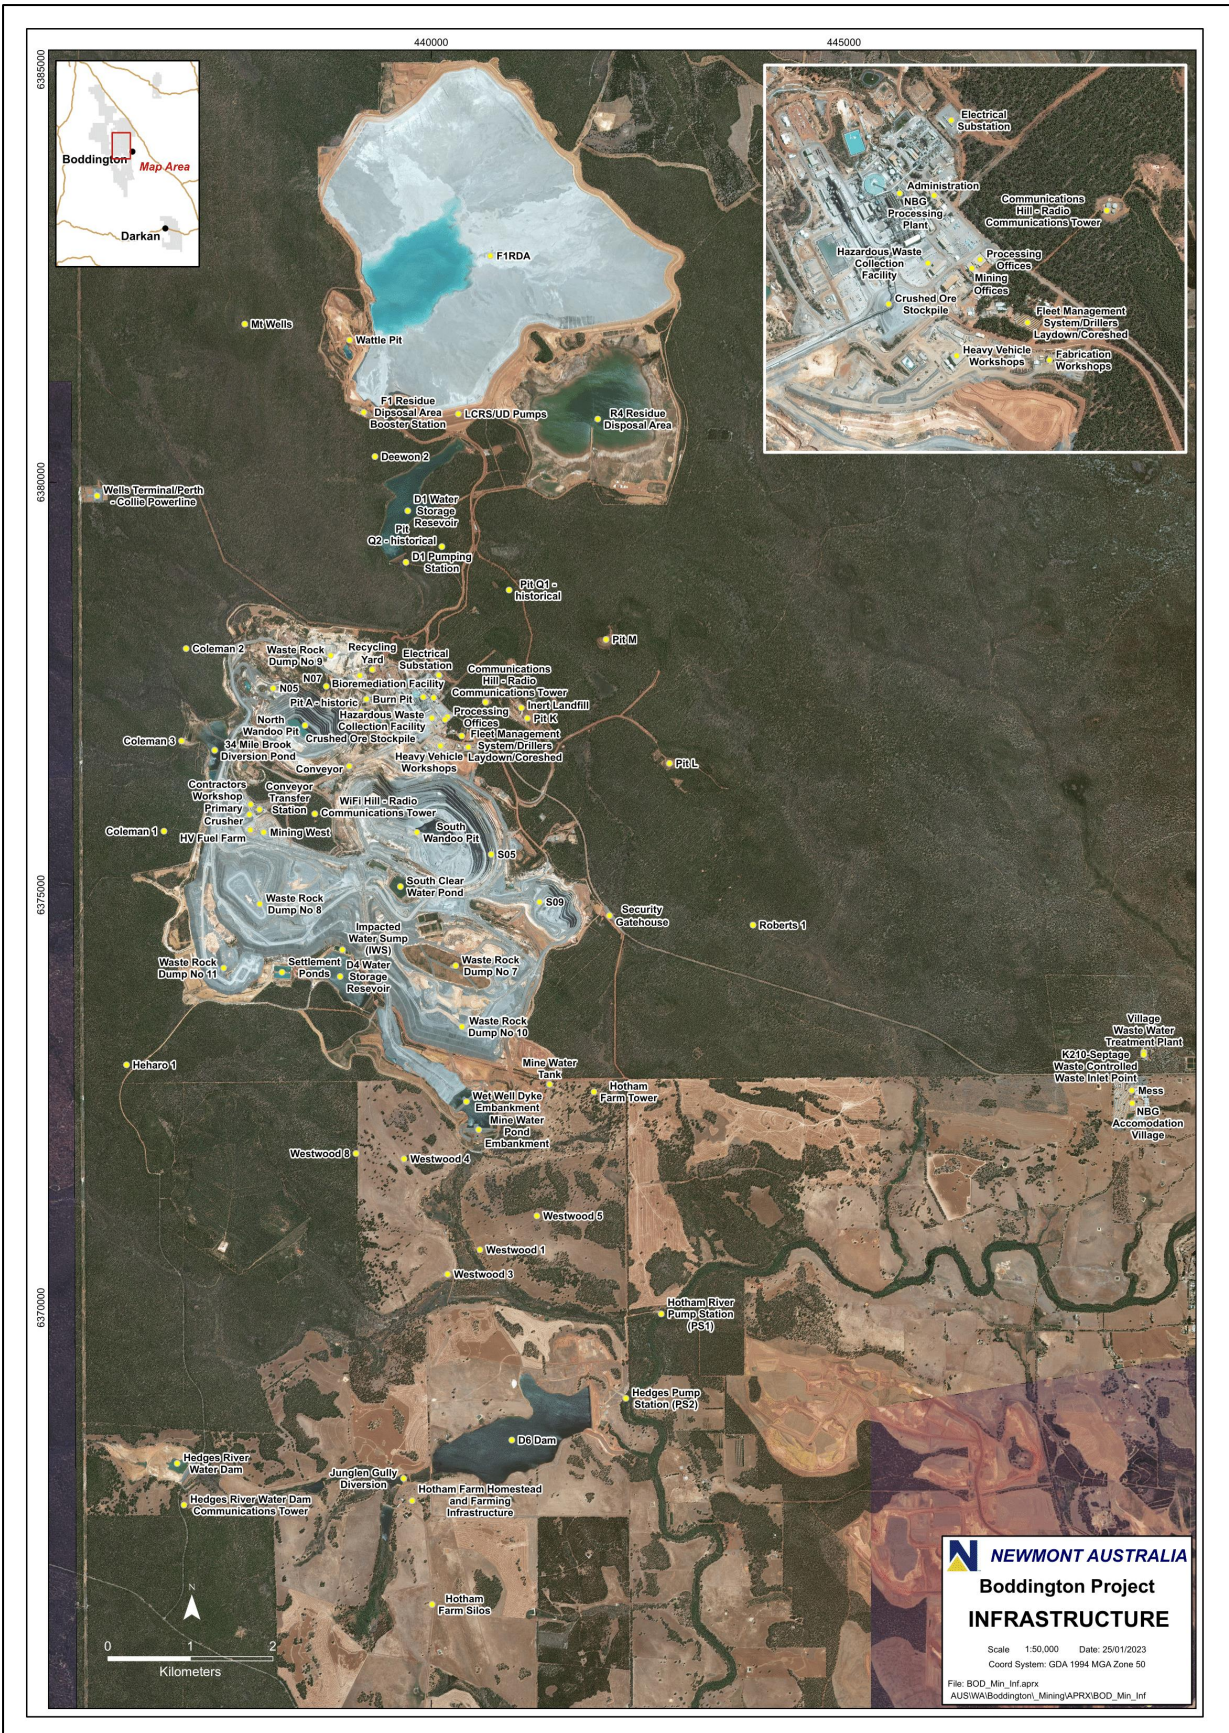
Figure 2: Site infrastructure, including F1 RDA and Thirty-Four Mile Brook Diversion Pond

The F1 RDA has been operational since 2009 and is the current discharge location for tailings produced from the processing circuit (Figure 2). The RDA facility was constructed over natural ground (i.e., F1 area) and existing oxide tailings (i.e., within F3 RDA, which was operated prior to care and maintenance). The RDA is confined by nine constructed embankments/saddle dams along its northern, eastern and southern perimeters and natural topography along its western extent.

Active mine dewatering occurs in two locations at the premises: North Wandoo Pit and South Wandoo Pit. Currently, mine dewater from the North Wandoo Pit is extracted and stored at the North Clear Water Pond (Figure 2). The majority of the mine dewater stored will be pumped and reused in the processing circuit and for dust suppression.

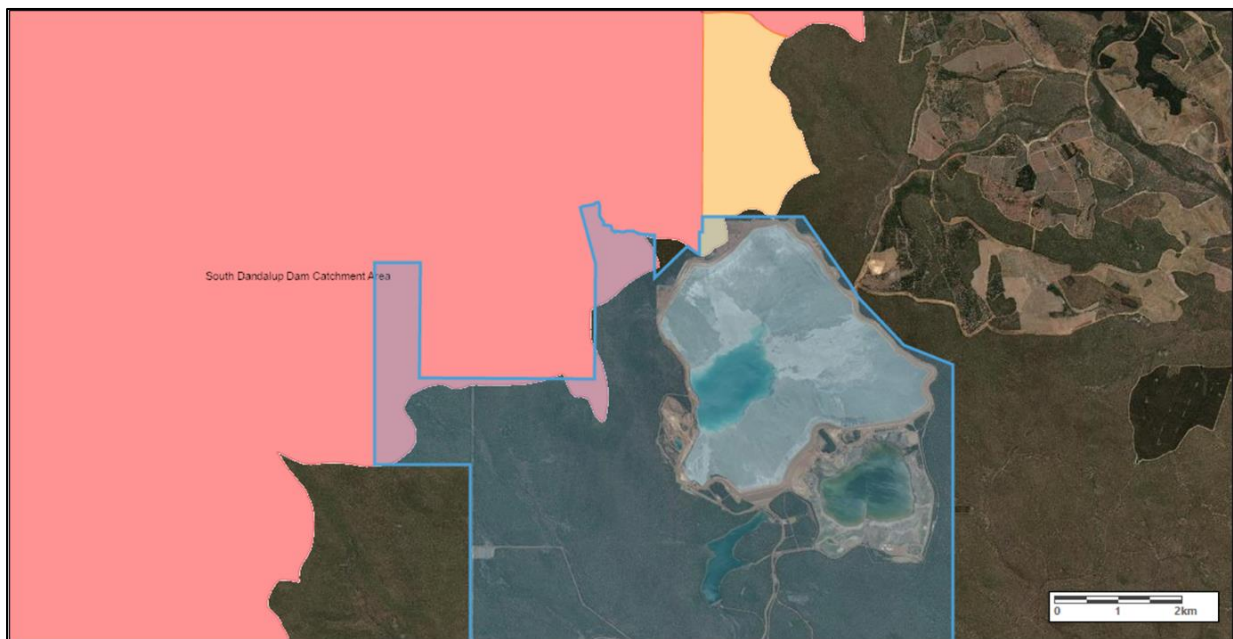
Figure 3: Distance of South Dandalup Dam Catchment Public Drinking Water Source Area – Priority 1 (red) and Priority 2 (orange) from the prescribed premises boundary (blue)

Table 5 and Figure 3 below provides a summary of potential human and environmental receptors that may be impacted as a result of activities upon or emission and discharges from the prescribed premises (*Guideline: Environmental Siting* (DWER 2020a)).

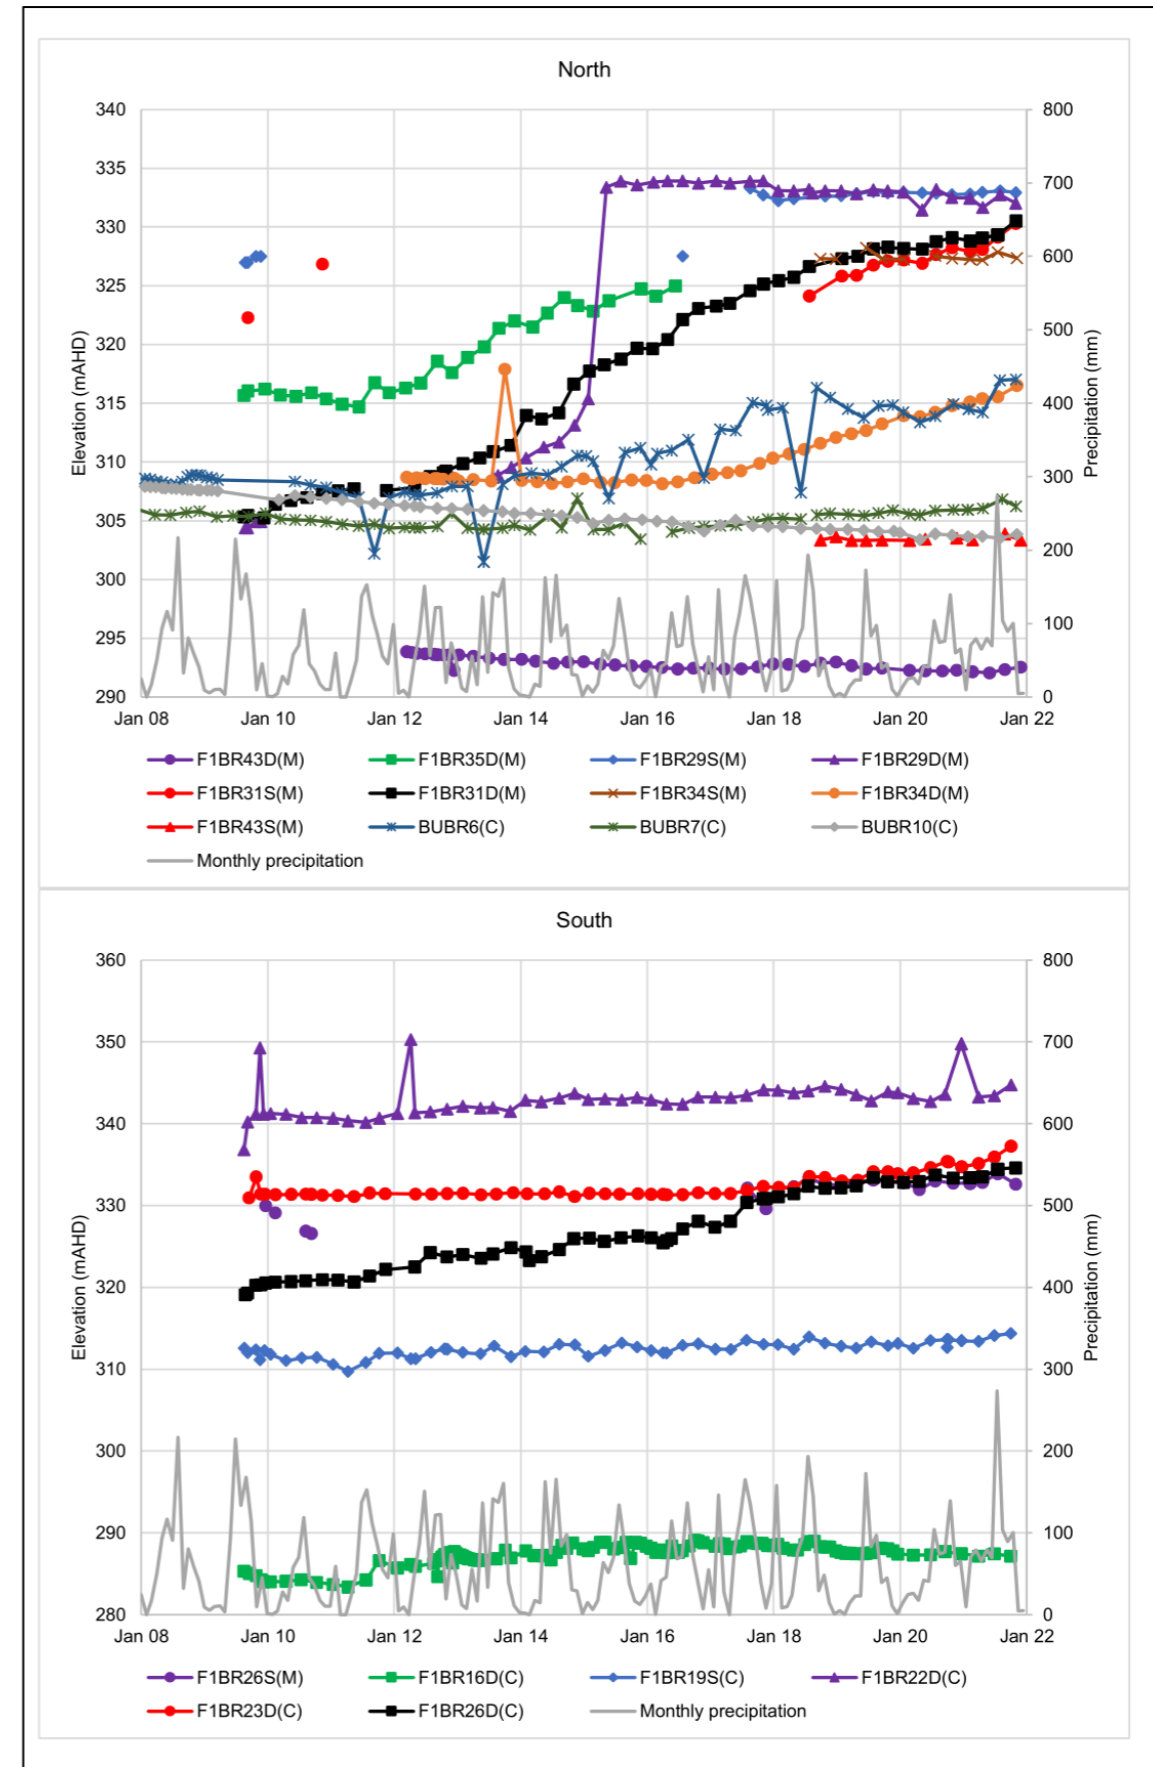
Figure 5: Historical groundwater elevation at the northern and southern portion of F1 RDA

Currently, the following trends were observed (Figure 5):

- The shallowest standing water levels were observed at F1BR26S, F1BR26D, F1BR29S and F1BR29D, which were typically within 3.0 metres below top of casing (mBTOC) (Figure 5). The F1BR26 and F1BR29 series bores are located adjacent to the north-western corner of the F1 RDA embankment toe.
- The highest groundwater elevations were measured at F1BR29S, F1BR29D, F1BR31D, F1BR31S and F1BR34S (in decreasing order). The F1BR31 and F1BR34 series bores are located within the PWDSA.
- A consistent mounding trend have been observed at F1BR34D, F1BR31D, F1BR31S and BUBR6. These bores are located in the northern portion of F1 RDA, with both F1BR31 and F1BR34 series bores located within the PWDSA.
