Application for Licence Amendment

Licence Number	L8612/2011/1
Licence Holder	Pantoro South Pty Ltd
ACN	633 003 737
File Number	2011/010196-1
Premises	Norseman Gold Project Legal description – Being part mining tenements Miscellaneous Licence: L63/32 Mining lease: M63/11, M63/13, M63/14, M63/15, M63/29, M63/36, M63/42, M63/43, M63/48, M63/68, M63/112, M63/133, M63/140, M63/142, M63/155, M63/156, M63/173, M63/214, M63/257, M63/275, M63/325 and M63/659
Date of Report	19 April 2024
Proposed Decision	Revised licence granted

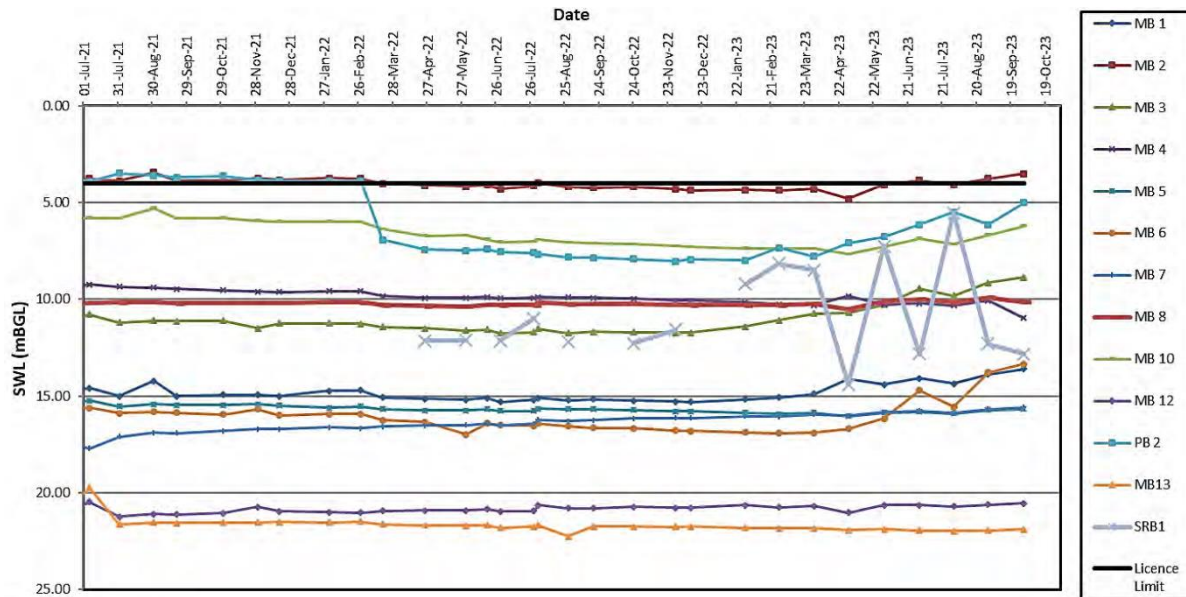
A summary of standing water level (SWL) at TSF4 (Valley) was provided by the Licence Holder (Pantoro South 2023c) and is shown below in Figure 1.

Figure 1: SWL (mBGL) at TSF4 (Valley) Compliance Bores

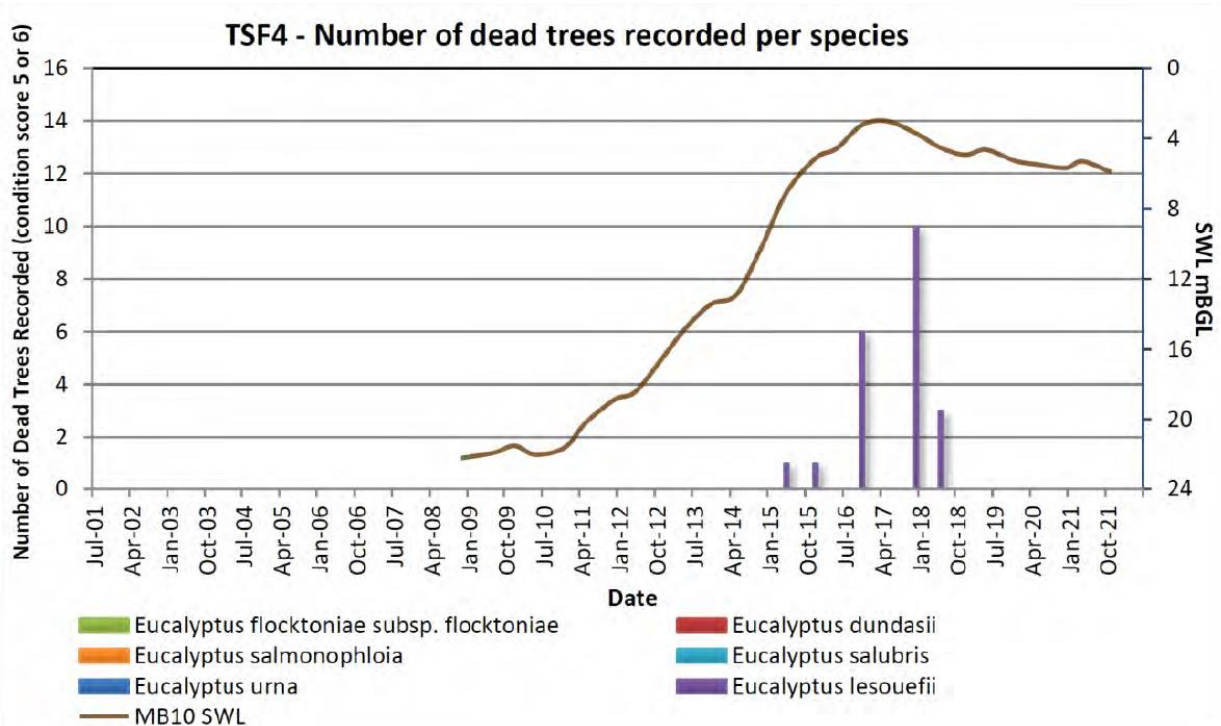
The native vegetation monitoring detected several trees death, which was attributed to the high-groundwater level. According to Native Vegetation Solutions (environmental consulting business), Bore MB10 was over the groundwater level limit between 2015-2016 which is considered to be the cause of several trees’ death, refer to Figure 2 below. Nevertheless, there has been no new tree death registered during the 2021-22 monitoring period.

Figure 2: TSF4 Number of death trees recorded per species (Pantoro South 2022b)

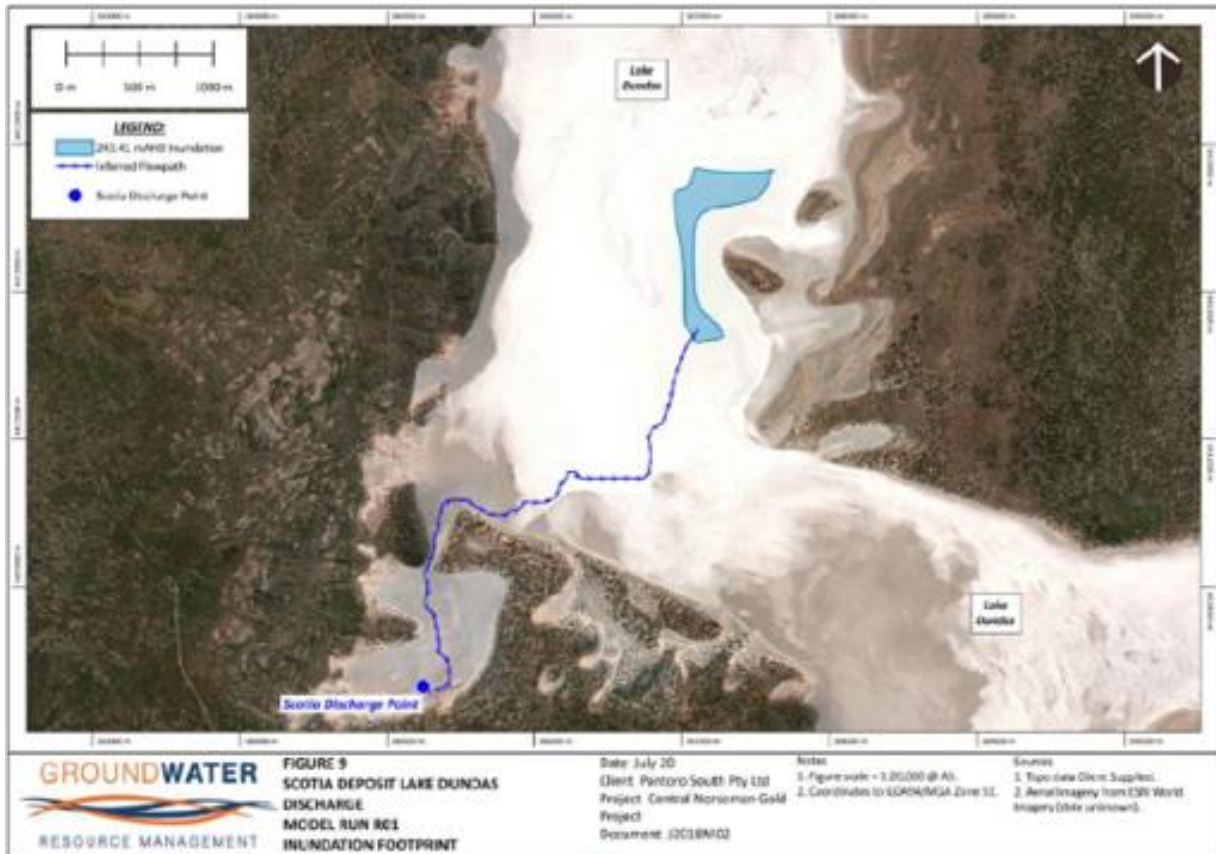
- The discharge is likely to accumulate within the deepest northern section of the lake (Figure 4) which is where the only *Parartemia serventyi* species was found. It is unclear what the salinity of the discharge water is, but it is assumed likely to be high. Per 100g/L of salinity, a discharge of 380,000 tonnes of water per annum would equate to about 38,000 tonnes of salt/annum accumulating on the surface of sediment with low permeability. This may create an additional depth of salt crust which may cover areas of *P. serventyi* egg bank, and result in higher salinities earlier in the hydrological cycle than would otherwise be the case. With juvenile *P. serventyi* requiring lower salinity to develop, this may affect the *P. serventyi* populations, especially when there is only a partial fill event.

Figure 3. Modelled flowpath from the Scotia discharge point to Lake Dundas (GRM 2020)

Figure 4: Modelled flowpath from Scotia discharge point to Lake Dundas (Pantoro South 2020, WRM figure 3)
