Application for Licence Amendment

Licence Number	L9155/2018/1
Licence Holder	Karora (Higginsville) Pty Ltd
ACN	108 547 217
File Number	APP-0032460
Premises	<p>Higginsville Gold Project</p> <p>M15/351, M15/289, M15/225, M15/642, M15/348, M15/31, M15/786, M15/506, M15/507, M15/620, M15/629, M15/639, M15/640, M15/580, M15/581, M15/597, L15/225, L15/288, L15/302, G15/19, G15/23, M15/528, M15/231, M15/748, M15/512, M15/352, M15/610, M15/375, M15/338, M15/1790, M15/1814, L15/282, L15/347, G15/26, G15/27, G15/29, L15/382, L15/389, M15/325, M15/681, M15/817, M15/1132 and L15/298</p> <p>As defined by the premises map on the revised licence</p>
Date of Report	28 May 2026
Decision	Revised licence granted

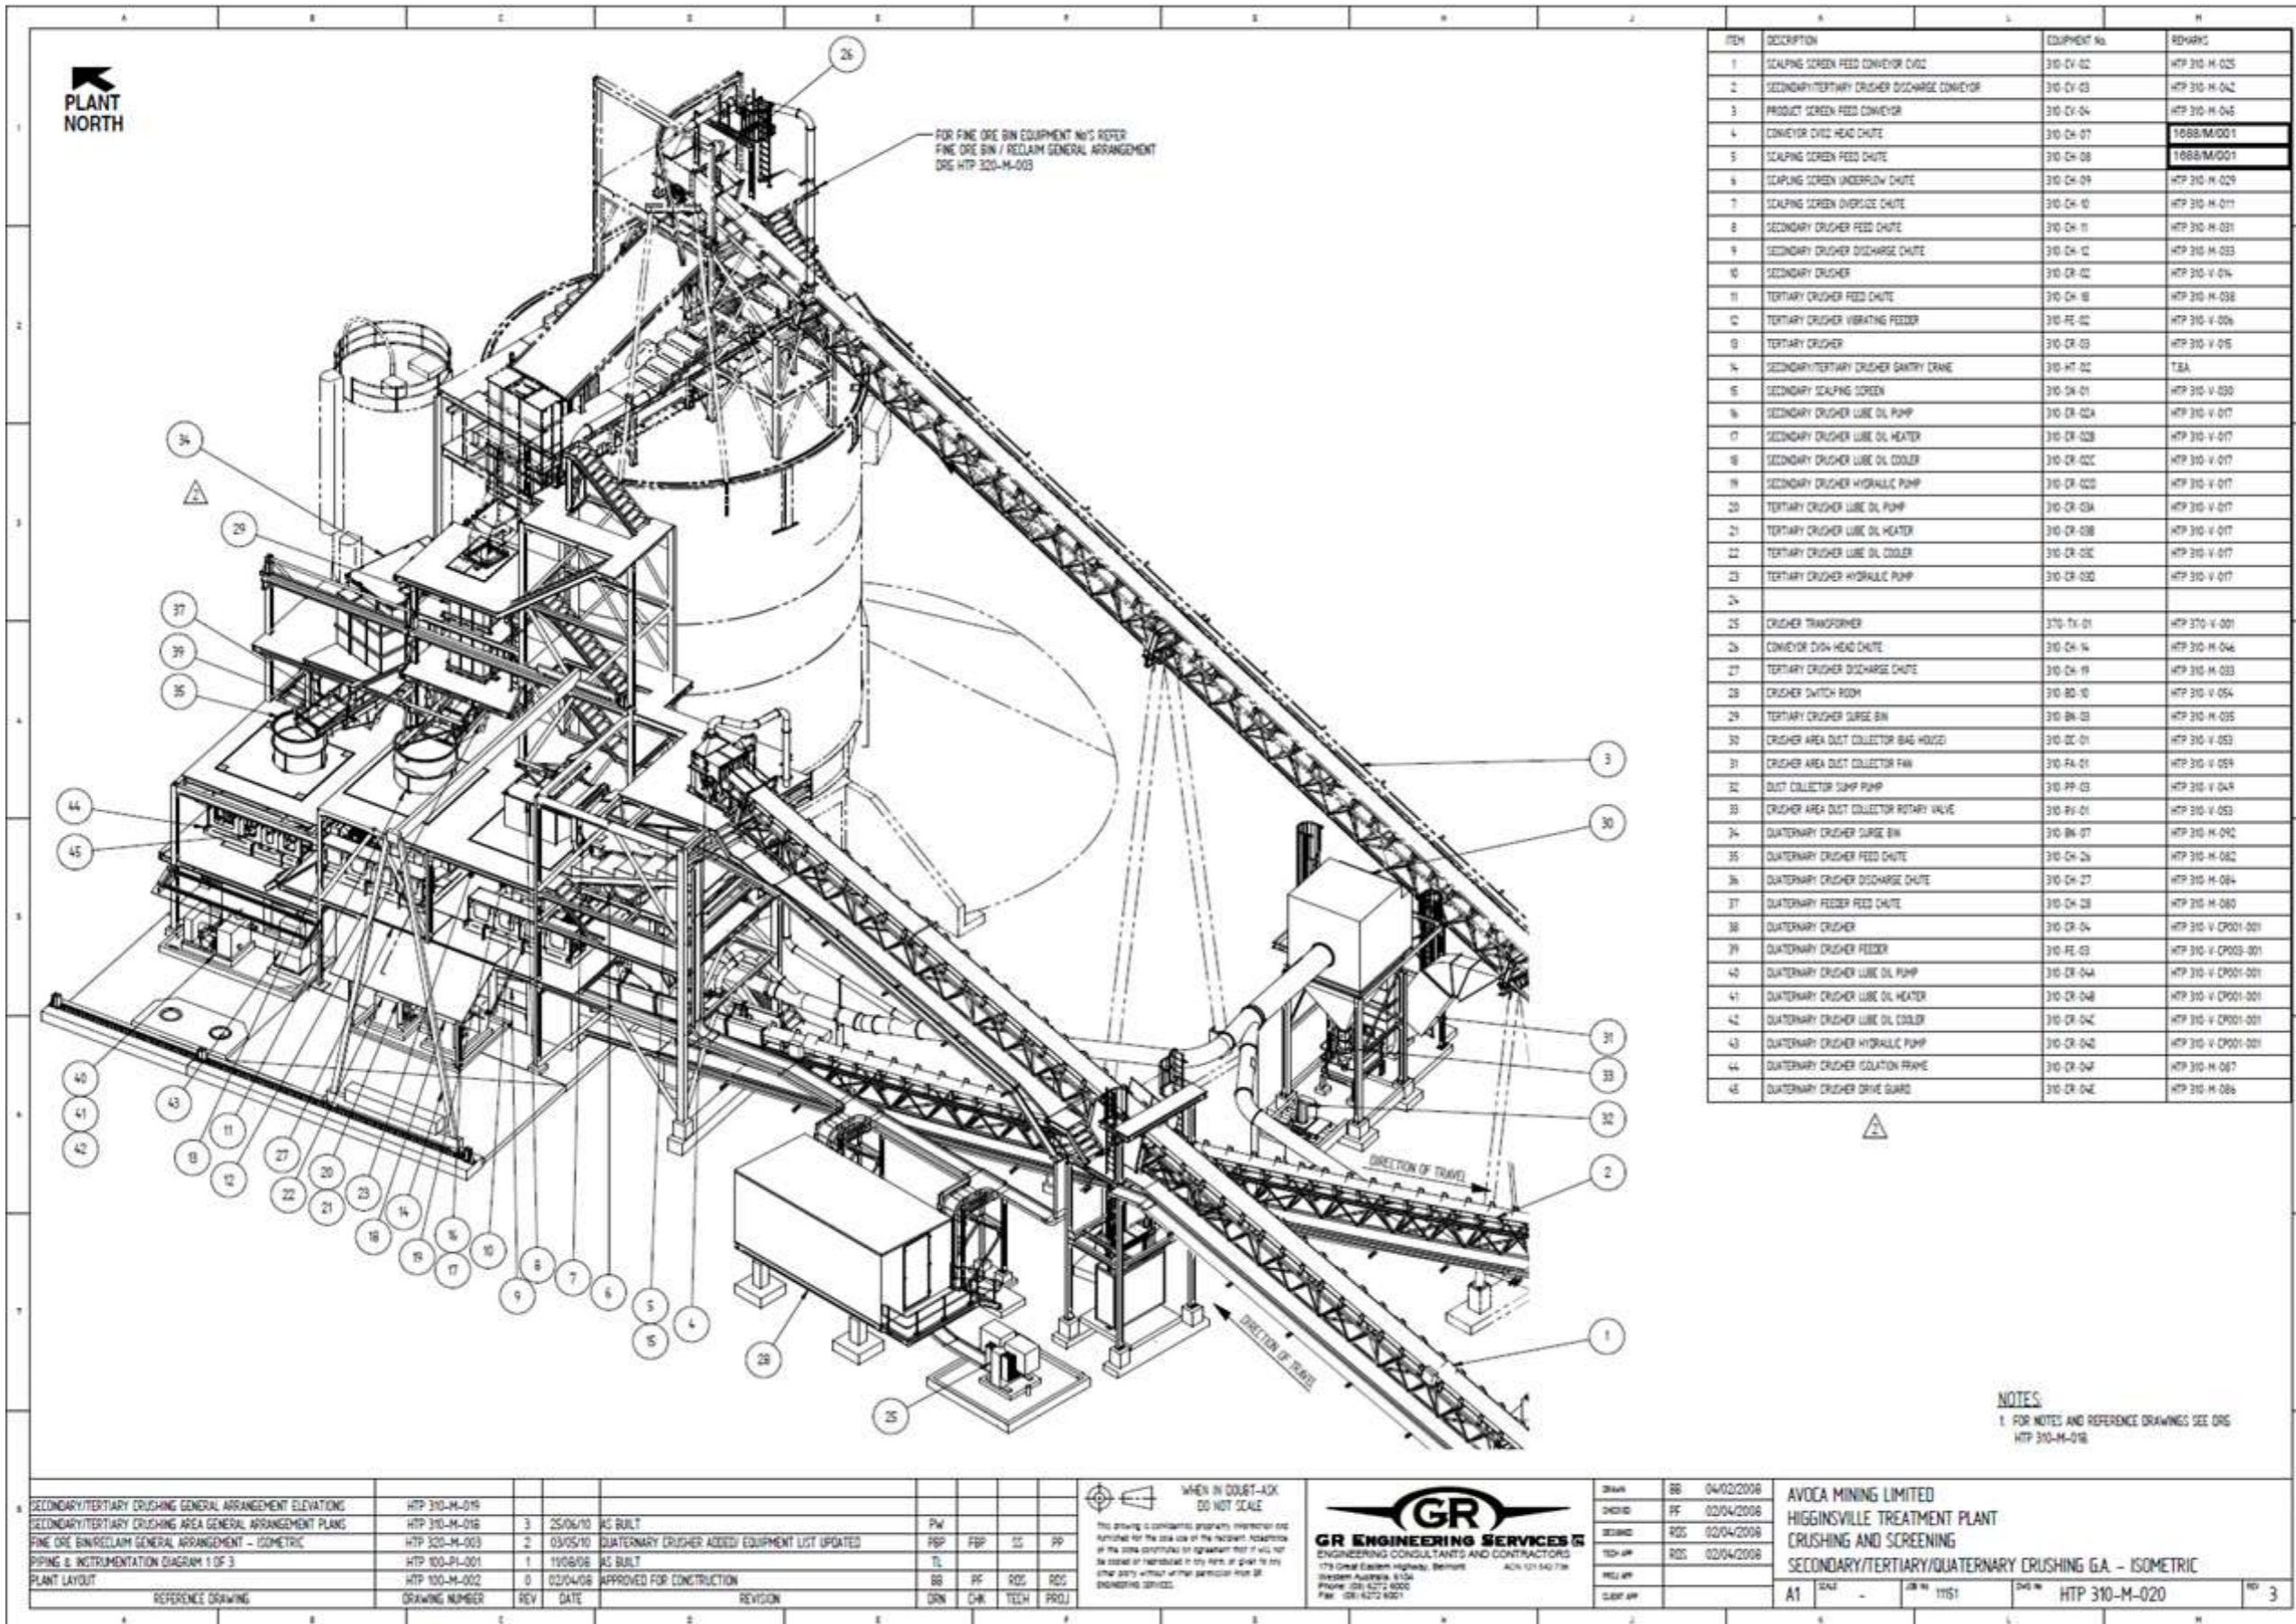
Figure 2: Fine Ore Bin and screening - Crushing and screening infrastructure

A layout of the plant components is shown in Figure 1. Design drawings of the crushing and screening plant are presented in Figure 2 and Figure 3. Stormwater management infrastructure is shown in Figure 4. The Delegated Officer notes that Figure 4 is dated, nonetheless it still provides an overview of the infrastructure.

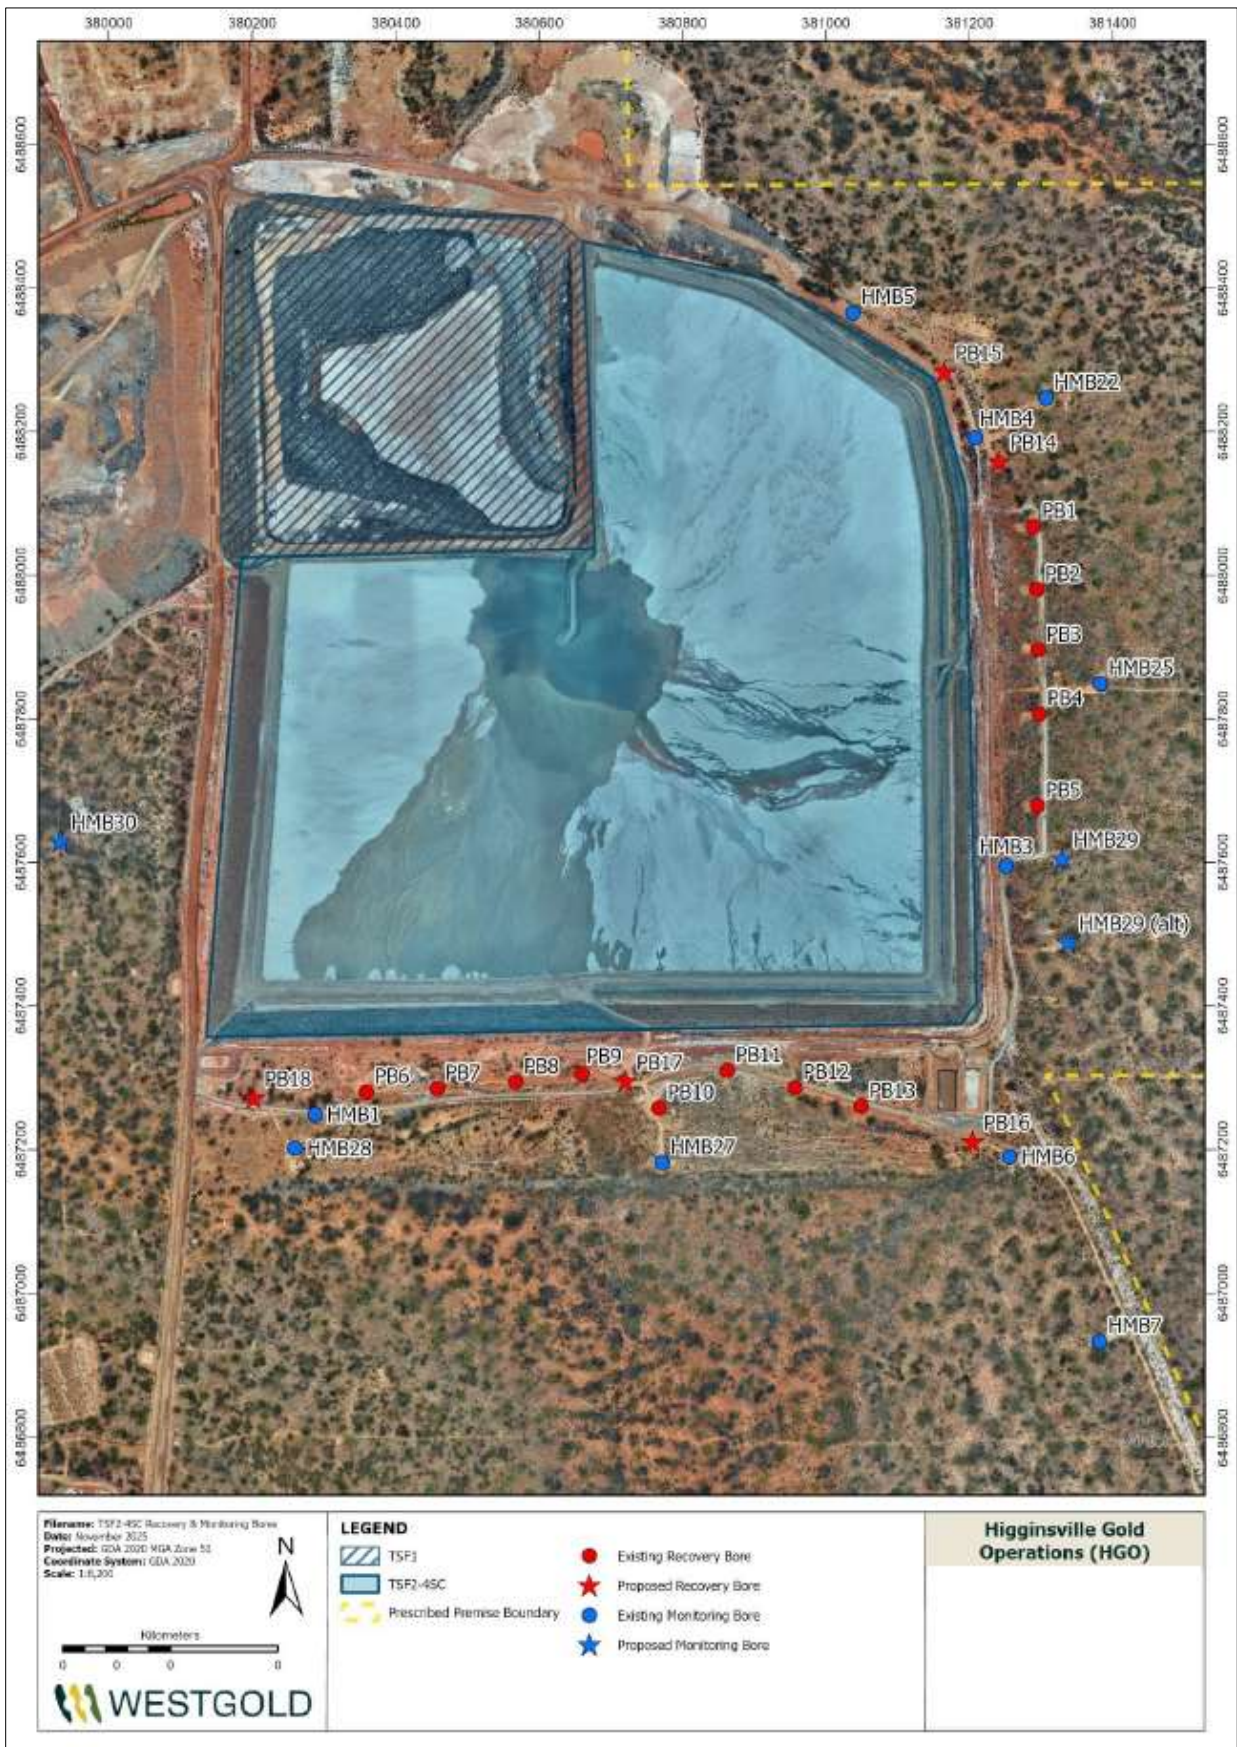
Figure 7: Proposed and existing monitoring and seepage recovery groundwater bores surrounding TSF2-4

historically converted bores yielding minimal recovery (see Section 2.5 for additional information). As part of this amendment, the licence holder proposed to add five seepage recovery bores (PB14-18), two located to the northeast (PB14-15) and three equally distributed along the south perimeter of the TSF (PB16-18) (Figure 7). The licence holder stated that an upgrade to higher yield submersible pumps for some of the existing recovery bores may also occur to ensure more effective recovery.

Figure 7 shows the location of the current and proposed monitoring and seepage recovery bores. (Please note the two locations for HMB29, noted as HMB29 (alt)).

Condition and / or reference	Summary of licence holder's comment	Department's response
2, Table 2	<p>A revised map of the monitoring bores has been provided. Duplication of HMB29 (HMB29 and HMB29 Alt) was due to the uncertainty regarding the viability of reinstating an existing monitoring bore, in the HMB29 area. A copy of Form 2, previously submitted to the department, has been provided as evidence of construction.</p> <p>The revised map also includes the renaming of HMB30 to HMB29.</p>	<p>Evidence of construction of HMB29 (now HMB12) has been provided; therefore, this bore has been removed from condition 2 of the licence requiring construction.</p> <p>Condition 25 has been updated to include HMB12 and to remove HMB30.</p> <p>The relevant figure (Figure 11) has been updated accordingly.</p> <p>No changes to the risk assessment have been deemed necessary.</p>
7, Table 4	<p>Please remove Aphrodite, Fairplay East, and Vine in-pit TSF from the licence. Operational capacity has been reached, and tailings will no longer be stored within these in-pit TSFs. The facilities are currently transitioning to closure management under the site Mine Closure Plan.</p> <p>Monitoring of the aquifer will continue to occur as prescribed by the licence.</p>	<p>Reference to the in-pit TSFs in table 4 have been modified to clarify that they are decommissioned. It is the department's preference for the TSFs to remain visible on the licence so it is clear that there are other tailings storage facilities at the premises, but have mentioned have been removed from the licence. Reporting requirements under condition 24 of the licence on volume of tailings delivery and return water have also been removed.</p>

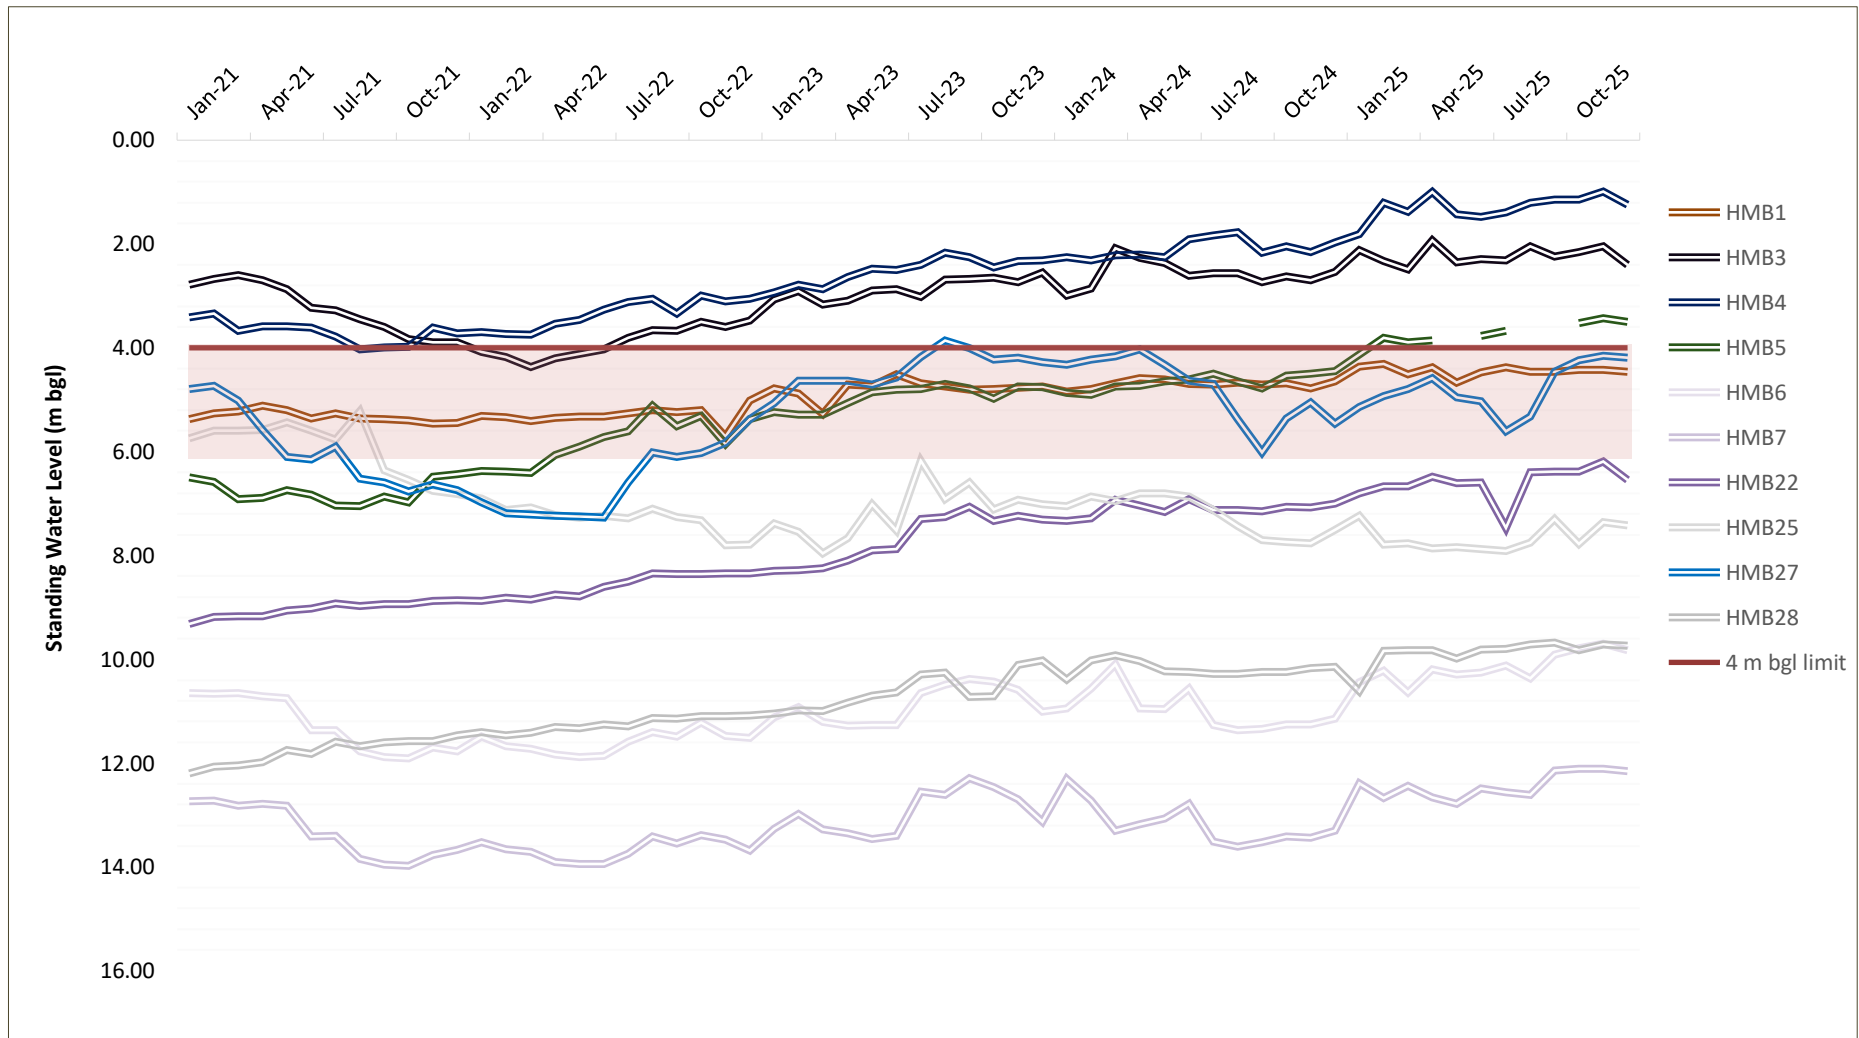
Figure 9: Standing water levels (m bgl) at the TSF2-4 monitoring bores between 2021 and 2025

During the assessment of this application, the department obtained standing water levels and seepage recovery volumes at the bores surrounding TSF2-4 for the period beginning in 2021. Trends for the period 2021–2025 are presented in Figure 9 and are consistent with the findings of the May 2025 report, which included data to the end of 2024.

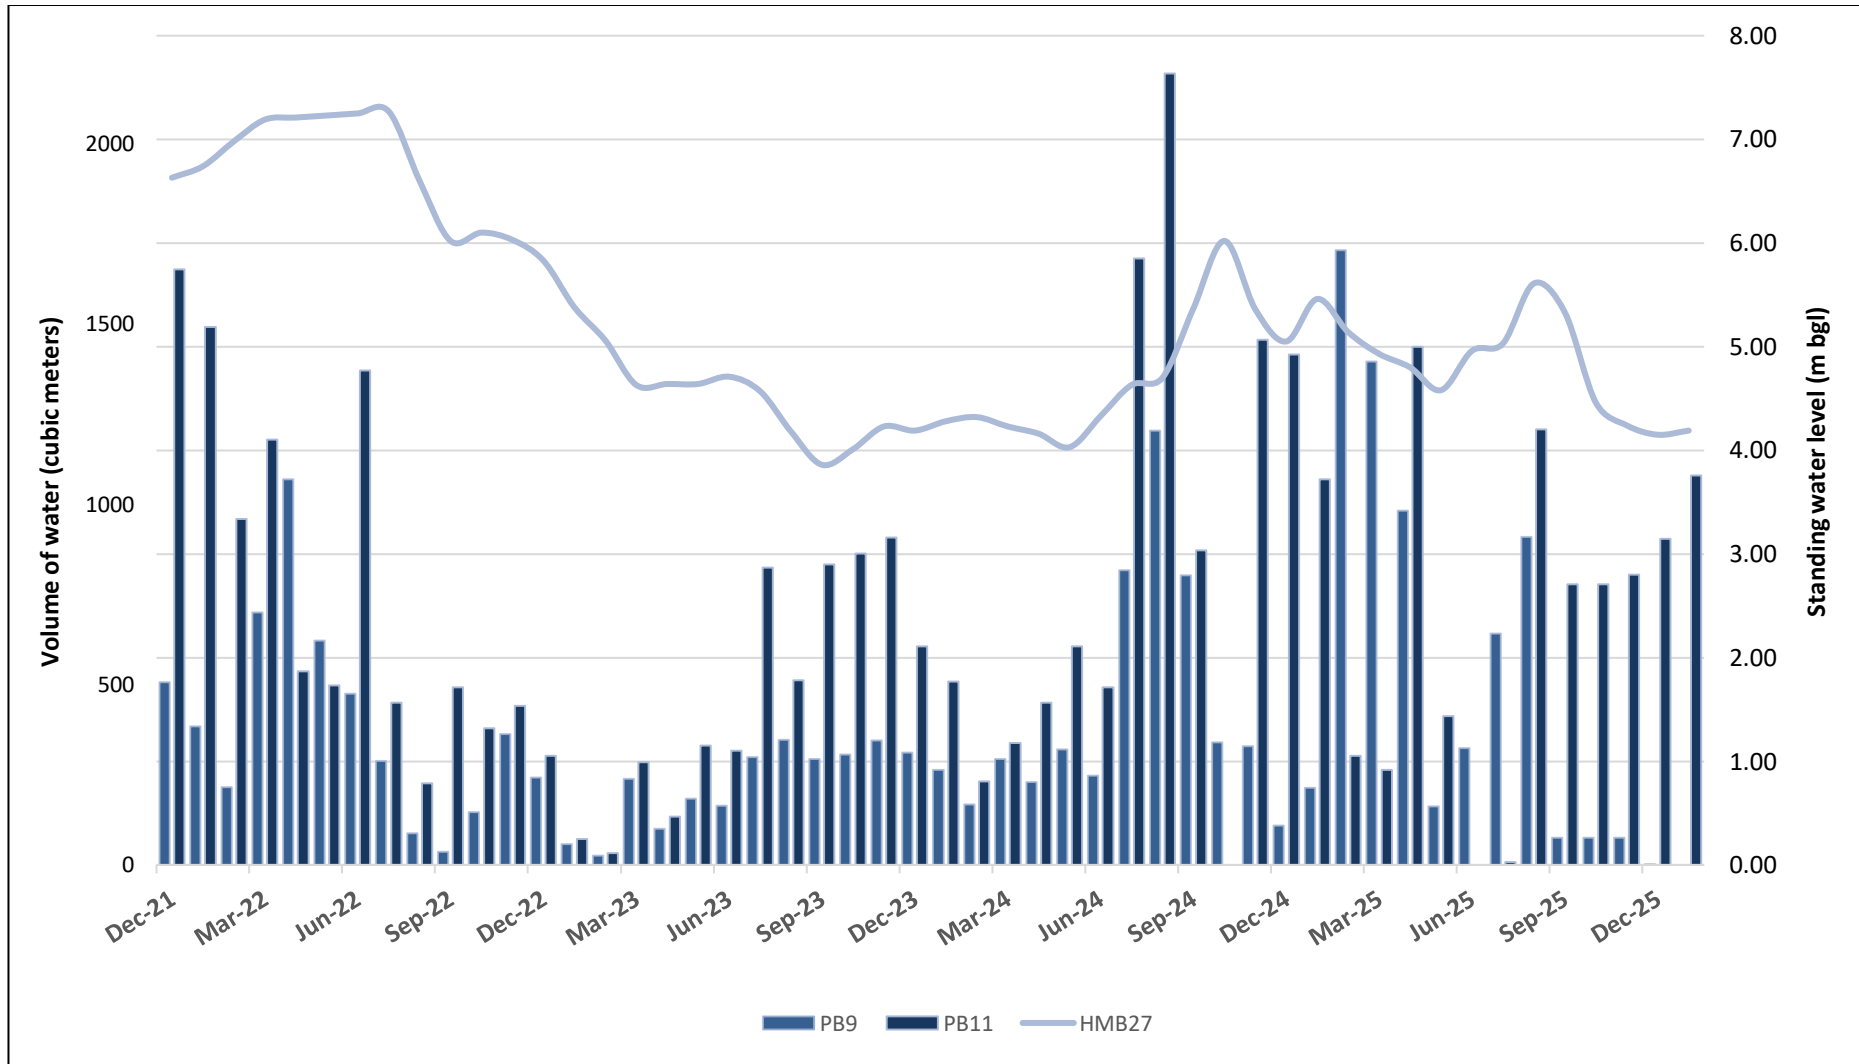
Figure 10: Monthly seepage recovery volumes at PB9 and PB1 (cubic meters) and standing water levels at HBM27 (in m bgl). Higher standing water levels values indicate a deeper water table.

Figures 5 and 6 compare pumping volumes at PB9/PB11 and PB3/PB4 with standing water levels at adjacent monitoring bores HMB27 and HMB25, respectively.

It is noted that interpretation of these figures should be approached with caution, as seepage

recovery represents only one of several factors influencing the fluctuation in standing water levels.

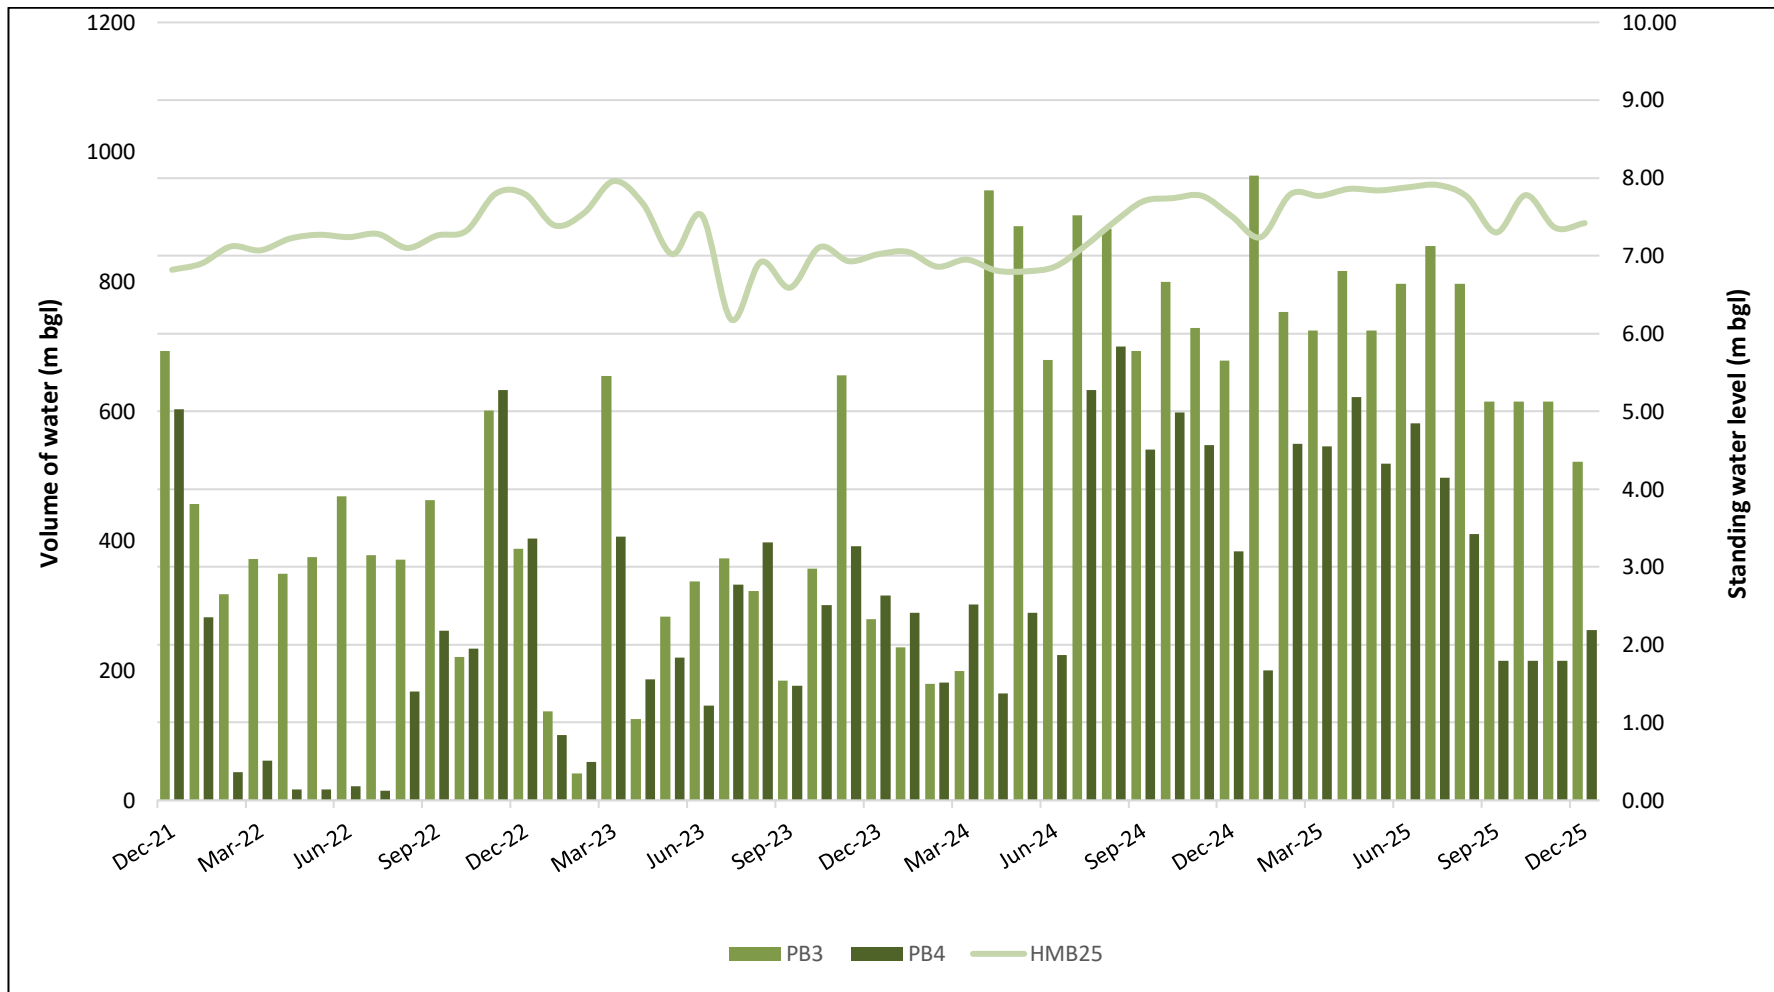
Figure 11: Monthly seepage recovery volumes at PB3 and PB4 (cubic meters) and standing water levels at HMB25 (in m bgl). Higher standing water level values indicate a deeper water table.
