Appendix 1. Annual Audit Compliance Report (AACR)

Section A – Licence Details			
Licence number:	L8923/2015/1	Licence file number:	DER2014/001486
Licence holder:	Jamala Enterprises Pty Ltd		
Trading as:			
ACN:	078 002 730		
Registered address:	West Nodes Farm – Lot 3 on Plan 60276 as depicted in Schedule 1		
Reporting period:	01 / 07 / 2019 to	30 / 06 / 2020

Section E - Details of Non-Compliance with Licence Condition

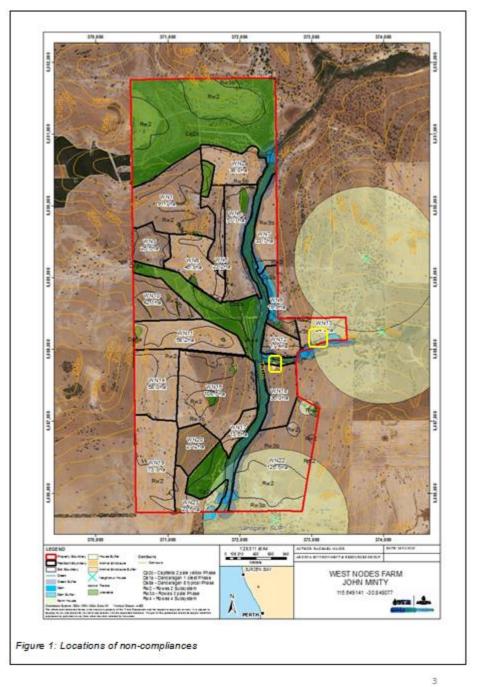
Biosolids cake was applied to WN13 paddock within the 1km residential buffer zone and the 50m intermittent watercourse buffer zone, namely 750m and 30m respectively.

There was no environmental impact based on:

- · Visual inspections of creek lines indicating no biosolids material had reached the creek;
- Conservation farming practices and crop residues decreased surface runoff and effectively contained the biosolids; and
- There was no discernable <u>odour</u> during inspection and no complaint from the resident.
 See Figure 1 for map refer to yellow highlighted areas.

Please use a separate page for each condition with which the licence holder was non-compliant at a time during the reporting period.			
Condition no:	1.3.3 – Table 1.3.2 (iv)	Date(s) of non- compliance:	13/12/2019 to 31/01/2019
Details of non-comp	oliance:		
As a result of vehicle movement restrictions under a total fire ban a decision was made to divert deliveries to an emergency hardstand south of WN12 paddock. The hardstand is bunded and within the 100m dam buffer.			
What was the actua	al (or suspected) environmen	tal impact of the non-c	ompliance?
NOTE - please attack compliance took place	h maps or diagrams to provide i e.	nsight into the precise lo	cation of where the non-
There was no envir	onmental impact as the bioso f event.	olids were contained in	the bund. See Figure 1
Cause (or suspecte	ed cause) of non-compliance:

Cause (or suspected cause) of non-compliance:			
Poor communication between the Farme application of biosolids within the buffers.	r (licensee) and the machinery operator resulted in the		
Action taken to mitigate any adverse effect	ts of non-compliance and prevent recurrence of the		
non-compliance:			
The Water Corporation have re-enforced the importance of full compliance and in particular the risks related to not adhering with regulatory requirements. The Water Corporation implemented an 'Allocation Kick-off Pack' which includes a copy of all paddock REFs and approvals. The licensee has committed to ensuring operators are better supervised and informed, including an increased awareness of regulatory compliance obligations and paddock REFs. Inspected the application area to confirm no adverse effect on any sensitive receptors.			
Was this non-compliance previously reported to DWER?			
Yes, and

•	and total fire bans prevented		equired paddock further
into the farm			
Action taken to mitig non-compliance:	gate any adverse effects of r	on-compliance and pre	event recurrence of the
The biosolids stockpile was stored within a bunded area The dam and adjacent streams were inspected for signs of any biosolids, which confirmed 100% of biosolids were contained.			
Was this non-compliance previously reported to DWER?			
Yes, and			
☐ Reported to I	DWER verbally	Date: / /	
☐ Reported to I	DWER in writing	Date: / /
