Annual Audit Compliance Report Form

Section A – Licence	details				5	
Licence number:	L6912/1997/	11	Licence file	number;	2012/001754	
Licence holder name:						
Trading as:						
ACN:						
Registered business address:						
Reporting period:	1 /1 / 2021	to 31	/12 /20201

ANNUAL ENVIRONMENTAL REPORT SHIRE OF BROOME WASTE MANAGEMENT FACILITY **RESERVE 40813 BUCKLEYS ROAD, BROOME**

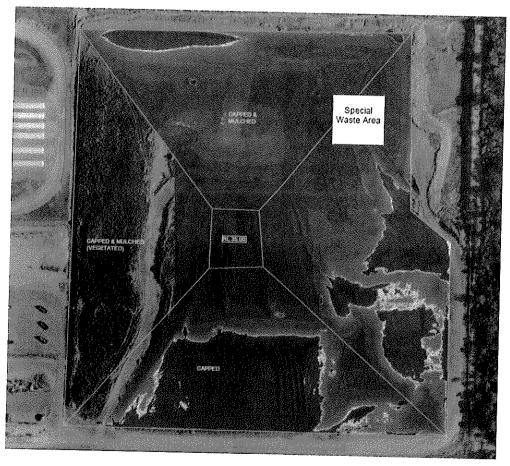
Please refer to the below survey image (North upwards) from December 2021 that indicates the disposal area for asbestos and medical waste during 2021. The survey files are recorded in the Shire's electronic records system for future reference.

Waste logs indicating date, time volume and supervised burial are attached. The quarantine waste was disposed of in the same location referred to in G9 (a) (vii) Special wastes type 1 and 2 disposal areas
