Annual Audit Compliance Report Form

Environmental Protection Act 1986, Part V Division 3

Section A – Licence details					
Licence number:	8155/2004/2	Licence file number:			
Licence holder name:	EDL NGD (WA) Pty Ltd				
Trading as:	EDL NGD (WA) Pty Ltd				
ACN:	070 941 721				
Registered business address:	Level 6, 1 Eagle Street Brisbane QLD 4000				
Reporting period:	01/07/2022 to 30	0/06/2023

Section E – Details of Non-compliance with Licence Condition

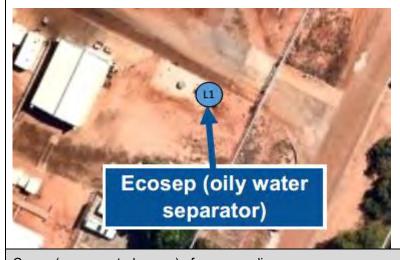
Condition 5 requires output of the Oily Water Separator (L1) to be less than 15 mg/L of Total Recoverable Hydrocarbons. Testing of L1 was conducted on 24 May 2023 and returned a non-compliant result of 156 mg/L TRH. The laboratory report is included in Attachment 3.

L1 also returned a non-compliant result in 2022 at the end of an extreme weather event, with the high level shut-off valve being blown off by the force of the incoming stormwater. In response to this incident, EDL decided to limit the amount of stormwater entering the system by installing a cover on a drain that feeds the system. It was hoped that this would protect the separator in large weather events.

In early January 2023 another large weather event occurred, with 557mm deposited over 6 days, at a peak of 204mm deposited in a single day on 04 January 2023. It is likely that the high level shut-off valve was damaged during this event, although since the system contains no alarms and is underground, this was not apparent until after sampling occurred in May.

It is likely that during the January event the water level rose within the separator chamber and contaminated the outlet (which contains the sampling point) with oil, resulting in the non-compliant sample some months later.

There is no evidence to suggest that any substantial quantity of oil has left the system. There is no sign of any oil coming to the surface at the underground dispersal area, and the separator still contains the expected quantity of oil. Any oil leaving the system would have been highly dispersed by the outgoing stormwater.

Section E – Details of Non-compliance with Licence Condition				
The high level shut-of valve was not able to withstand the force of the stormwater inflows.				
Action taken to mitigate any adverse effects of non-compliance and prevent recurrence of the non-compliance:				
Despite taking action after the 2022 incident to reduce the stormwater catchment feeding into the system as much as is feasible, EDL has concluded that the system is still receiving more stormwater than it is capable of handling. Therefore EDL is planning to (pending any necessary approvals): 1. Decommission the separator system; 2. Block the transformer bund sumps and install discharge valves; 3. Manage and dispose of contaminants at their sources; 4. Check captured stormwater for contaminants and release it from bunds directly in a controlled manner. EDL believes that taking these actions will reduce the risk of environmental harm.
