**CPS 818/6 – OFFSET PROPOSAL – SLK 145.7 EXPANSION OF MATERIAL SOURCE
WITHIN EURARDY STATION (NORTH WEST COASTAL HIGHWAY)**

North West Coastal Highway

Shire of Northampton
SLK 145.7

Material Pit Rehabilitation Plan

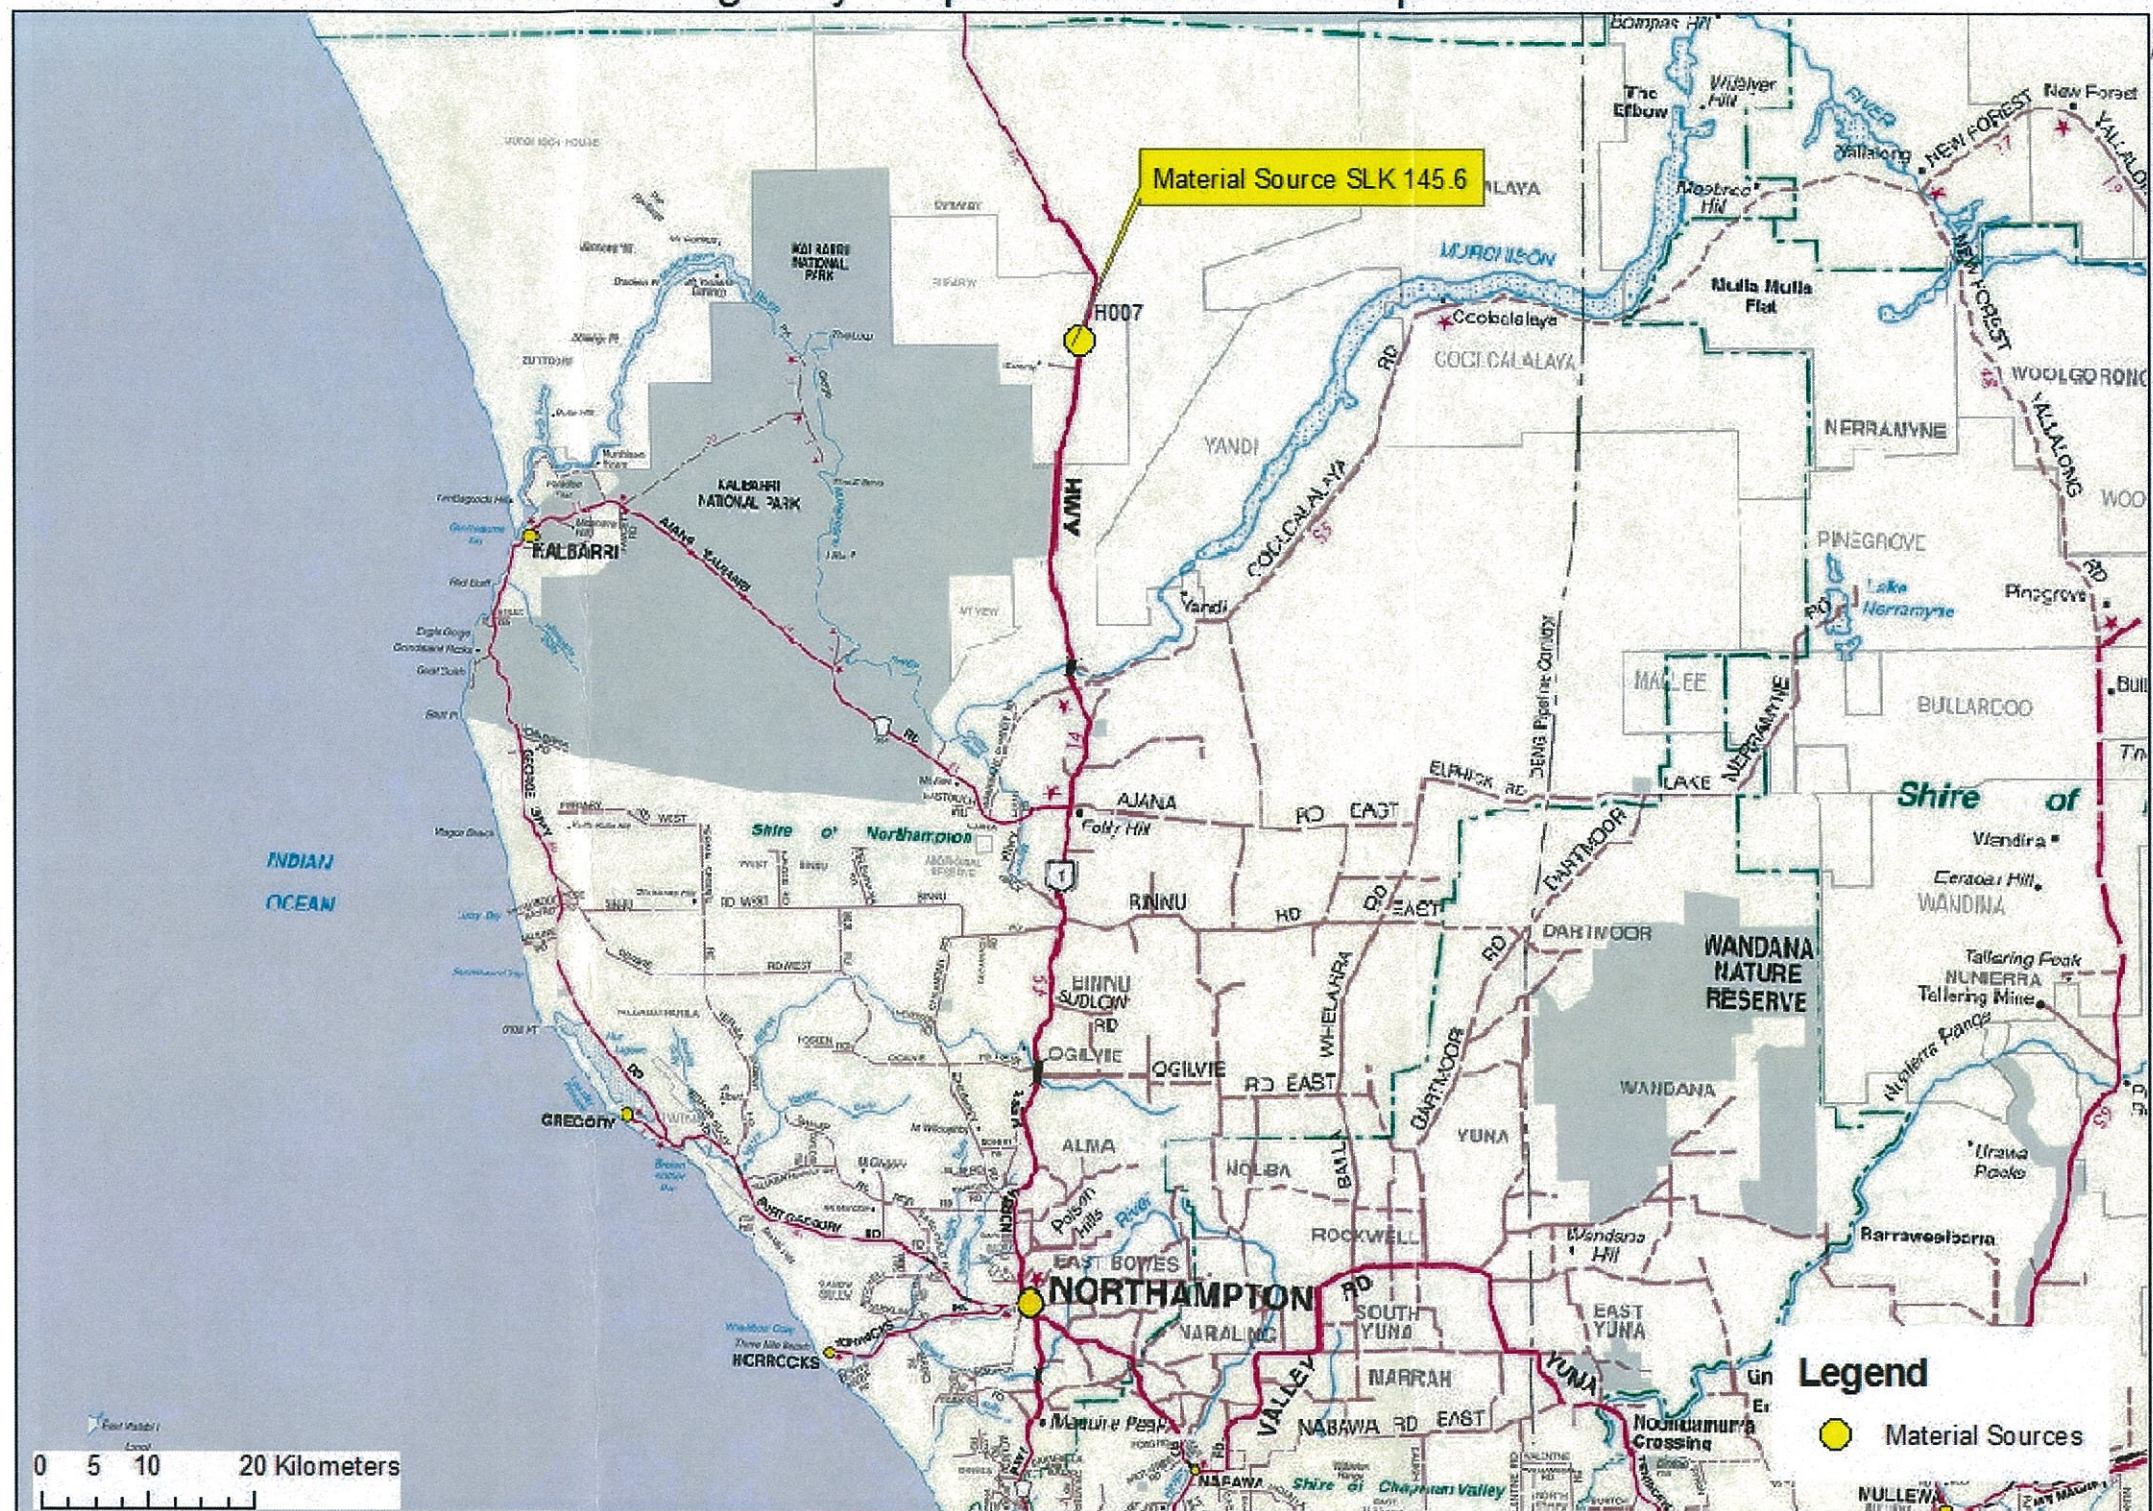
FIGURE 1 MATERIAL SOURCE LOCATION

North West Coastal Highway Proposed Material Pit Expansion Area SLK 145.6

Main Roads has identified a potential material site within Eurardy Station, located along North West Coastal Highway approximately 30 km north of the Murchison River. The proposed material site has been vested to Main Roads through Section 19 approvals for material extraction, in accordance with the *Mining Act 1978*.

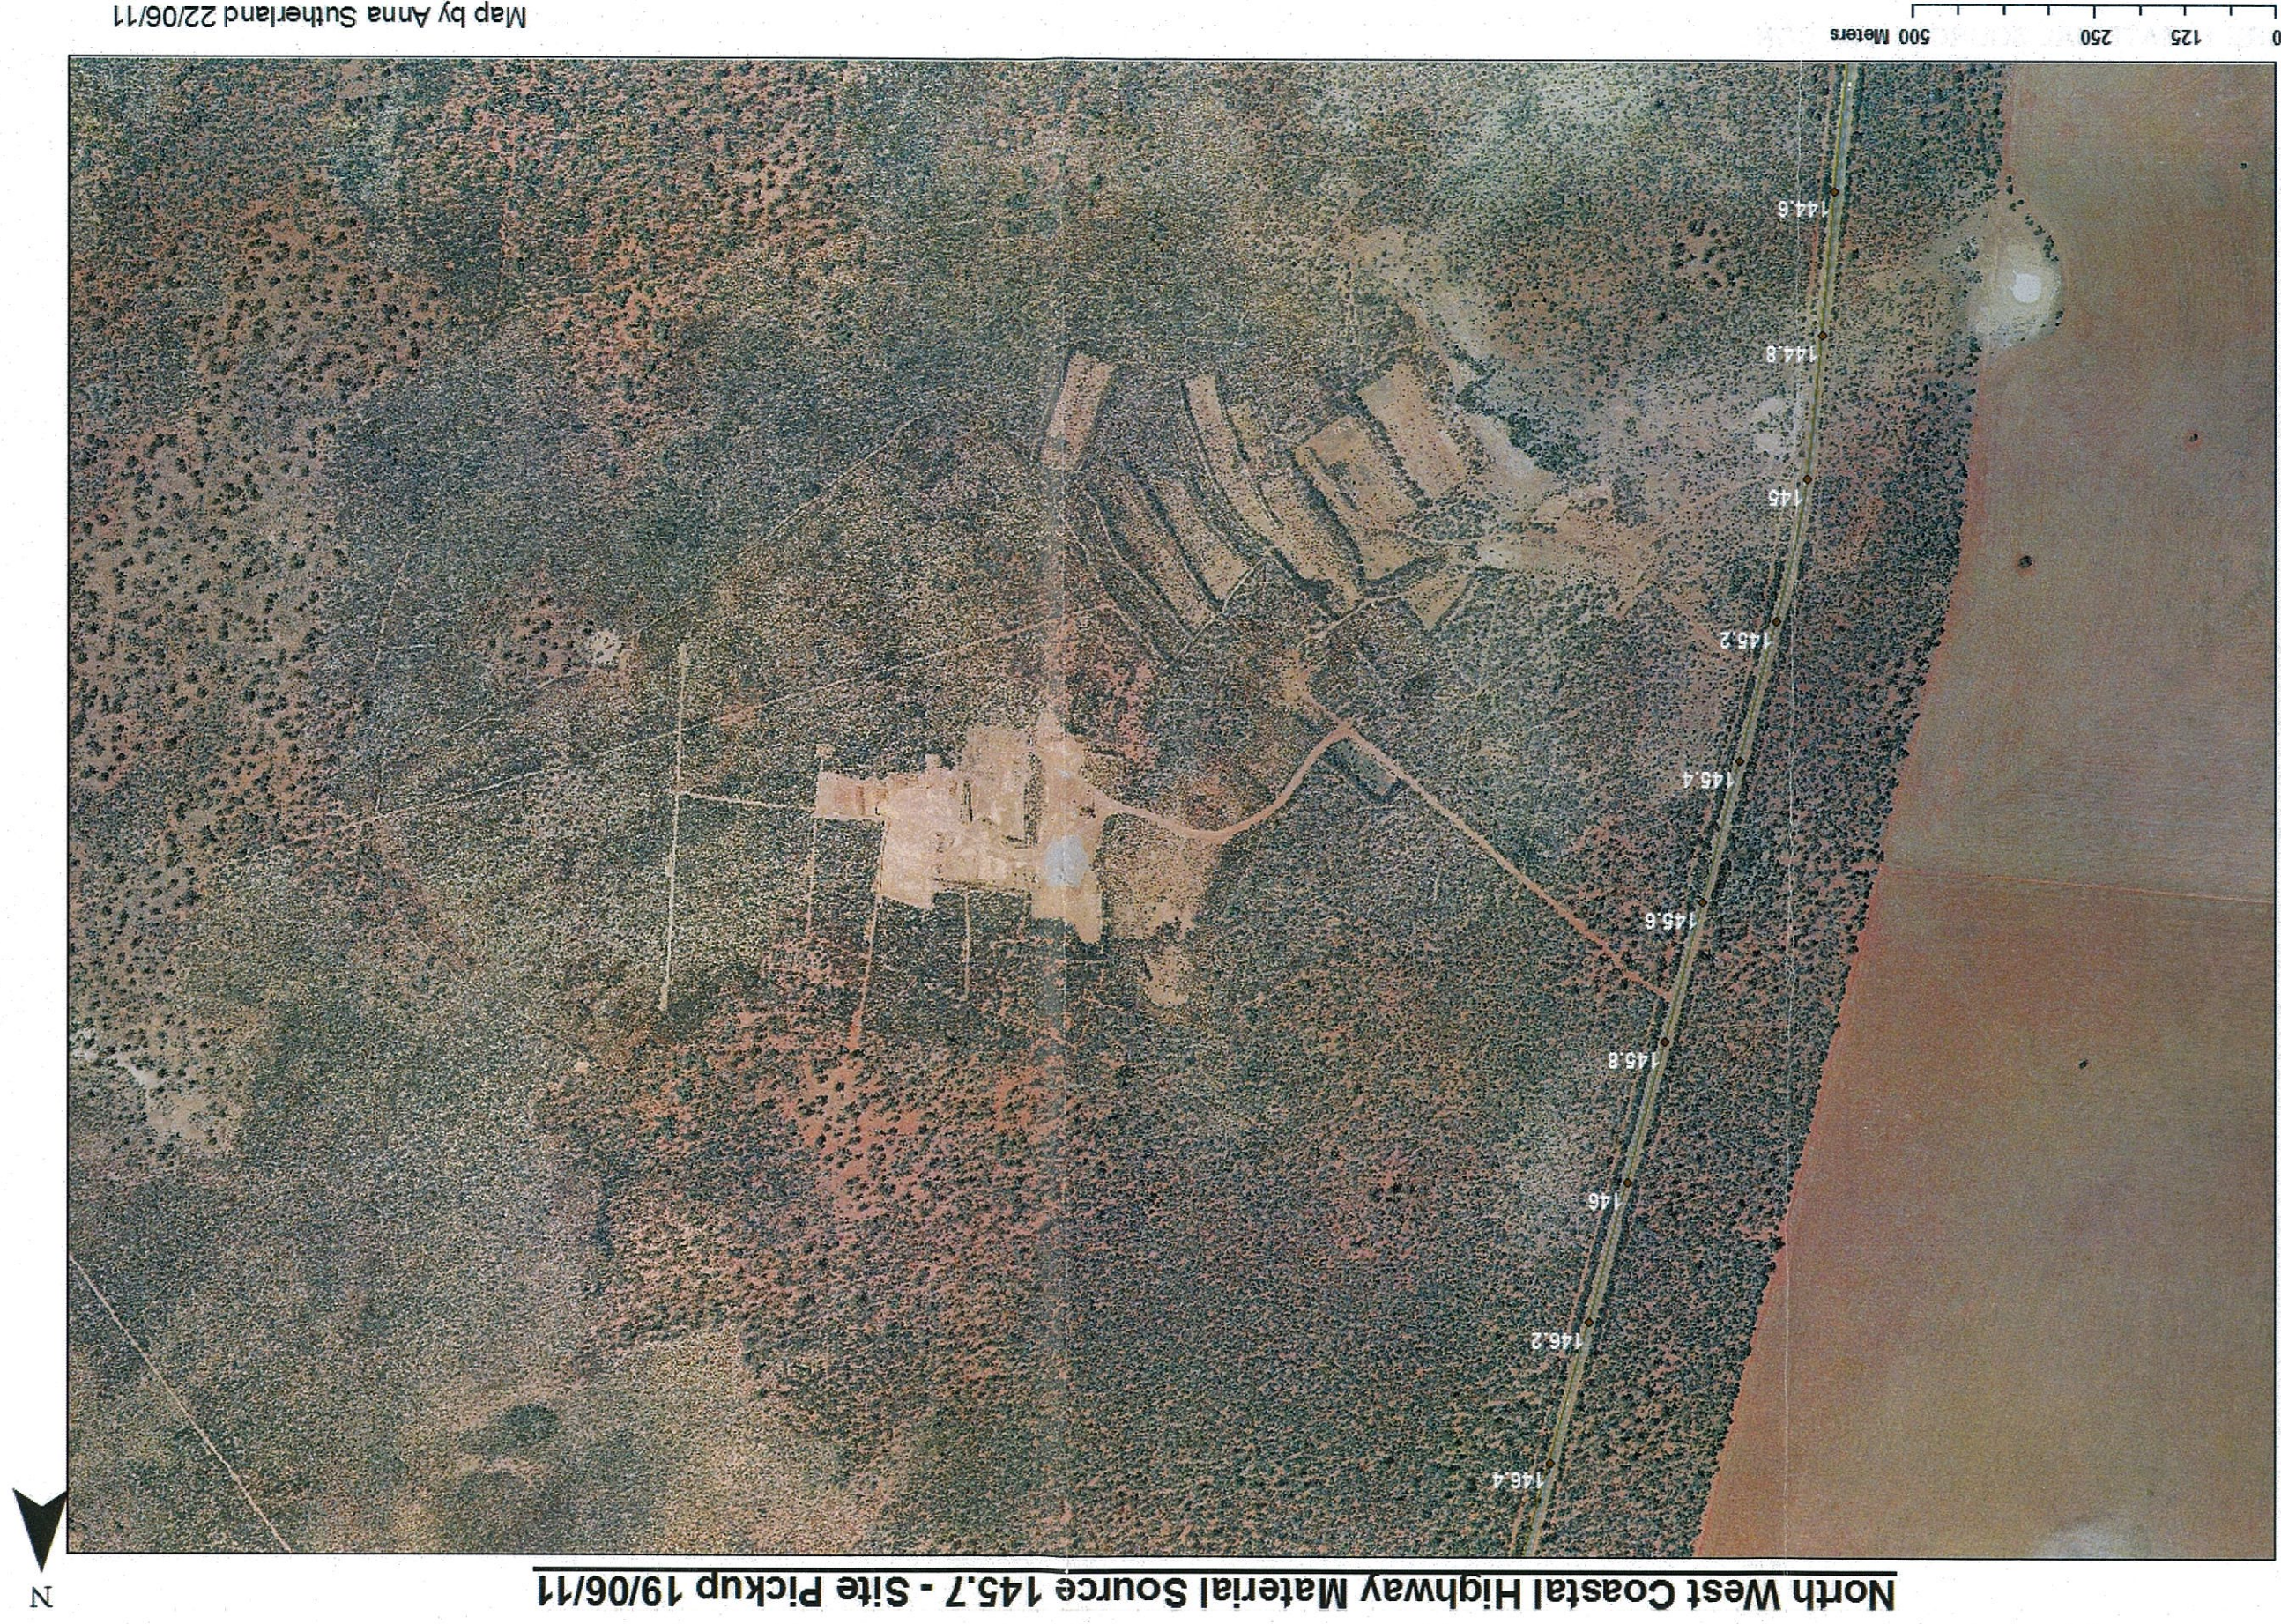
Figure 2 2006 Image of Material Source at SLK 145.7

Main Roads proposes to extend an initial section of this potential material site for the purpose of grave extraction. The total area of native vegetation proposed to be cleared during this initial stage of grave extraction is 4.5ha. The area identified in blue in figures 2 & 3, will be cleared, with the material to be stockpiled in the green section. This allows the for the blue section to be rehabilitated.

The revegetation of this material pit will be contained within the areas detailed in figures 2 & 3 and comprise of seeding with locally occurring indigenous species. The total area to be revegetated is approximately 9 ha.

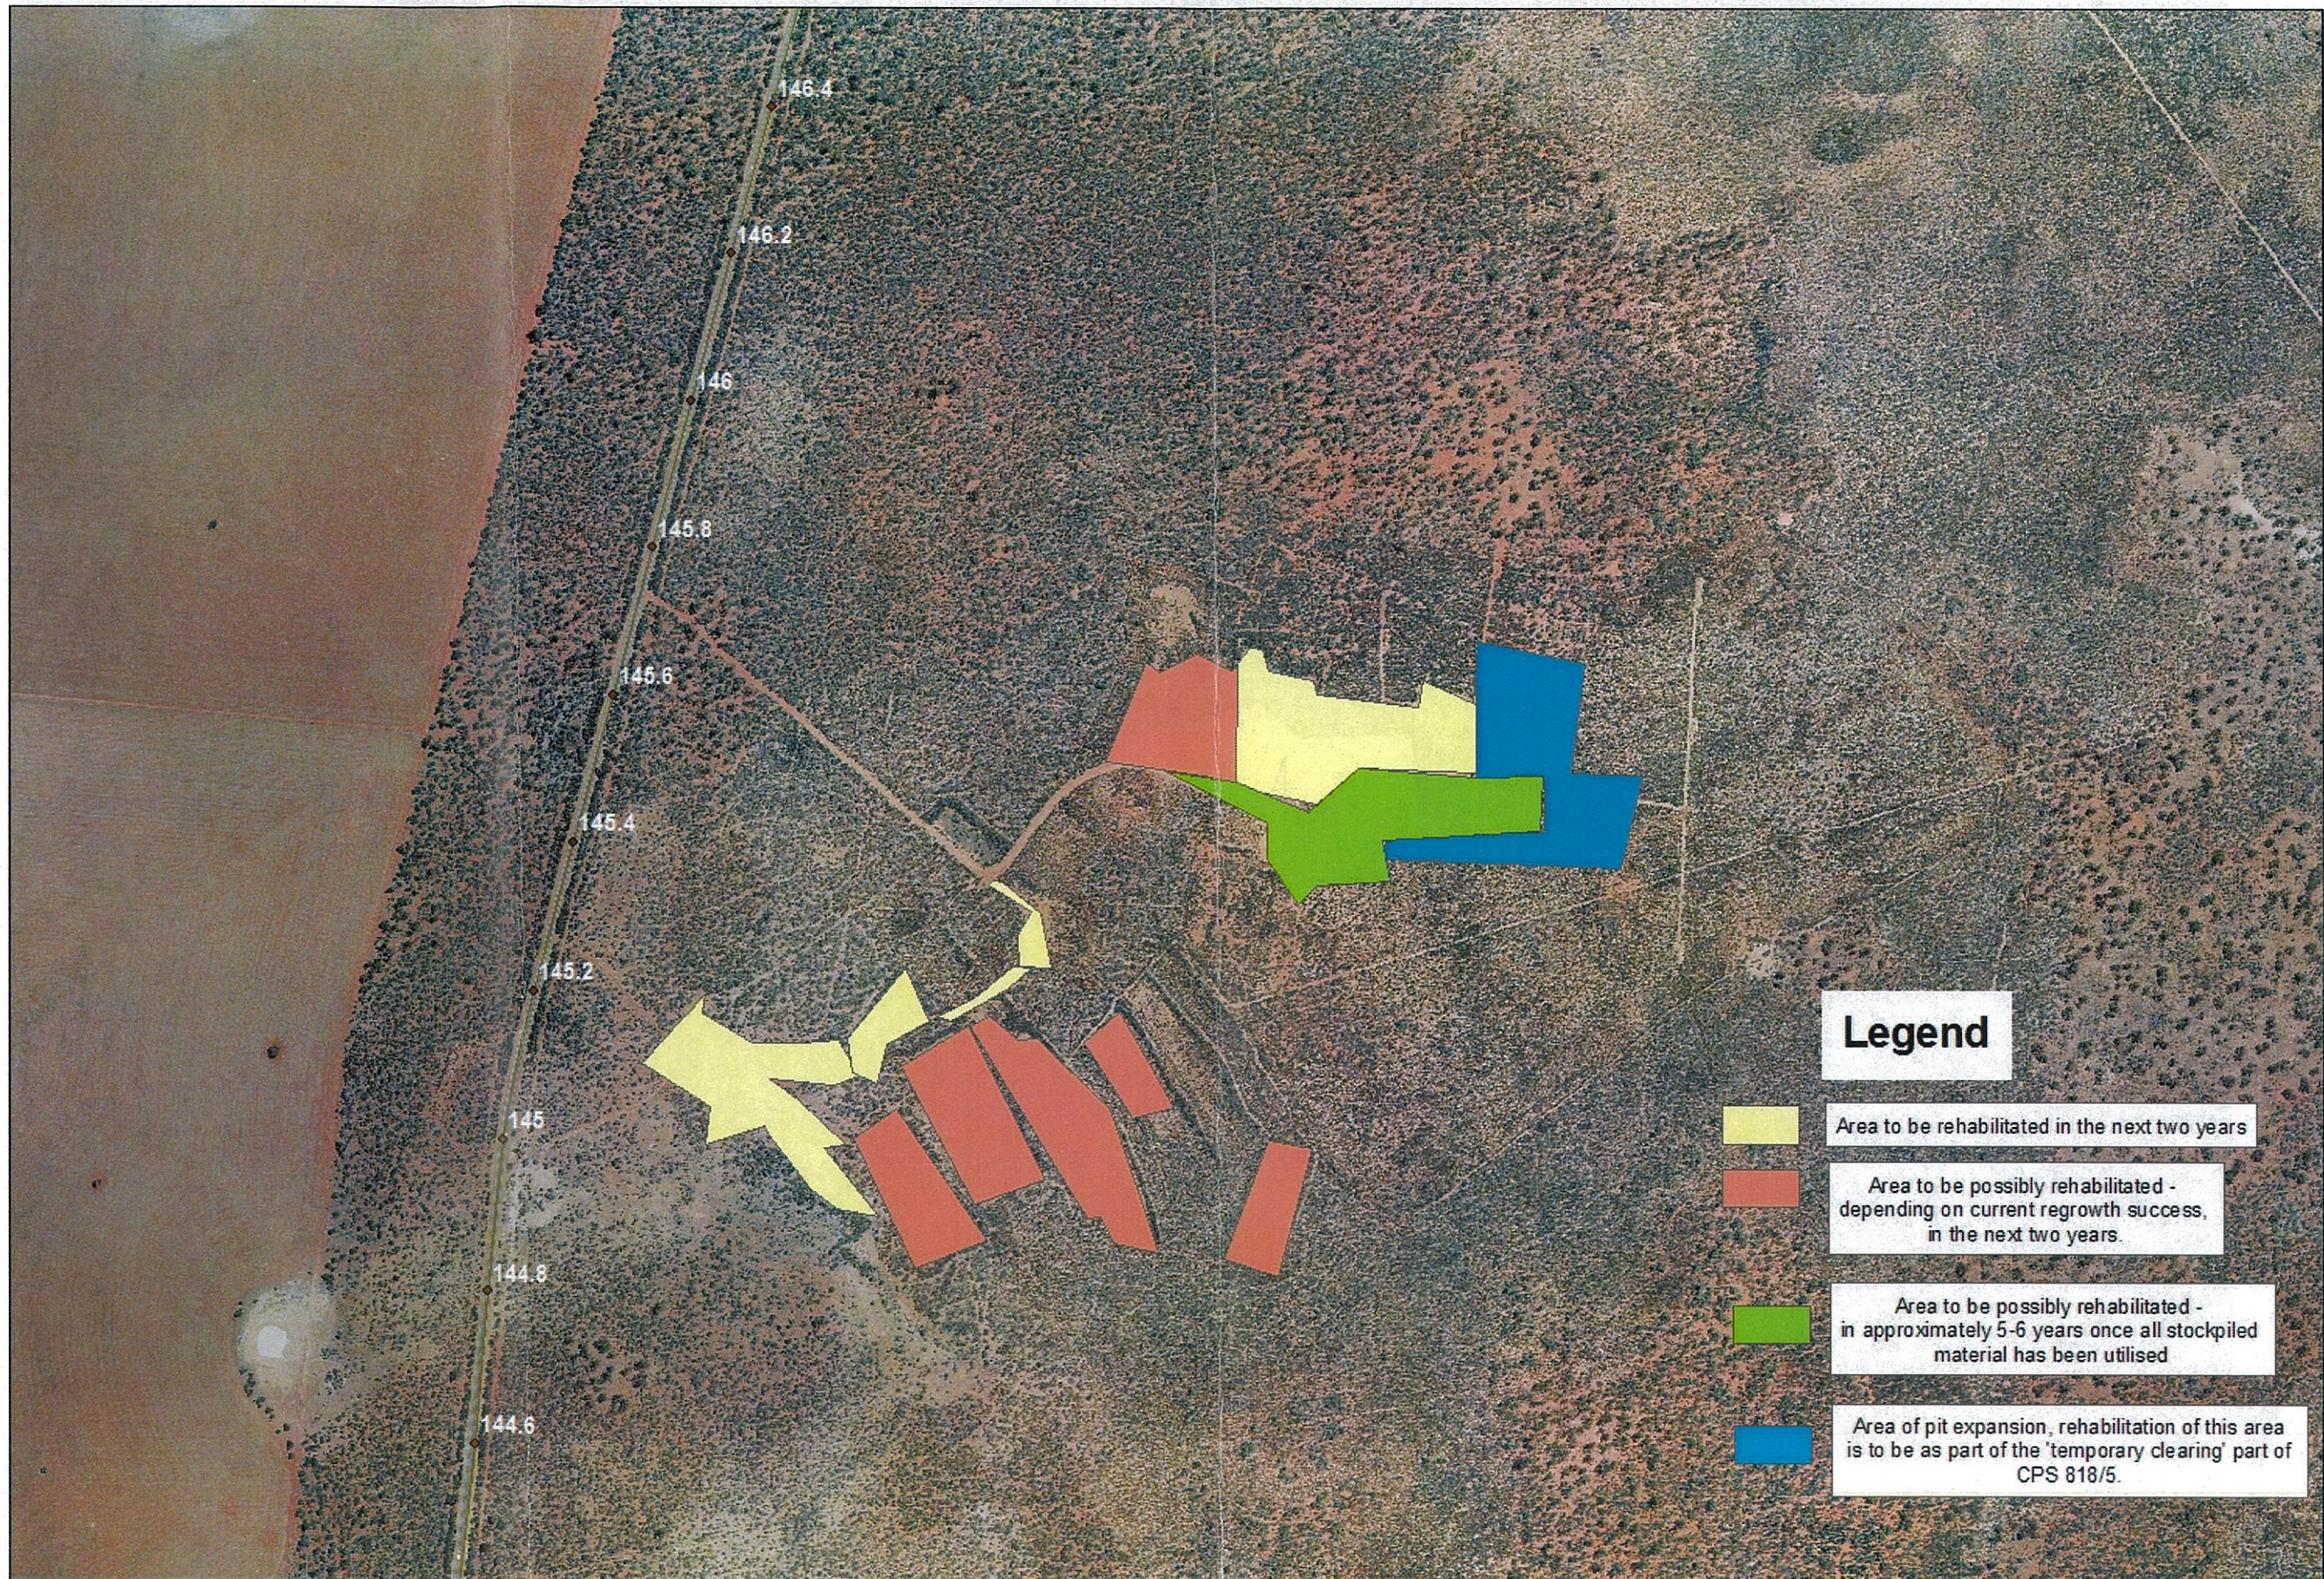
North West Coastal Highway Material Source 145.7 - Site Pickup 19/06/11

- Area to be rehabilitated in the next two years
- Area to be possibly rehabilitated - depending on current regrowth success, in the next two years.
- Area to be possibly rehabilitated - in approximately 5-6 years once all stockpiled material has been utilised
- Area of pit expansion, rehabilitation of this area is to be as part of the 'temporary clearing' part of CPS 818/5.

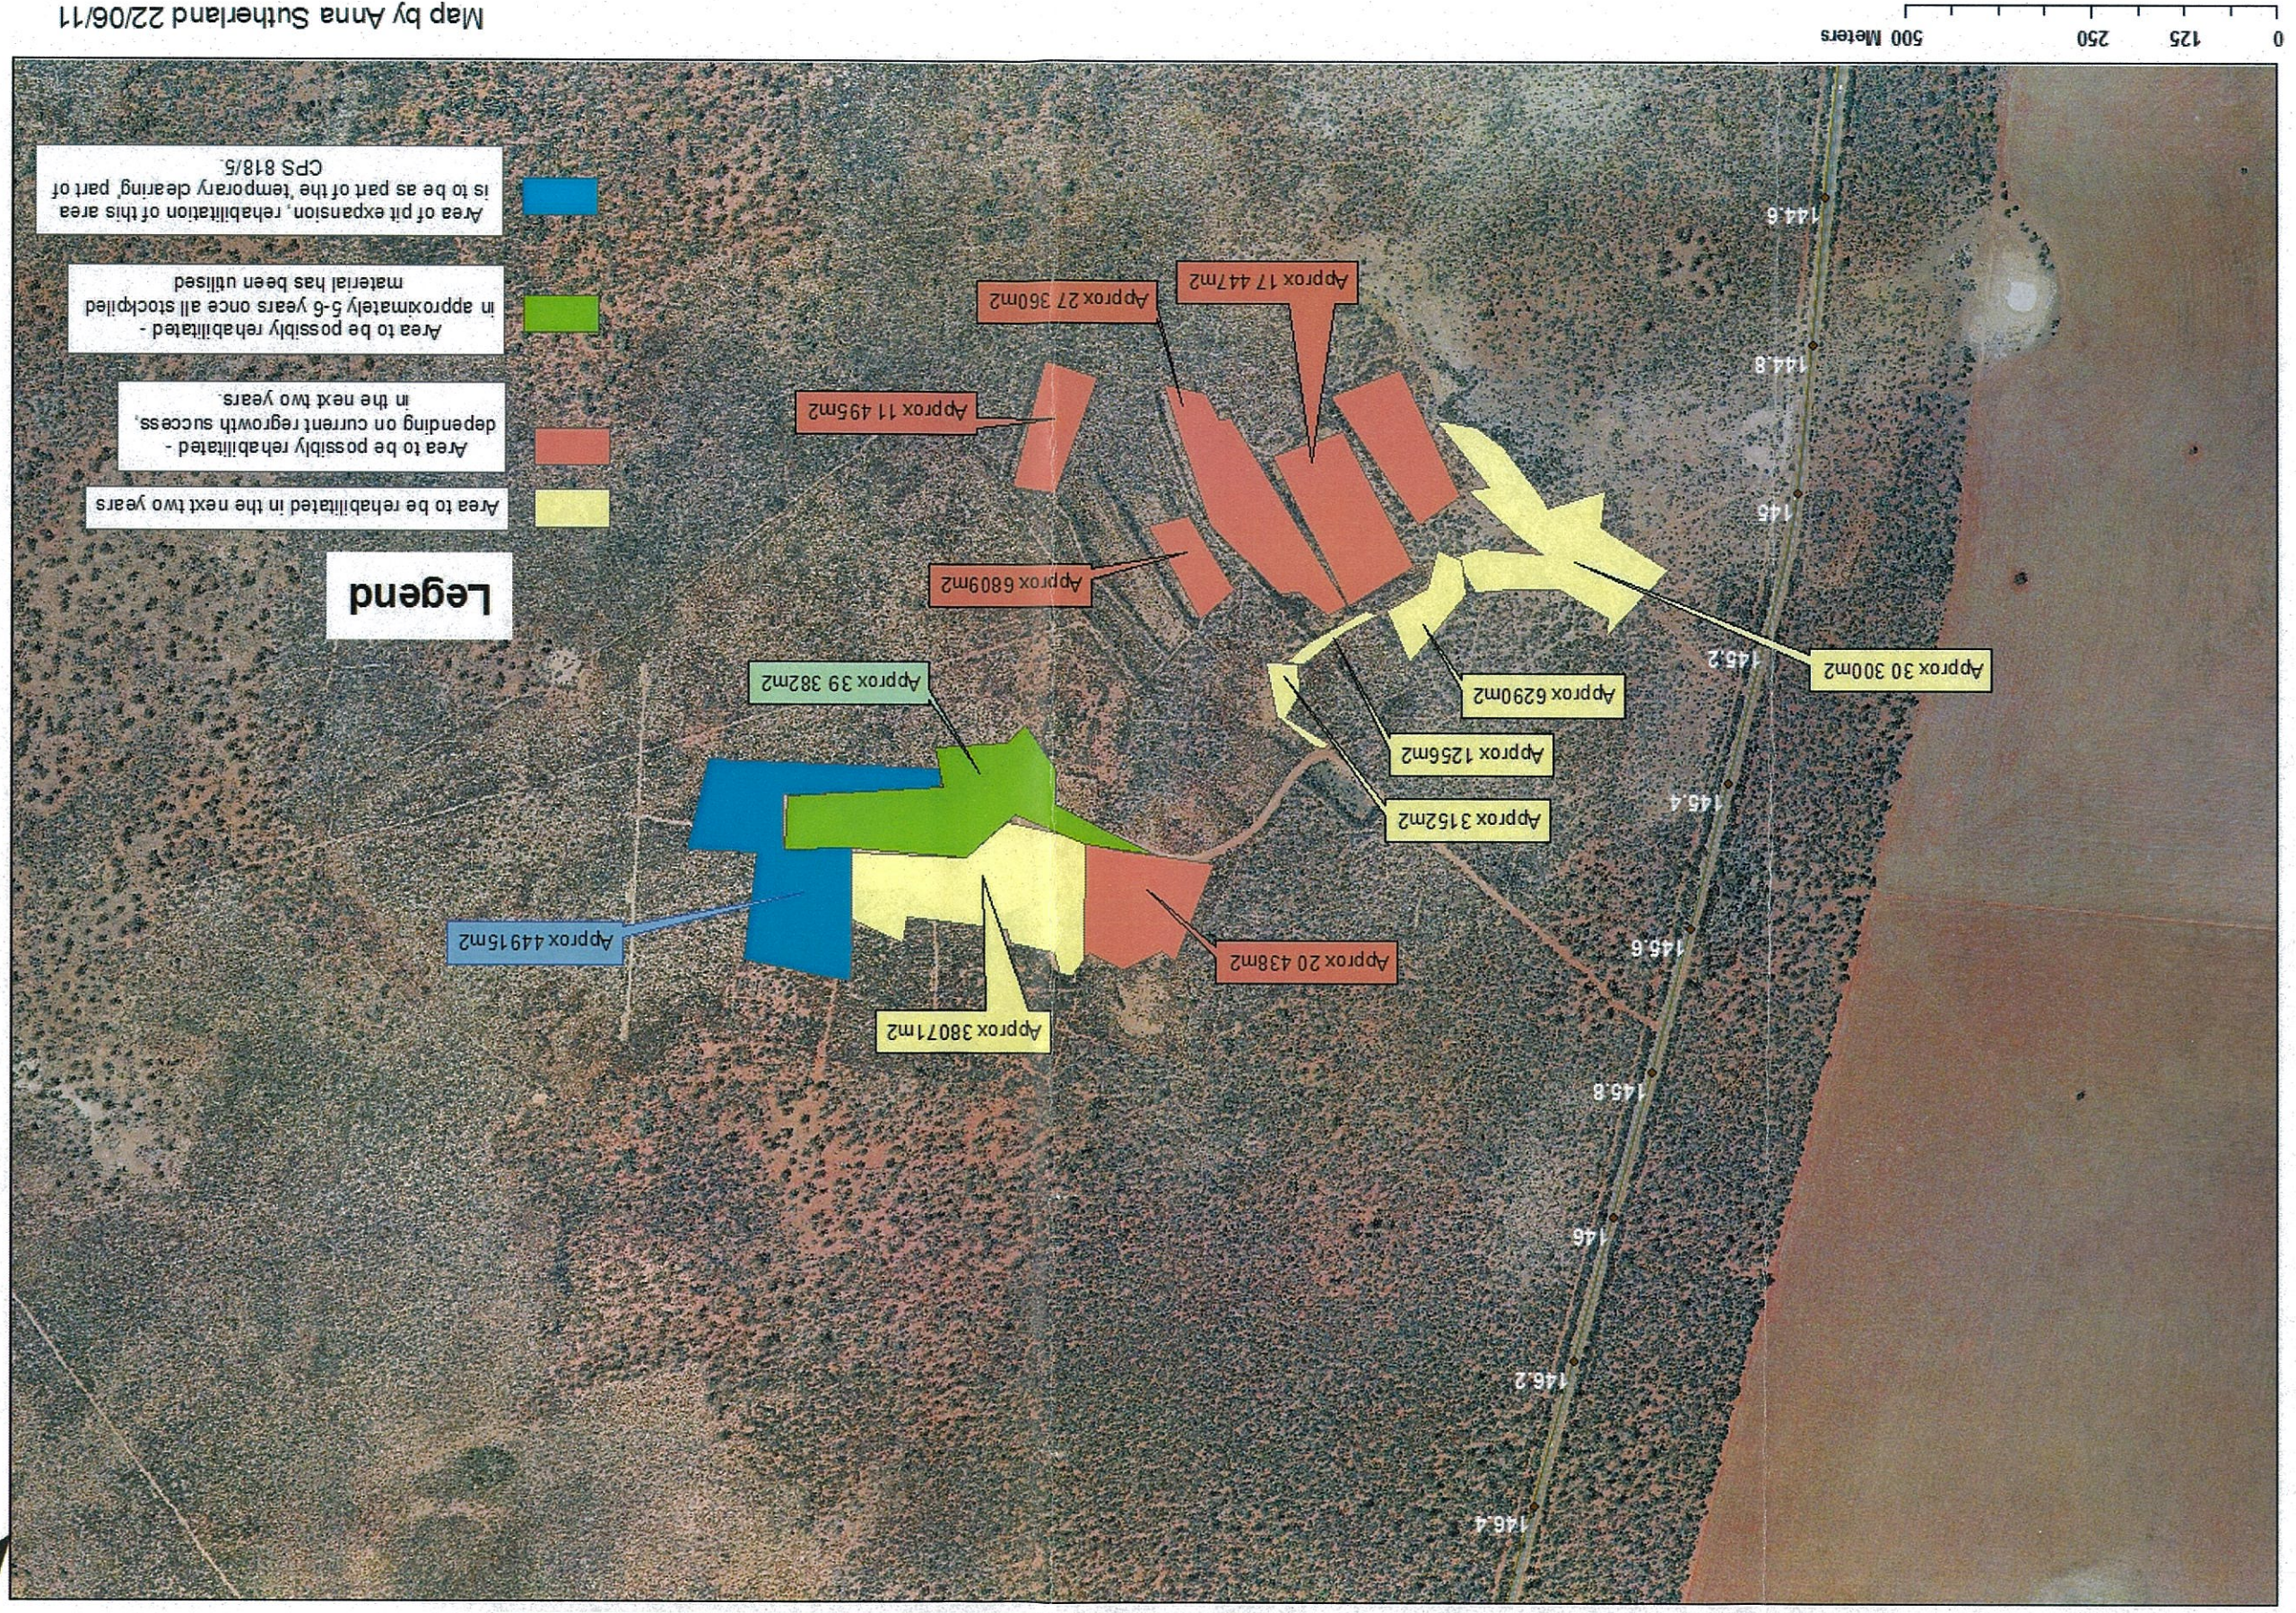
North West Coastal Highway Material Source 145.7 - Site Pickup 19/06/11

- Use monitoring points selected by GPS by site visit 19/06/11
